**United States  
Department of the Interior**

**Aviation Safety Review  
Fiscal Year 01**

**Prepared by  
Office of Aircraft Services  
Aviation Safety Office  
February, 2002**

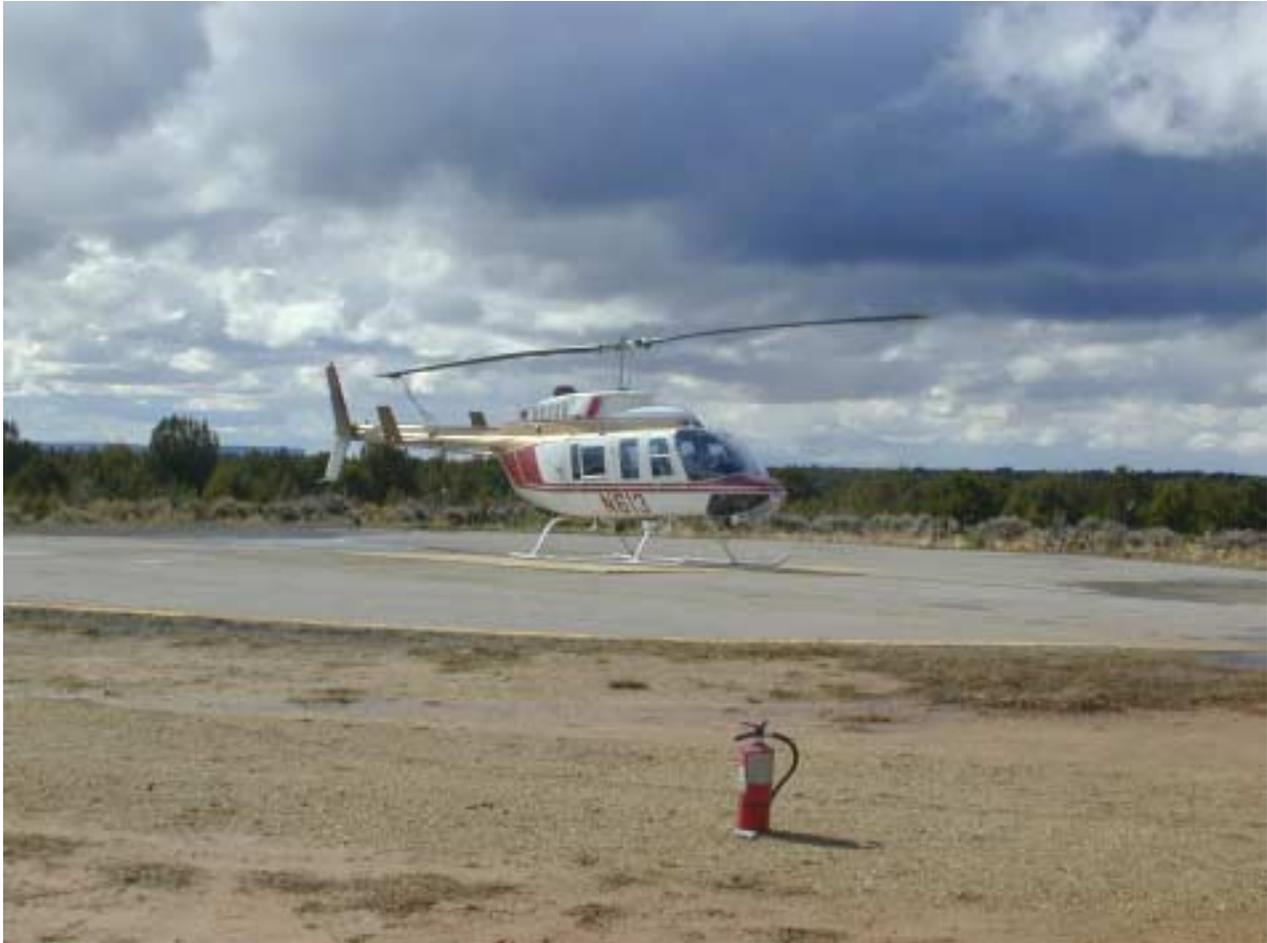
**AIRCRAFT ACCIDENT  
01-1F01-O-FNP**

**Narrative:** On October 30, 2000, at 1130 Mountain daylight time, a Bell 206 L-1 helicopter, N613, sustained substantial damage when a tail rotor blade failed during approach to a helicopter landing pad at Mesa Verde National Park, Colorado. The airline transport certificated pilot, the sole occupant, was not injured. The flight was a public use flight operating under Title 14 CFR Part 91 and no flight plan was filed. Visual meteorological conditions prevailed. The flight originated from the pad about 0930. The pilot conducted a normal landing and during inspection following shutdown, the pilot found that one tail rotor blade had shed the trailing edge counterweight and trailing edge skin. He also found that three of the four mounting points for the tail rotor gearbox had fractured. Both tail rotor blades, which had accumulated approximately 30.8 hours since new, were sent to the NTSB Materials Laboratory for examination. The helicopter was repaired and when the shipping container containing new tail rotor blades was opened and the blades unpacked, the repair station rejected one blade for visual abnormalities in the area of the trailing edge counterweight.

**Probable Cause:** The National Transportation Safety Board determines that the probable cause of this accident was: The manufacturer's use of improper materials, and inadequate quality control of the tail rotor blades during the manufacturing process, which resulted in fatigue failure of the blade.

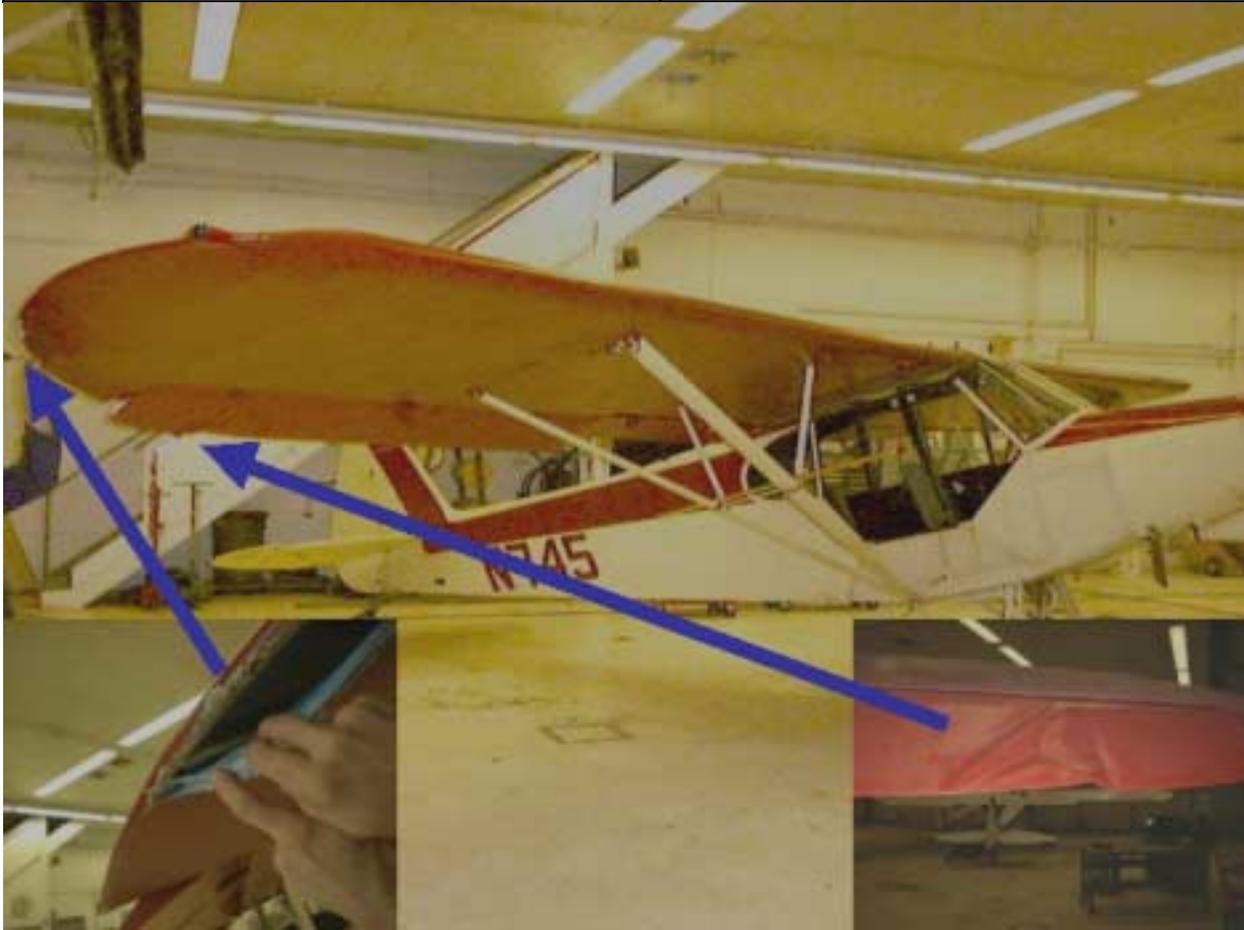
**AIRCRAFT ACCIDENT  
01-1E01-O-FWS**

**Narrative:** On April 21, 2001, about 1400 Alaska daylight time, a tundra tire equipped Piper PA-18 airplane, N745, sustained substantial damage during landing at the King Salmon Airport, King Salmon, Alaska. The airplane was being operated as a visual flight rules (VFR) cross-country government flight, under Title 14, CFR Part 91, when the accident occurred. The airplane was operated by the U.S. Department of the Interior, U.S. Fish and Wildlife Service. The commercial certificated pilot, the sole occupant, was not injured. Visual meteorological conditions prevailed, and VFR company flight following procedures were in effect. The flight originated at the Cold Bay Airport, Cold Bay, Alaska, about 1010. The wind conditions were reported to the pilot as 070 degrees at 6 knots. After touchdown, the airplane veered to the left. The pilot applied right rudder and right brake pressure, but the airplane continued to the left. The right wingtip and the right aileron struck the gravel-covered ground along the left side of the runway.

The pilot, using a three-point landing technique, attempted to land with a quartering tailwind.

**Probable Cause:** The National Transportation Safety Board determines the probable cause(s) of this accident as follows: The pilot's inadequate compensation for wind conditions, and inadequate weather evaluation resulting in a loss of directional control during the landing roll.

**Contributing Factors:** Factors in the accident were the presence of a quartering tailwind, and an inadvertent ground loop.

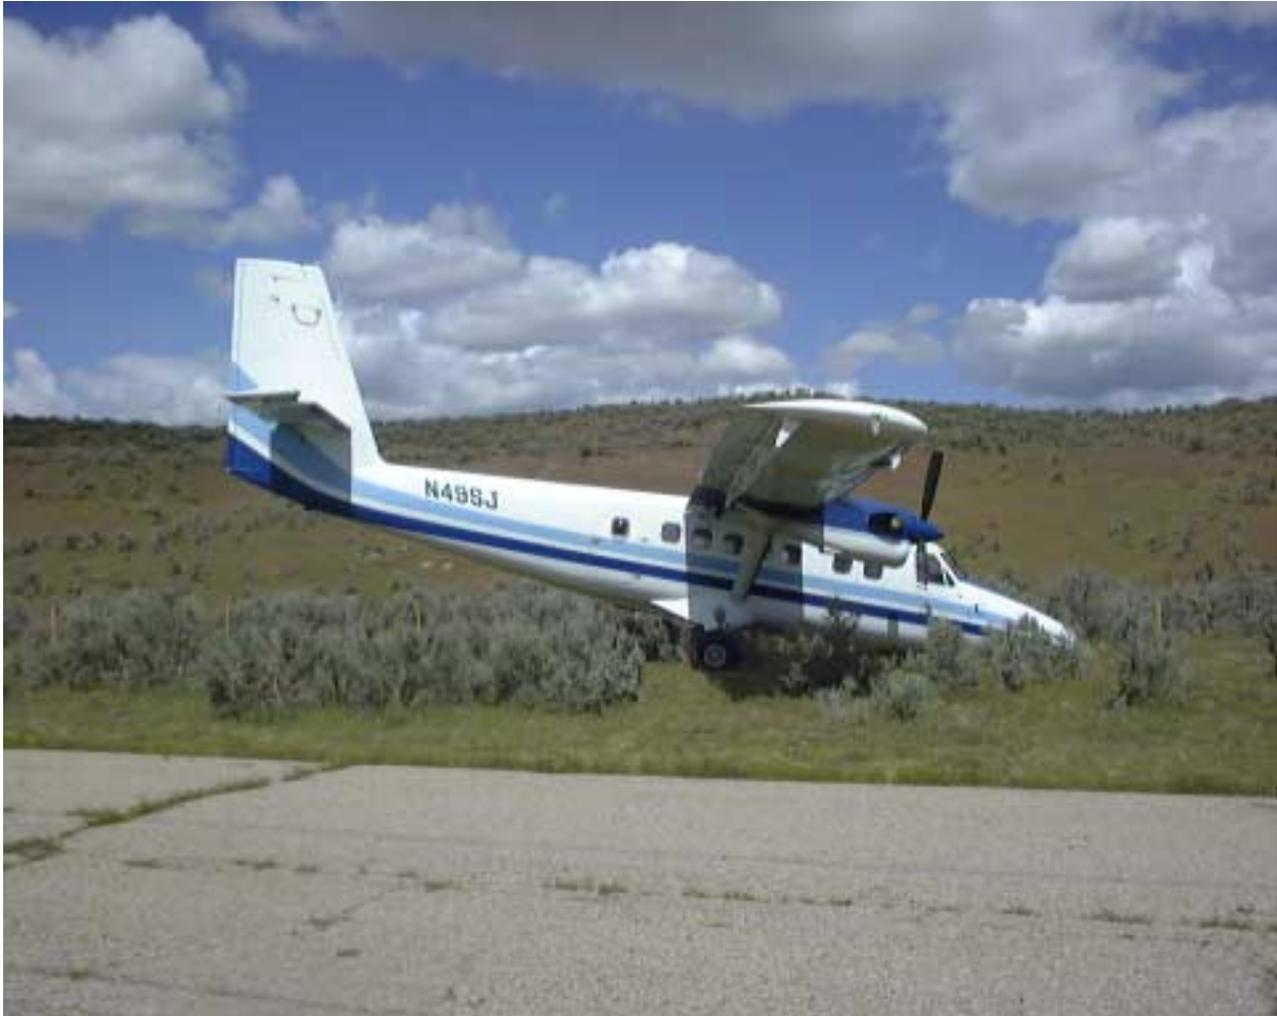
**AIRCRAFT ACCIDENT  
01-1F03-O-LLM**

**Narrative:** On May 1, 2001, approximately 1030 Mountain daylight time, a deHavilland DHC-6-300, N49SJ, registered to the Department of the Interior, Office of Aircraft Services as a public use flight, was substantially damaged when the aircraft veered off the runway at Star Parachute Airport, Star, Idaho, and collided with the terrain. Visual meteorological conditions prevailed and no flight plan was filed. Neither the commercial pilot nor the passenger were injured. The flight originated from Boise, Idaho, at an unknown time. The pilot reported that during the landing roll, the aircraft began to veer to the left. When aileron and rudder control were not effective to re-align the aircraft's direction of travel, the pilot transferred over to the nose wheel steering control. The pilot applied corrective input all the way to the right when he heard a "clink" sound. The aircraft exited the side of the runway and collided with the terrain. Post-accident inspection of the aircraft found that the nose wheel steering cable was broken.

The pilot elected to use the nose wheel steering during a crosswind landing and at an excessive ground speed.

Pre-existing metal fatigue was discovered in the nose wheel steering cable during the post-accident investigation.

**Probable Cause:** The National Transportation Safety Board determines the probable cause(s) of this accident as follows: Fatigue failure of the nose wheel steering cable during the landing roll.

**Contributing Factors:** Rough/uneven terrain was a factor.

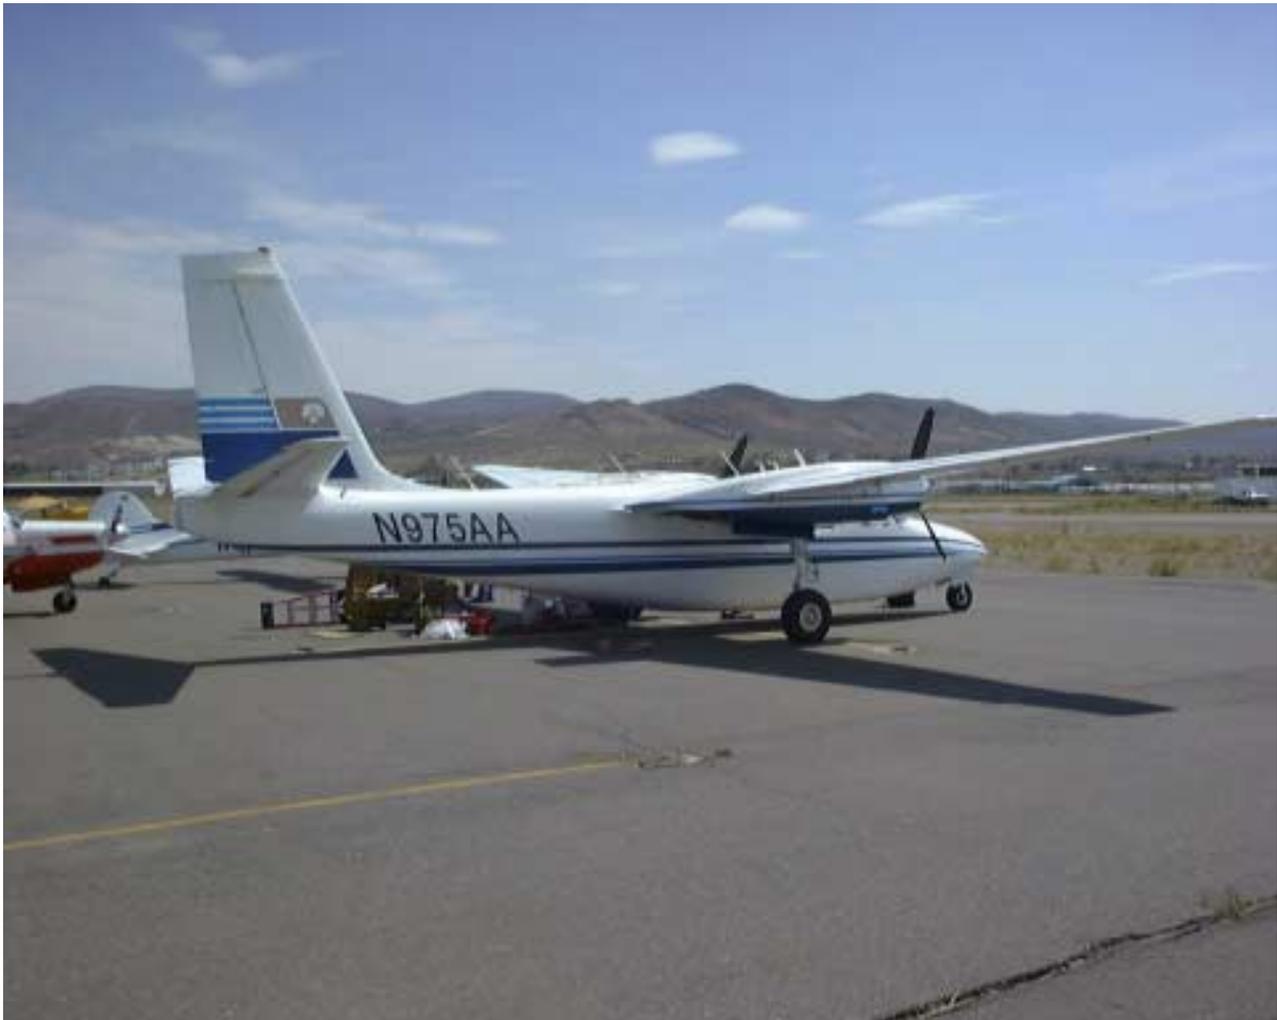
**AIRCRAFT ACCIDENT  
01-1F04-C-LLM**

**Narrative:** On August 21, 2001, at 1503 hours Pacific daylight time, an Aero Commander 500, N975AA, had both main landing gear collapse on landing at Elko, Nevada. Avcenter, Inc., was operating the airplane as a public use fire command and control flight under the provisions of 14 CFR Part 91. The commercial pilot and two passengers were not injured; the airplane sustained substantial damage. The local flight departed Elko about 1330. Visual meteorological conditions prevailed, and a company VFR flight plan had been filed. The operator reported that the airplane touched down and began its landing roll. About 100 feet down the runway, both main landing gear collapsed. The resulting skid ground off the belly skin and damaged several structural airframe components.

After the mishap the aircraft was moved and partially disassembled by the vendor prior to the arrival of investigators.
