**United States
Department of the Interior**

**Aviation Safety Review
Fiscal Year 02**

**Prepared by
National Business Center
Office of Aircraft Services
Aviation Safety Office
February 2003**

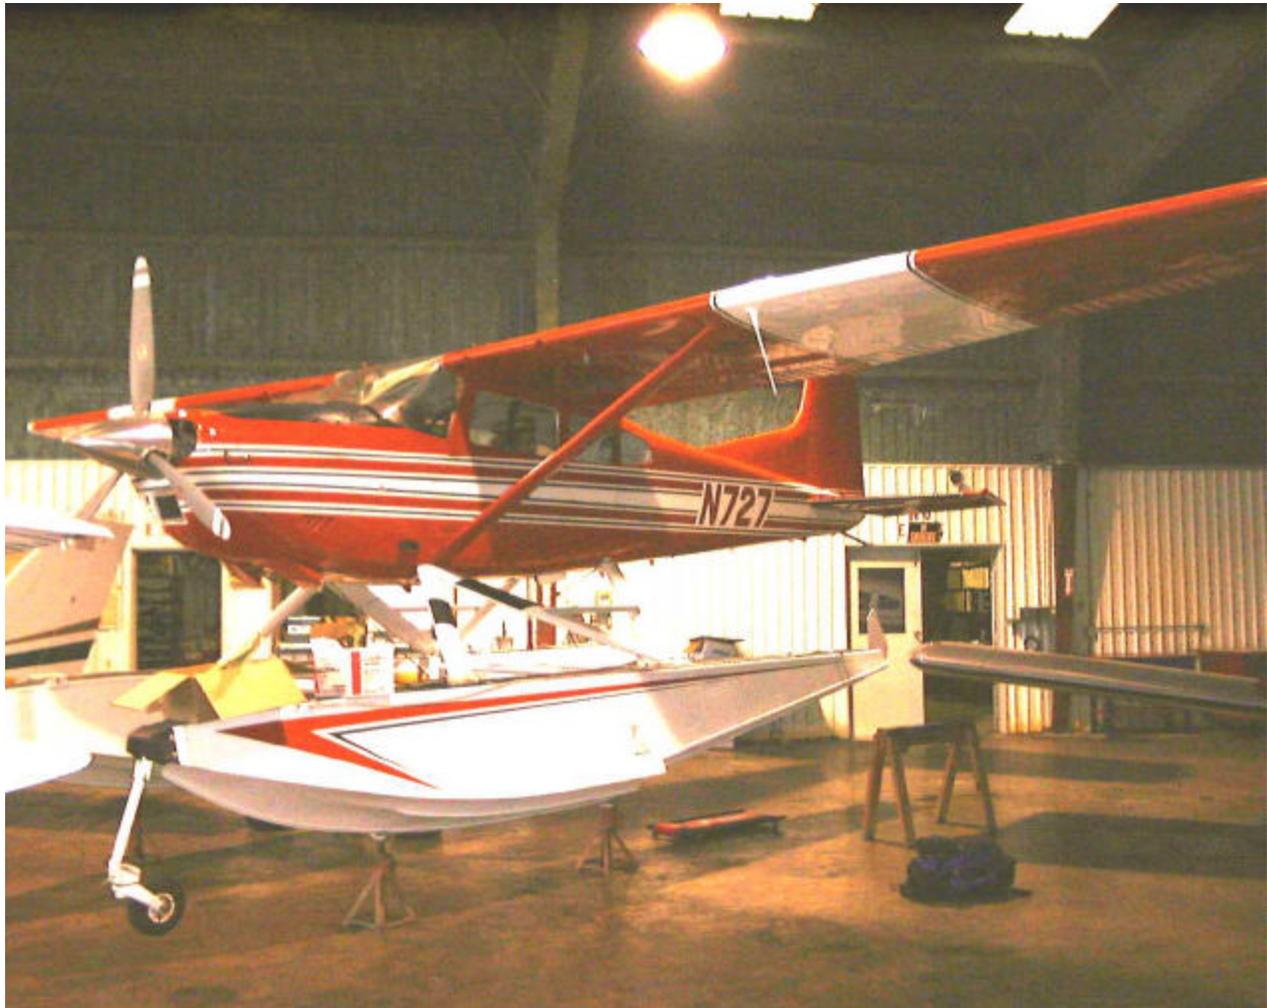
**AIRCRAFT ACCIDENT
02-2F01-O-EGS**

AIRCRAFT DATA: Cessna A185F	DATE: October 3, 2001
BUREAU: U.S. Geological Survey	LOCATION: Houma, LA
INJURIES: One Uninjured	SOURCE: Fleet

Narrative: On October 3, 2001, at 0900 central daylight time, a Cessna A185F amphibian, N727, was substantially damaged during a hard landing at the Houma-Terrebonne Airport, Houma, Louisiana. The airplane was registered to the U.S. Department of the Interior and was operated by the U.S. Geological Survey. The commercial pilot, who was the sole occupant, was not injured. Visual meteorological conditions prevailed and an instrument flight rules flight plan was filed for the 14 Code of Federal Regulations Part 91 positioning flight. The flight departed Lafayette, Louisiana, at 0800. According to a representative from the U.S. Department of the Interior, the pilot was landing on runway 18 at Houma, when he flared too high and made a hard landing. The representative stated that one of the fuselage bulkheads sustained structural damage.

- Pilot flared too high
- Preflight inspections are important

Probable Cause: The National Transportation Safety Board determines the probable cause(s) of this accident as follows: The pilot's high flare, which resulted in a hard landing.

Landing in a level attitude (pitch) with power may be a more appropriate procedure for landing an amphib-configured aircraft on hard surfaced runways.

Check your aircraft thoroughly before each flight for structural damage. Especially at the rear float attach points.

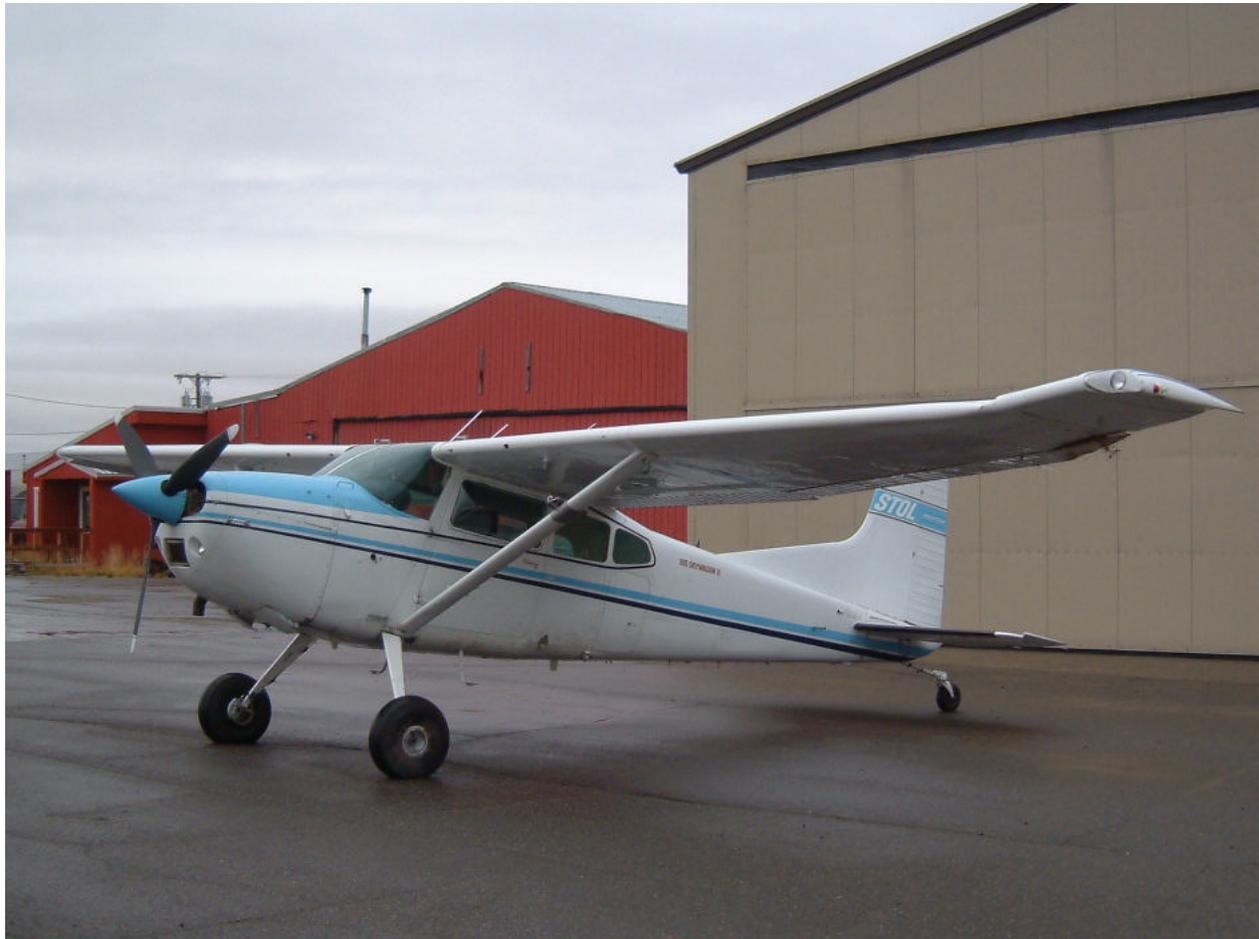
**AIRCRAFT ACCIDENT
02-2E01-O-FWS**

AIRCRAFT DATA: Cessna 185 (Wheel)	DATE: October 5, 2001
BUREAU: U.S. Fish and Wildlife Service	LOCATION: Bethel, AK
INJURIES: Three Uninjured	SOURCE: Fleet

Narrative: On October 5, 2001, about 1750 Alaska daylight time, a wheel-equipped Cessna 185F airplane, N9344N, sustained substantial damage during landing at the Bethel Airport, Bethel, Alaska. The airplane was being operated as a visual flight rules (VFR) cross-country government flight under Title 14, CFR Part 91, when the accident occurred. The airplane was owned and operated by the U.S. Department of the Interior. The public use flight was being operated in support of a bird survey for the U.S. Fish and Wildlife Service. The certificated commercial pilot and the two passengers were not injured. Visual meteorological conditions prevailed, and a VFR flight plan was in effect. In a written statement to the National Transportation Safety Board, the pilot reported that while on approach for landing on runway 18, he encountered wind estimated to be from 230 degrees at 8 knots, which required a right crosswind correction. He added that as the main wheels touched down on the runway, the airplane did not bounce. The pilot wrote: "Upon contact of the mains, I felt a very hard pull to the right. I then applied left rudder and brake, but this was ineffective in stopping it from coming around to the right." The airplane ultimately ground looped to the right, and the left wing and left elevator struck the edge of the runway. The airplane sustained substantial damage to the left wing and left elevator. A post-accident disassembly and inspection of the accident airplane's tailwheel assembly revealed that tailwheel steering horn showed signs of wear.

This was the pilot's first flight in the aircraft since it had been reconfigured from floats to wheels. The pilot chose to take two passengers on an operational mission rather than take a more conservative (but not mandatory) approach by taking the aircraft around the traffic pattern to re-familiarize himself with its wheeled landing characteristics.

Probable Cause: The National Transportation Safety Board determines the probable cause(s) of this accident as follows: The pilot's inadequate compensation for wind conditions.

Contributing Factors: Factors associated in the accident were a crosswind, and a worn tailwheel steering horn.

The risk of ground looping could also have been reduced if the pilot had chosen to make his first landing to the gravel runway instead of the paved runway (crosswind was essentially the same for either runway).

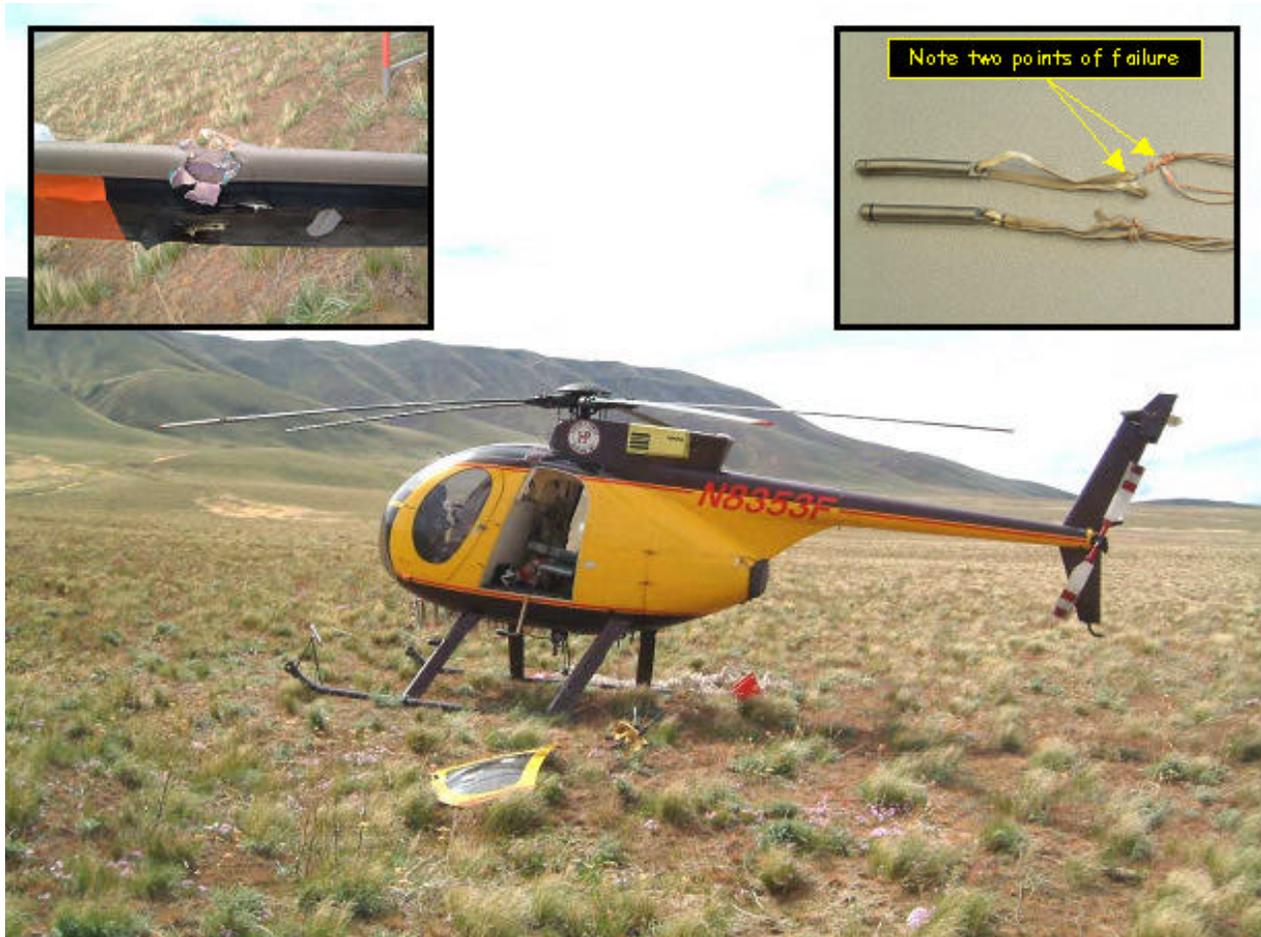
**AIRCRAFT ACCIDENT
02-2F02-C-FWS**

AIRCRAFT DATA: Hughes 369D	DATE: April 11, 2002
BUREAU: U.S. Fish and Wildlife Service	LOCATION: Richland, WA
INJURIES: Four Uninjured	SOURCE: End Product (Improper)

Narrative: On April 11, 2002, approximately 1510 Pacific daylight time, a Hughes 369D, N8353F, operated by the U.S. Fish and Wildlife Service as a public use aerial animal capture operation, was substantially damaged when a weight from the net separated and contacted a main rotor blade. The operation was being conducted about seven miles north of Richland, Washington. Visual meteorological conditions prevailed at the time and a visual flight rules flight plan was filed. The commercial pilot, the gunner (net gun shooter) and two muggers (animal capture ground support) were not injured. During the aerial animal capture flight, the helicopter was positioned about 15 feet above ground level over the elk for capture. The pilot positioned the helicopter to get the gunner into firing position and told the gunner to get ready. When ready, the gunner fired the net. Immediately after the shot, a loud bang was heard and the helicopter began to vibrate. The pilot landed the helicopter without further incident. After the main rotor blades stopped turning, it was noted that one of the blades had a hole on the leading edge that exposed the spar. Additional holes were noted on the back of the blade about two inches from the trailing edge. The net that was discharged was examined. It was noted that one of the net weights from one of the four corners was missing and had separated from the attaching material. The weight was later found about 300 feet from the net and displayed impact damage and was slightly bent.

Probable Cause: The National Transportation Safety Board determines the probable cause(s) of this accident as follows: Failure of the netting material securing a net weight while maneuvering.

Contributing Factors: The net weight was a factor.

Note: Inspection of the net assembly by the OAS investigator identified failure to the net webbing and to the lanyard that attaches the net to the weight.

A single point of failure in tension, of either the lanyard or the netting, would be consistent with a material weakness. A single point failure would result in either the lanyard failing and the netting remaining intact, or the netting failing and the lanyard remaining intact.

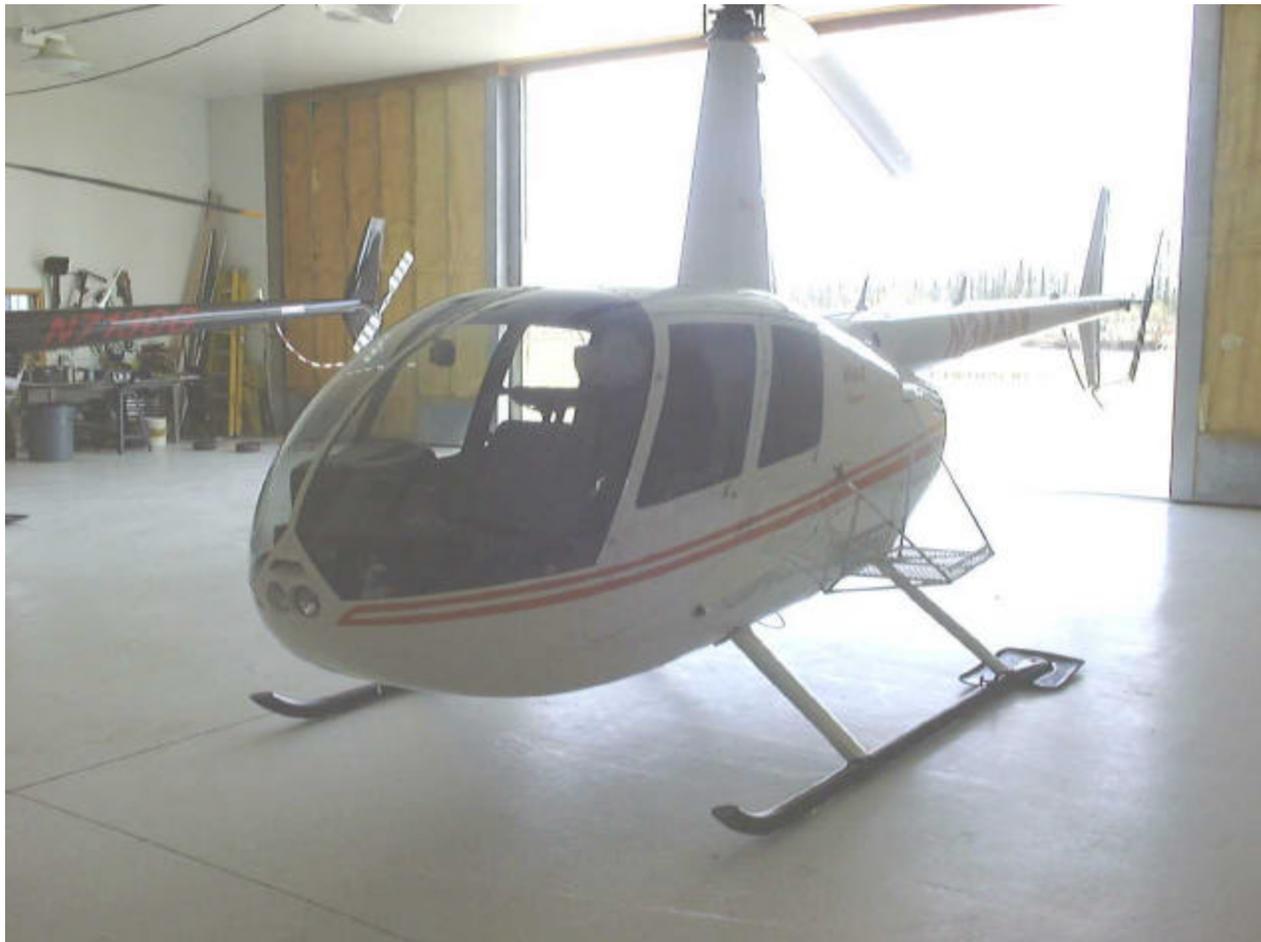
**AIRCRAFT ACCIDENT
02-2E02-A-EGS**

AIRCRAFT DATA: Robinson R-44	DATE: May 16, 2002
BUREAU: U.S. Geological Survey	LOCATION: Cantwell, AK
INJURIES: Three Uninjured	SOURCE: ARA

Narrative: On May 16, 2002, about 1230 Alaska daylight time, a Robinson R-44 helicopter, N344AK, sustained substantial damage while maneuvering near trees, about 23 miles southwest of Cantwell, Alaska. The helicopter was being operated as a visual flight rules (VFR) public use government flight when the accident occurred. The commercial certificated pilot and the two passengers were not injured. Visual meteorological conditions prevailed. A VFR flight plan was filed. The helicopter was being utilized by the U.S. Geological Survey to track caribou. The area of the accident was in the Denali National Park boundary. The pilot reported that he was maneuvering the helicopter in an attempt to move radio-collared caribou out of an area of trees along the west fork of the Chulitna River. Prior to beginning the maneuvering, the pilot said he conducted a hover power check, and was satisfied with the helicopter's available power. He then began to hover near several caribou. The pilot said that when he raised the collective control to move from his hover position, the low rotor annunciator sounded. He said he did not have sufficient power available to climb away from his position, and the helicopter began to settle toward the ground. One of the helicopter landing gear skids settled into low bushes, and the pilot was able to regain sufficient rotor RPM to move to a nearby landing area. After landing, the pilot found that one of the main rotor blades had a tear in the bottom surface of the blade surface. The other main rotor blade had several dents. He said he did not feel any rotor contact with the trees.

Maximum gross weight of the R-44 is 2,400 pounds.

Planned operating weight was 2,396.35 pounds. (3.65 pounds to spare).

In the operating environment (2000" PA/10°C) the maximum continuous power was limited to 23.4" Hg.

Power check indicated 24.1" Hg. required for HOGE.

Pilot chose to use the maximum T/O power limitation (5 minute limit) by adding 1.6" Hg. for a total of 25" Hg.

Probable Cause: The National Transportation Safety Board determines the probable cause(s) of this accident as follows: A failure of the pilot-in-command to maintain adequate main rotor rpm during an out-of-ground-effect hover.

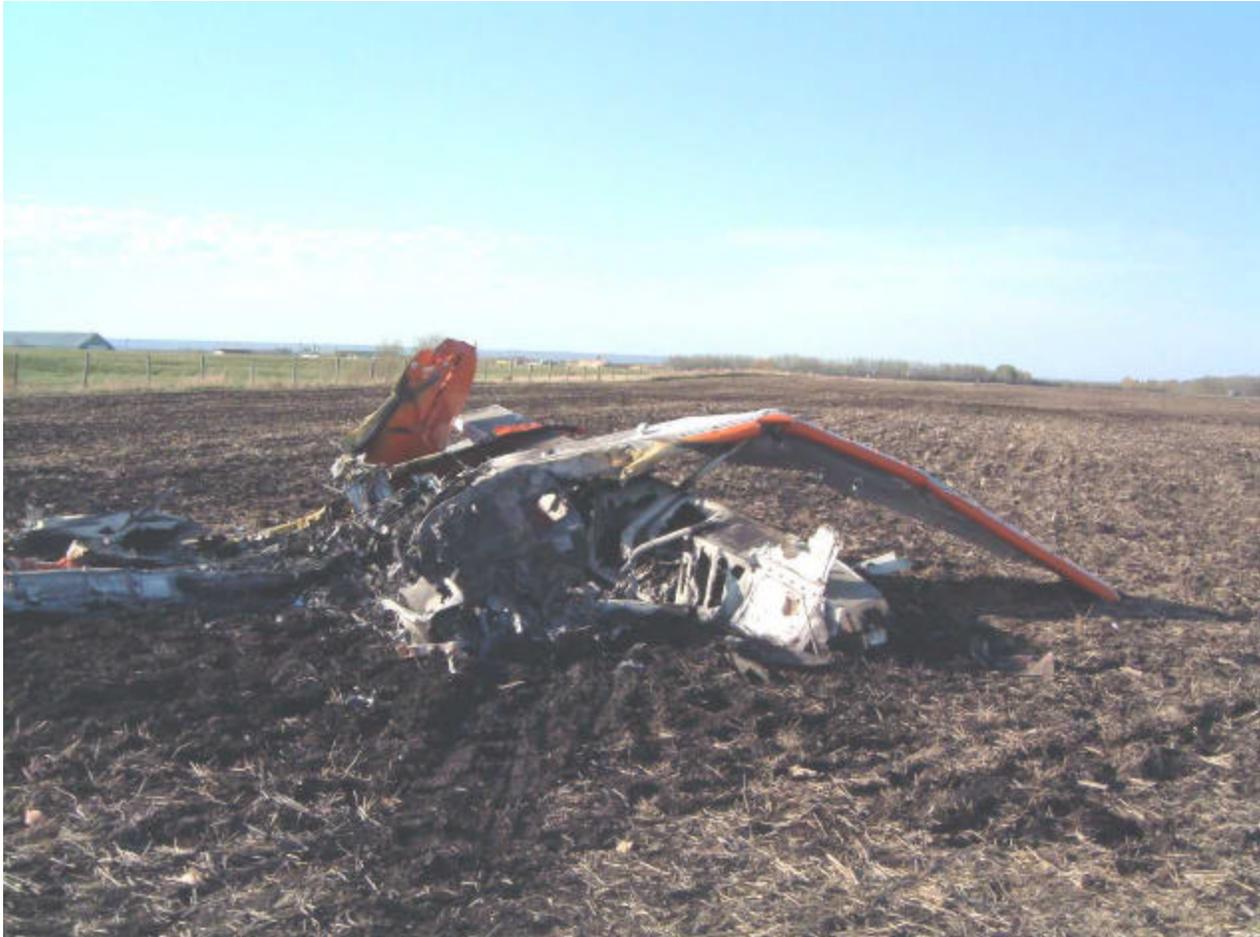
**AIRCRAFT ACCIDENT
02-2F03-O-FWS**

AIRCRAFT DATA: Cessna TU206F	DATE: May 27, 2002
BUREAU: U.S. Fish and Wildlife Service	LOCATION: Swan River, Manitoba, Canada
INJURIES: One Minor, One Uninjured	SOURCE: Fleet

Narrative: The amphibious Cessna TU206F, N753 operated by the United States Department of the Interior, had just taken off from runway 20 at Swan River when the pilot felt the engine begin to vibrate and noticed the manifold pressure slowly and progressively decreasing. The pilot turned downwind to return to the airport, but was unable to maintain altitude and performed a forced landing about one mile west of the airport. The aircraft was destroyed in a post-impact fire. The pilot sustained minor injuries and the second crewmember was not injured.

The pilot did not request assistance during the emergency.

The passenger did not offer assistance to the pilot during the emergency.

Pilot was not wearing a flight helmet or gloves and suffered first-degree burns on his hand during the egress.

Improper Procedure: Pilot did not retract the landing gear in accordance with the Takeoff and the Emergency Landing checklists.

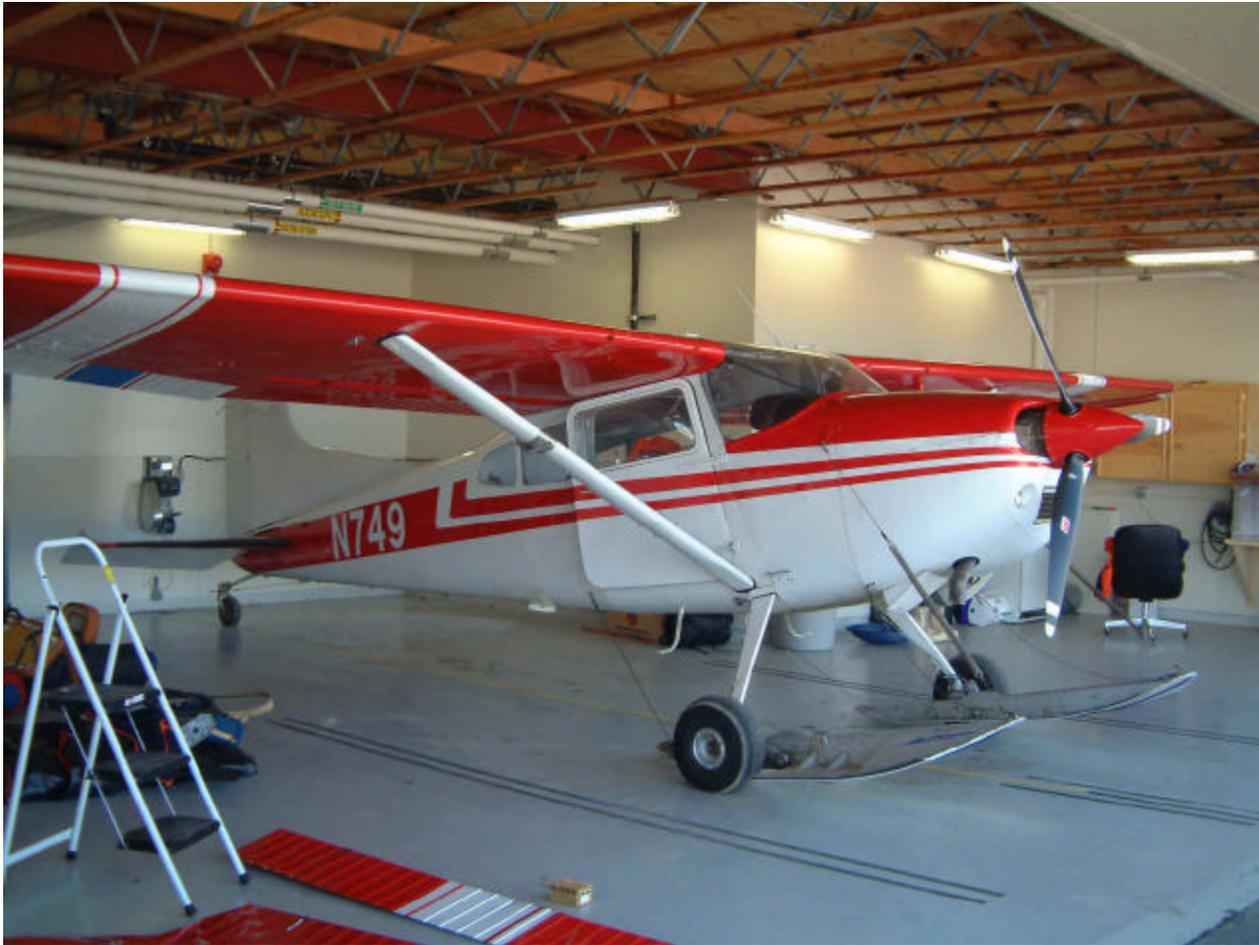
**AIRCRAFT ACCIDENT
02-2E03-O-FWS**

AIRCRAFT DATA: Cessna 185 (Wheel/Ski)	DATE: June 7, 2002
BUREAU: U.S. Fish and Wildlife Service	LOCATION: Kaktovik, AK
INJURIES: Two Uninjured	SOURCE: Fleet

Narrative: On June 7, 2002, about 1815 Alaska daylight time, a wheel/ski-equipped Cessna 185 airplane, N749, sustained substantial damage during the landing roll on a remote, ice-covered lake, about 45 miles southwest of Kaktovik, Alaska. The airplane was being operated as a visual flight rules local area public use flight when the accident occurred. The commercial certificated pilot and the sole passenger were not injured. Visual meteorological conditions prevailed. VFR flight following procedures were in effect. During a telephone conversation with the National Transportation Safety Board (NTSB) investigator-in-charge (IIC) a Federal Aviation Administration inspector, Fairbanks Flight Standards District Office (FSDO), reported that the operator was requesting a ferry permit to move the airplane from the accident site to Fairbanks. The inspector said the airplane needed to be moved off a frozen lake that was beginning to thaw. During a telephone conversation with the NTSB IIC, on June 10, an investigator with the U.S. Department of Interior, Office of Aircraft Services, reported that the pilot was landing on a remote lake at the conclusion of a caribou tracking flight. The pilot landed with the skis extended, and began sliding on the icy surface toward an area of open water. The investigator reported that the pilot initiated a left turn and applied engine power. The airplane's right wing and right elevator struck the ice. The airplane received damage to the right wingtip, right aileron, and the right elevator.

- Aircraft damage was repaired and the aircraft was moved to Fairbanks in violation of 49 CFR 830.10.
- Pilot landed to the west with a 5-7 knot tailwind.
- Pilot configured the aircraft for landing using skis.
- Once the pilot realized he was not going to be able to stop he elected not to execute a go-around

Pilot mistakenly thought he was landing into the wind, which had been out of the west during earlier takeoff and landings.

A subsequent change in wind direction was not detected by the pilot resulting in a downwind landing.

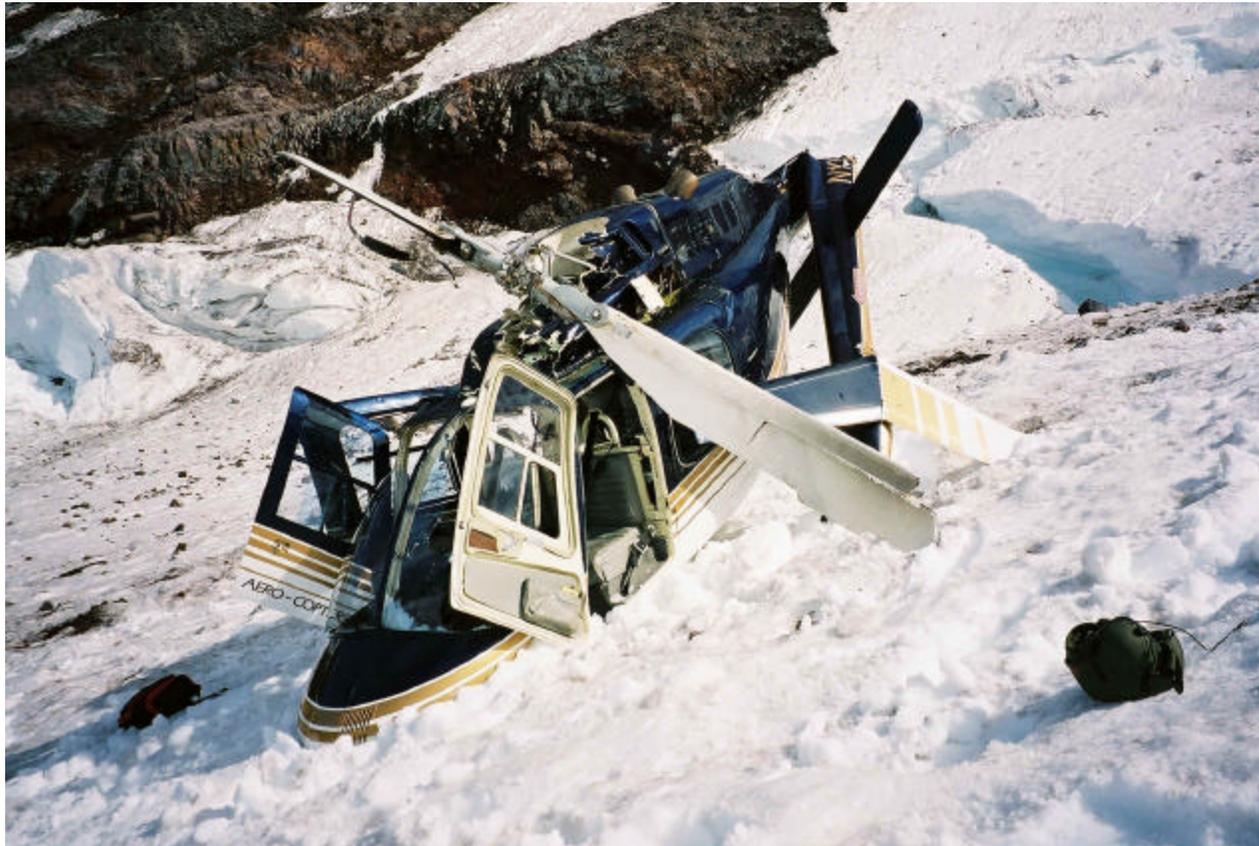
**AIRCRAFT ACCIDENT
02-2F05-A-FNP**

AIRCRAFT DATA: Bell 206B-III	DATE: June 25, 2002
BUREAU: National Park Service	LOCATION: Mt. Rainier NP, WA
INJURIES: Three Uninjured	SOURCE: ARA

Narrative: On June 25, 2002, at 1556 Pacific daylight time, a Bell 206B, N1087L, operated by the National Park Service as a public use flight, collided with the terrain on Mt. Rainier, Rainier, Washington. Visual meteorological conditions prevailed and a company visual flight rules flight plan was filed. The helicopter was substantially damaged and the commercial pilot and two passengers were not injured. The pilot reported that the purpose of the flight was to pickup and transport mountain rescue personnel to aid an injured climber on Mt. Rainier's Carbon Glacier. The pilot arrived at the Kautz Helibase about 1400 for a briefing and to pick up one of the rescue personnel. The flight departed from Kautz Helibase at 1518 and arrived at Camp Schurman about 20 minutes later to pick up the second rescuer. The flight then departed to the Carbon Glacier. The pilot reported that he made several passes over possible landing sites as well as checking aircraft performance. One attempt to land was aborted as the terrain was too steep. The pilot then maneuvered to a lower and flatter site. After landing, the climbing party asked the pilot to reposition to a more stable surface. The pilot stated that he took off and moved up the draw, monitoring power requirements as he went. The pilot set the helicopter down on the snow and slowly lowered the collective and checked for compaction of the snow under the skids. The pilot stated that he was on the snow about 8 to 10 seconds with the collective almost down when the helicopter suddenly pitched and began to shake. The pilot stated that he thought that he reached a droop stop limit and reacted by moving the cyclic forward and raising collective. The helicopter lifted off and climbed to about 20 feet and yawed to the right. The pilot reported that he had no tail rotor authority and lowered the collective and settled back to the ground. The helicopter landed upright pointing down hill. The tail boom broke and was bent forward.

The pilot was not carded to fly for this vendor.

The pilot was not carded for snow operations. The lack of a standard definition for “deep snow” may have contributed to this accident.

This mission was too complex for a pilot’s first flight to Mt. Rainier.

The helicopter manager did not act on warnings offered by the Army helicopter crew.

Passengers did not wear proper personal protective equipment (PPE) and did not have a waiver to DOI PPE requirements.

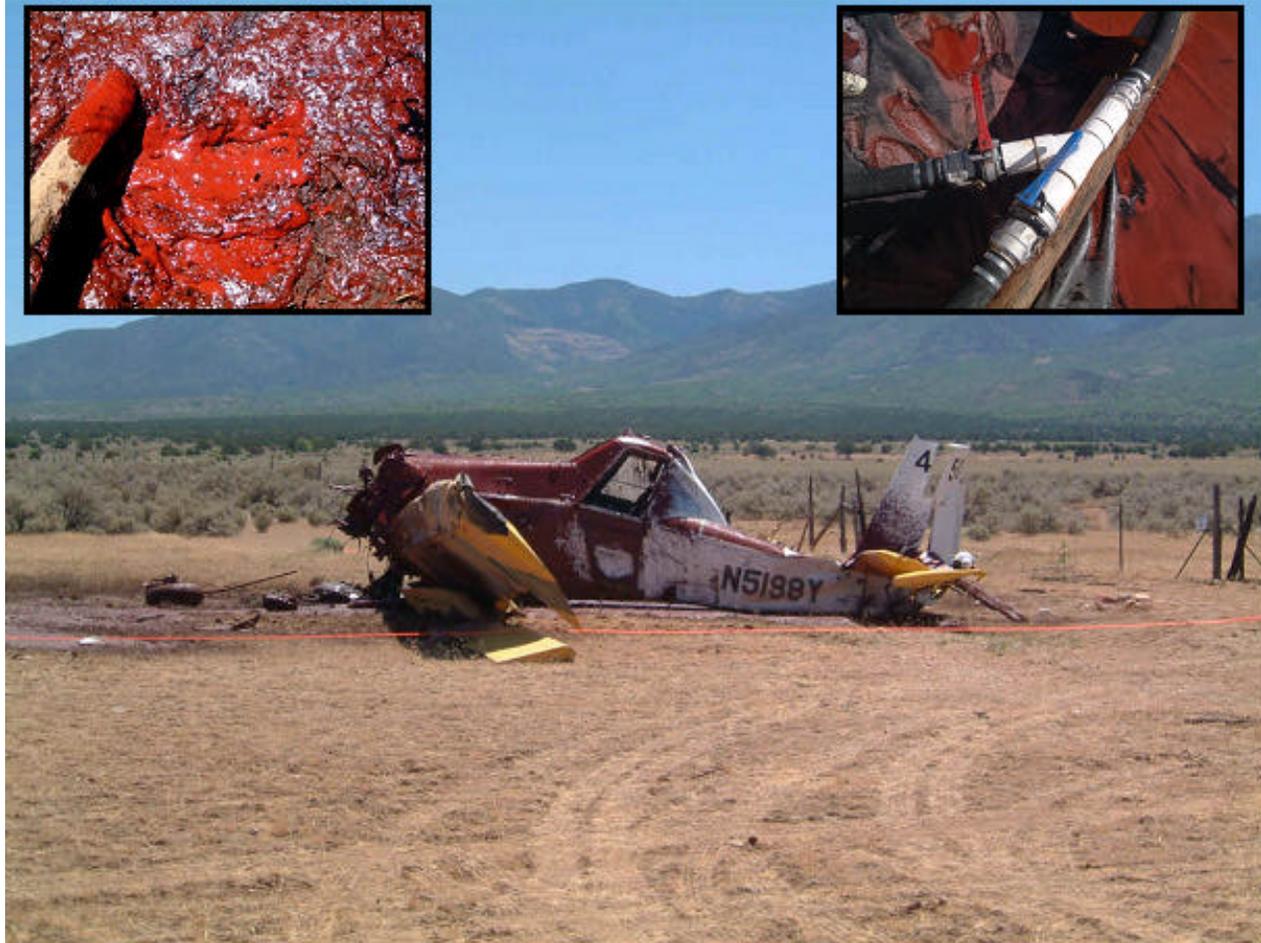
**AIRCRAFT ACCIDENT
02-2F06-C-LLM**

AIRCRAFT DATA: WSK PZL Mielec M-18A	DATE: July 7, 2002
BUREAU: Bureau of Land Management	LOCATION: Fillmore, UT
INJURIES: One Minor	SOURCE: Exclusive Use Contract

Narrative: On July 7, 2002, approximately 1830 mountain daylight time, a WSK PZL Mielec M-18A, N5198Y, operated as a public use aircraft by the U.S. Department of Interior, Boise, Idaho, was destroyed when it impacted terrain while maneuvering shortly after taking off from Fillmore, Utah Airport. The commercial pilot, the sole occupant aboard, received minor injuries. Day visual meteorological conditions prevailed, and a BLM-approved flight plan had been filed for the fire suppression flight being operated as a public use aircraft. The flight originated at Fillmore, Utah, approximately 1827. The airplane, operating as "Tanker 450," departed Fillmore Airport's runway 22 and turned east at 300 feet agl (above ground level). The pilot was unable to maintain altitude and he delayed jettisoning the retardant load. When the airplane was in a position to jettison the load, the pilot discovered the jettison switch guard was in the closed position. While attempting to remove the guard, the right wingtip scraped the ground, then the airplane struck the ground with its landing gear and spun around before coming to a halt. The landing gear was torn off, and both wings and the fuselage were buckled. The retardant had a "very thick consistency." A sample

of the retardant, removed from the sealed pump hose, was submitted to Wildland Fire Chemical Systems for testing. The sample was determined to be LCA-R (concentrated retardant unmixed with water). No water was found in the sample. The sample weighed 12.2 pounds per gallon, slightly heavier than pure concentrate (12.1 pounds per gallon). OAS investigators said this might have been due to the failure of the operators to recycle the concentrate as recommended by the manufacturer. Their investigation revealed that the water and retardant valves were working properly and should have delivered a proper water-retardant mix if they had been set correctly. They concluded the water valve was in the full closed position during the mixing process.

The SEMG and vendor crew failed to comply with the manufacturer’s recommendations for recirculating the retardant and for using the refractometer.

The SEMG and the pilot failed to notice the water valve was closed.

The vendor failed to adequately train his personnel.

The pilot failed to release all, or part, of his load due to lack of training and inexperience.

The pilot failed to properly set the retardant system’s water valve.
