**United States  
Department of the Interior**

**Aviation Safety Review  
Fiscal Year 03**

**Prepared by  
National Business Center  
Aviation Management Directorate  
Aviation Safety and Evaluation Division  
April 2004**

**AIRCRAFT ACCIDENT  
03-3E01-O-FWS**

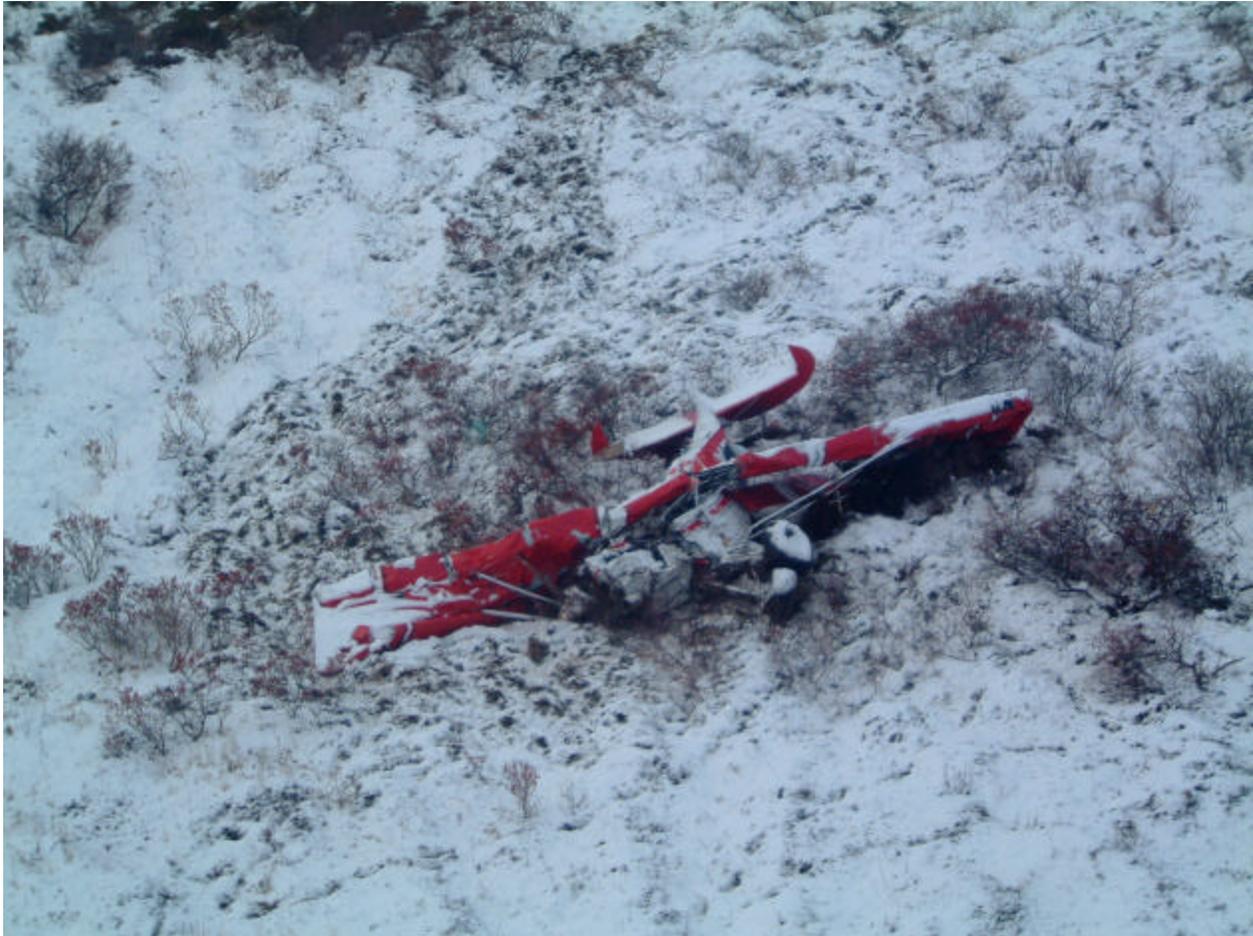
**Narrative:** The tundra tire-equipped airplane was being operated as a local, visual flight rules, public use, game management flight for the purpose of locating moose with data collection collars. According to the airplane's operator, a typical flight would require the pilot and observer to locate a collared moose, and then fly in the immediate vicinity of the moose to enable the equipment aboard the airplane to relay data from the moose's collar to a ground-based data collection site. There was no data transmission in progress at the time of the accident, however fresh moose footprints were observed within 50 yards of the accident site. An on-site inspection of the airplane disclosed ground scars and crush lines on the airplane consistent with a near-vertical impact. The inspection disclosed no evidence of any pre-impact mechanical anomalies with the airframe or engine, and a readout of data stored in the engine monitoring system installed on the airplane indicated that the engine had adequate fuel flow and combustion. The observer received head injuries in the accident, and was unable to provide any information about the accident.

**Probable Cause:** The National Transportation Safety Board determines the probable cause(s) of this accident as follows: The pilot's failure to maintain adequate airspeed, which resulted in an in-flight collision with terrain.

**Contributing Factors:** None.

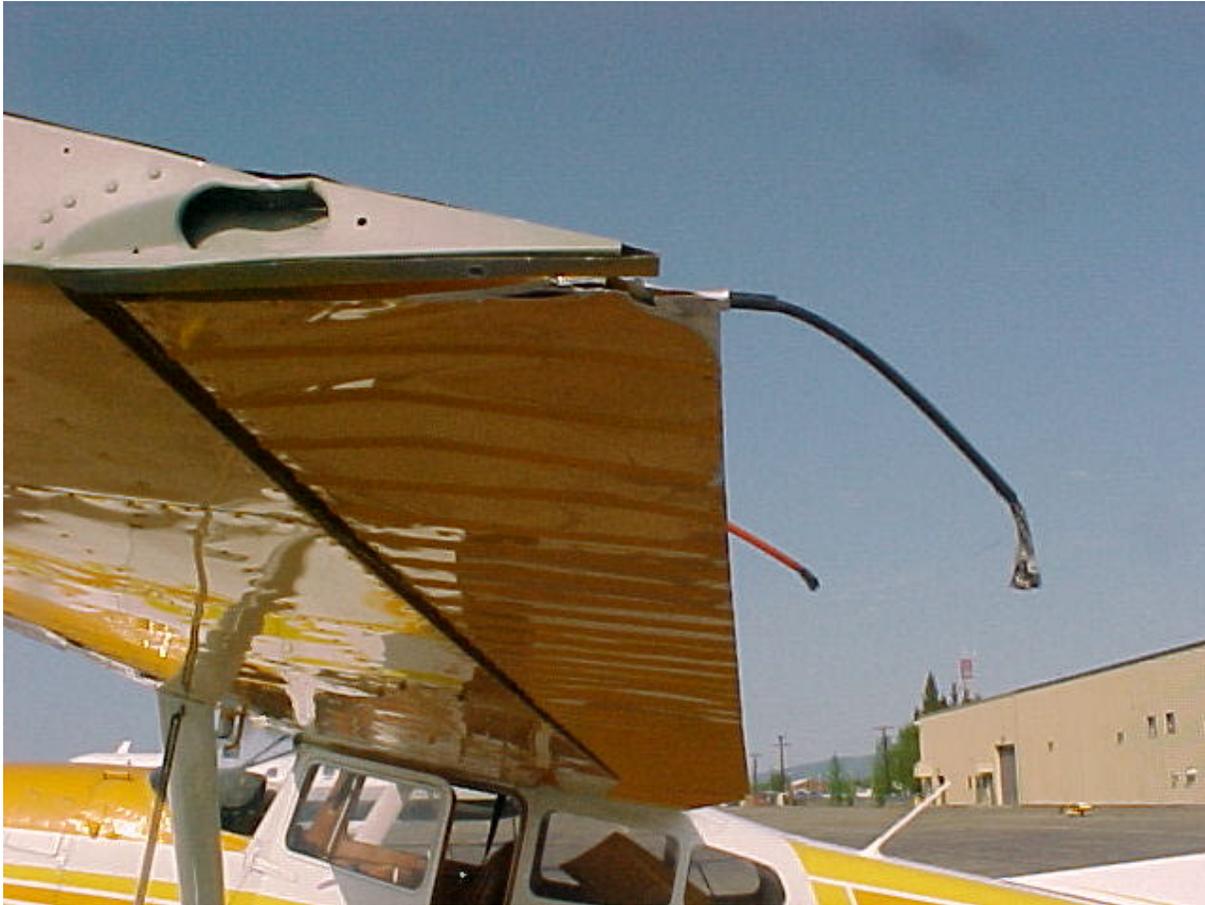
**AIRCRAFT ACCIDENT  
03-3E02-O-LLM**

**Narrative:** The airline transport certificated pilot was performing a full stop landing in a tailwheel and tundra tire-equipped airplane with a 15-knot right quartering crosswind. The pilot reported that during the landing, as the tailwheel touched the runway, the right wing began to rise. He added engine power to abort the landing, but the left wing struck the runway as the airplane became airborne. The pilot then performed an uneventful landing. An examination of the left wing disclosed damage to the outboard left wing rib, and the outboard left aileron rib.

**Probable Cause:** The National Transportation Safety Board determines the probable cause(s) of this accident as follows: The pilot's inadequate compensation for a crosswind during the landing roll.

**Contributing Factors:** A factor contributing to the accident was the presence of a crosswind.

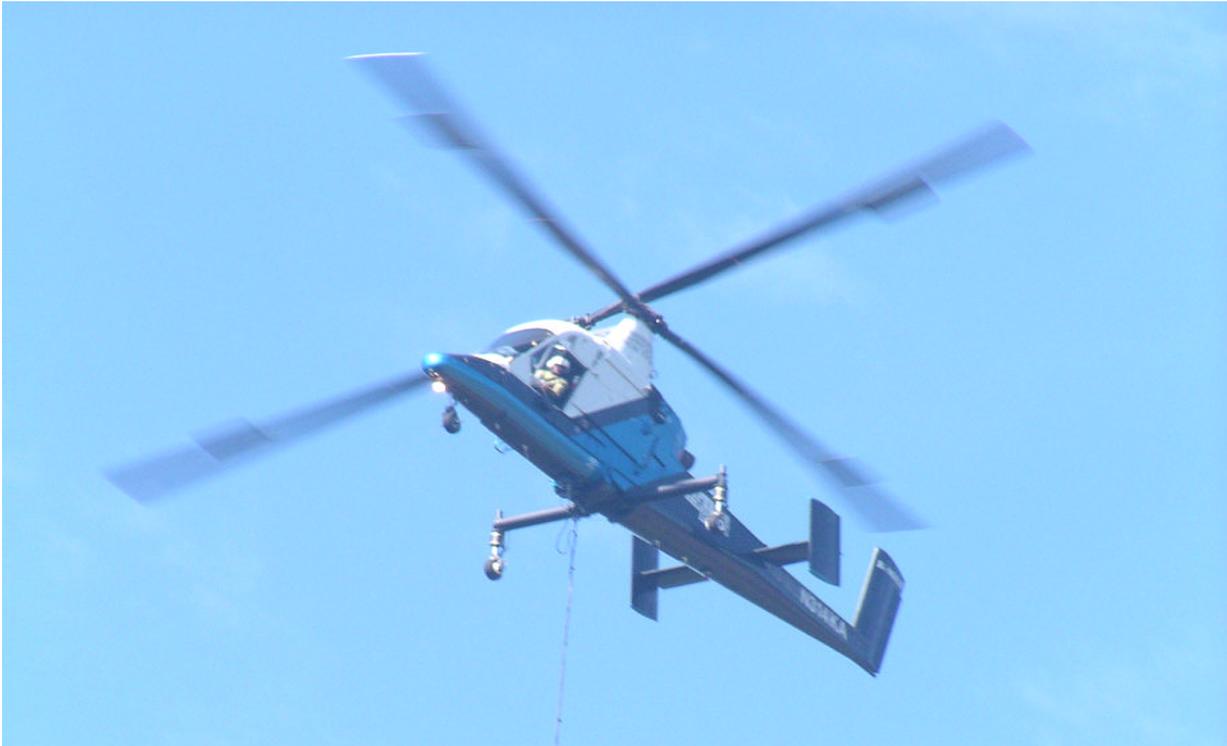
**AIRCRAFT ACCIDENT  
03-3F03-C-BIA**

**Narrative:** On July 25, 2003, approximately 1703 Pacific daylight time, a Kaman K-1200 helicopter, N314KA, registered to Superior Leasing LLC, operated by the Department of Interior (Bureau of Indian Affairs), and being flown by a commercial pilot, was destroyed following a loss of control in cruise and subsequent in flight collision with terrain within 1,000 feet of the Brush Creek fire line at the McGinnis Flats forest fire near Keller, Washington. The pilot sustained fatal injuries and a post crash fire consumed much of the rotorcraft. Visual meteorological conditions prevailed and an operational flight plan was in effect at the time. The flight, which was engaged in fire fighting operations at the McGinnis Flats forest fire, was being conducted as a public use operation by the Bureau of Indian Affairs, Department of the Interior. The rotorcraft had departed the Mt. Tolman fueling site approximately one hour previous to the accident and was commencing the fourth mission of the day. Witnesses reported hearing a change in the sound of the helicopter and a radio transmission from the pilot indicated a problem. On site examination revealed that all four rotor blades had separated near their respective hub assemblies, and all four blades were located circumferentially within a band 340 to 540 feet wide around the ground impact site. The Bambi bucket was located bearing approximately 150 degrees magnetic and 500 feet short of the ground impact site of the fuselage. The blades displayed little to no leading edge damage and all four blade flaps, although broken apart, were found in the vicinity of the blades and ground impact site. Both main rotor hubs were found north and east of the ground impact site and all eight wood blade fracture surfaces have been recovered. The wreckage is being recovered on July 31, 2003, and reconstruction of selected systems and portions of the airframe is anticipated in the near future, as well as an examination of all blade fracture surfaces and a disassembly of the Lycoming-Honeywell T5317-A turboshaft engine.

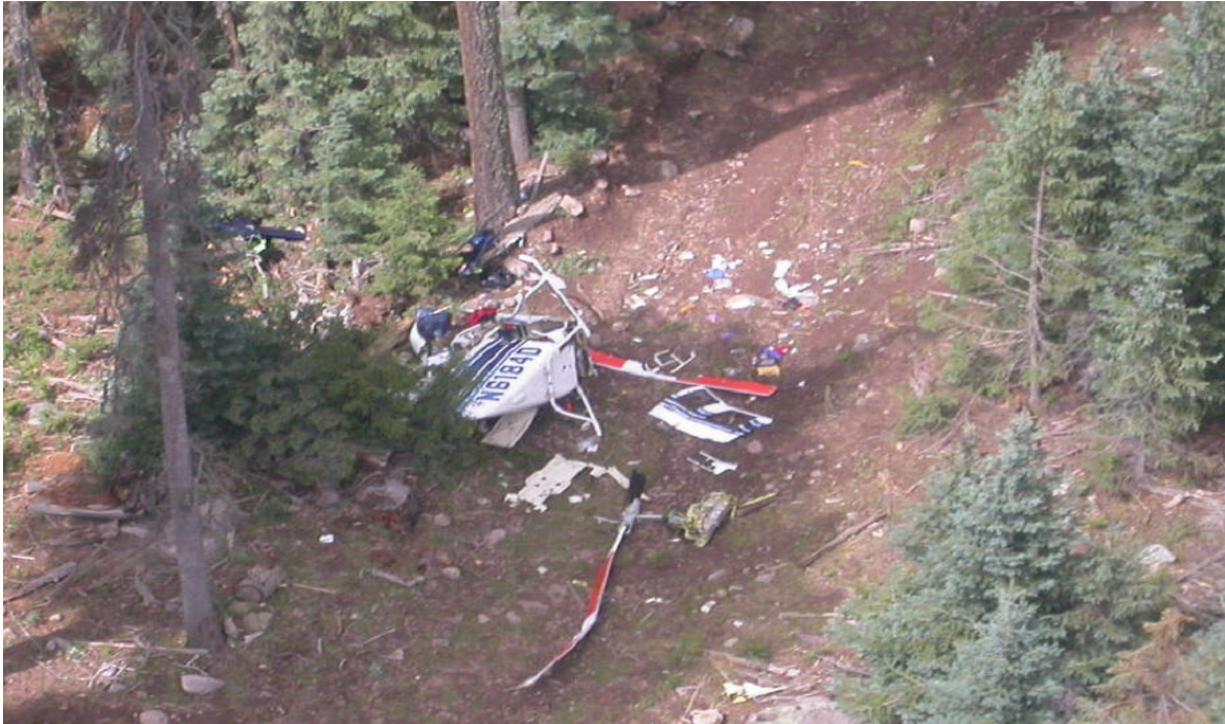
**AIRCRAFT ACCIDENT  
03-3F04-C-BIA**

**Narrative:** On July 26, 2003, at 1034 mountain standard time, a Bell 206L-3, N6184D, crashed near Whiteriver, Arizona. The Bureau of Indian Affairs (BIA), Fort Apache Indian Reservation, operated the helicopter under the provisions of 14 CFR Part 91. The helicopter was destroyed. The commercial pilot and one passenger were fatally injured; two passengers sustained serious injuries. One person on the ground was not injured. The public-use flight departed the Whiteriver Airport (E24), at 1000, en route to the Wilderness Fire in the vicinity of Aspen Ridge, 12 statute miles from E24. Day visual meteorological conditions prevailed, and a BIA company flight plan had been filed. The purpose of the flight was to insert a 3-person helicopter initial attack (helitack) crew to conduct an initial attack for a wildland fire along the Aspen Ridge. The Safety Board Investigator-in-Charge (IIC) interviewed a ground witness to the accident. The helitack crewman had been dropped off at the road-landing zone (LZ), 100 yards west of the accident site. He stated that there were five people in the helicopter when they departed E24. No problems were noted with the flight to Aspen Ridge. They landed at a meadow, and two of the helitack crew exited the helicopter. The helicopter then flew up the drainage area to the LZ, where the witness exited and off-loaded fire packs and tools. He stated that the initial landing was on the front side of a small hump in the road. Prior to his exiting, the pilot moved the helicopter back to a flatter area. When the pilot repositioned the helicopter, the witness heard a knocking noise. The witness stated that the pilot took off again for the meadow. He reported that when the helicopter came back to the LZ, it was about 10-20 feet above the tree line. He estimated that the trees were about 100-foot tall. He also stated that the helicopter was flying slowly. The witness stated that he was getting ready to marshal the flight in when the helicopter flew past him, continuing up the drainage. The witness reported that he did not know why they flew past him. He looked away to do something else, and heard a noise. When he looked up he saw the helicopter spinning to the right and then lost sight with the helicopter but heard what he believed was the helicopter hitting the trees. The ground witness ran to the accident site, and rescued the survivors.
