FY00

Department of the Interior Aviation Accident Review

Office of Aircraft Services

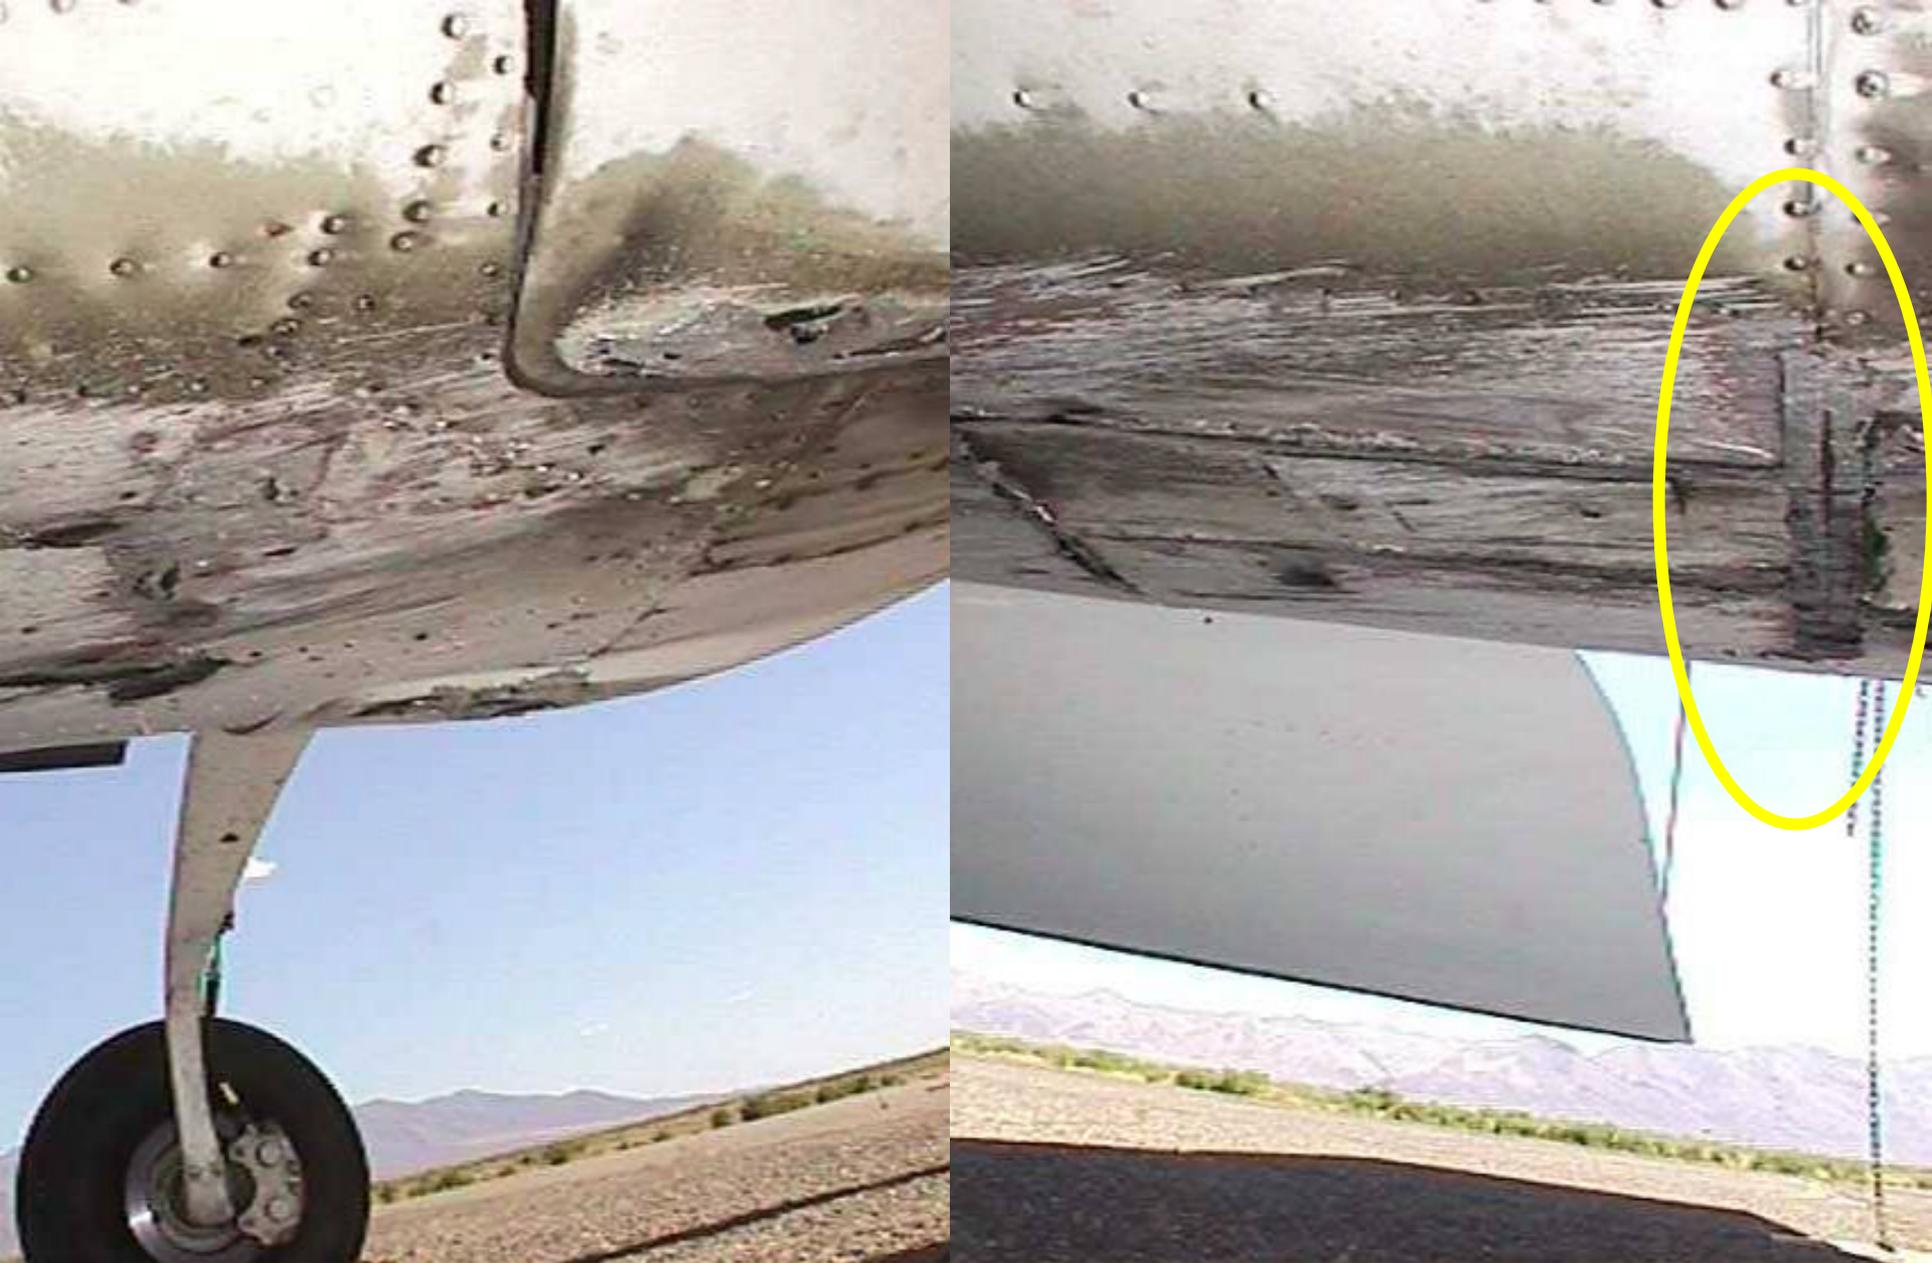
Structural Damage to Frame

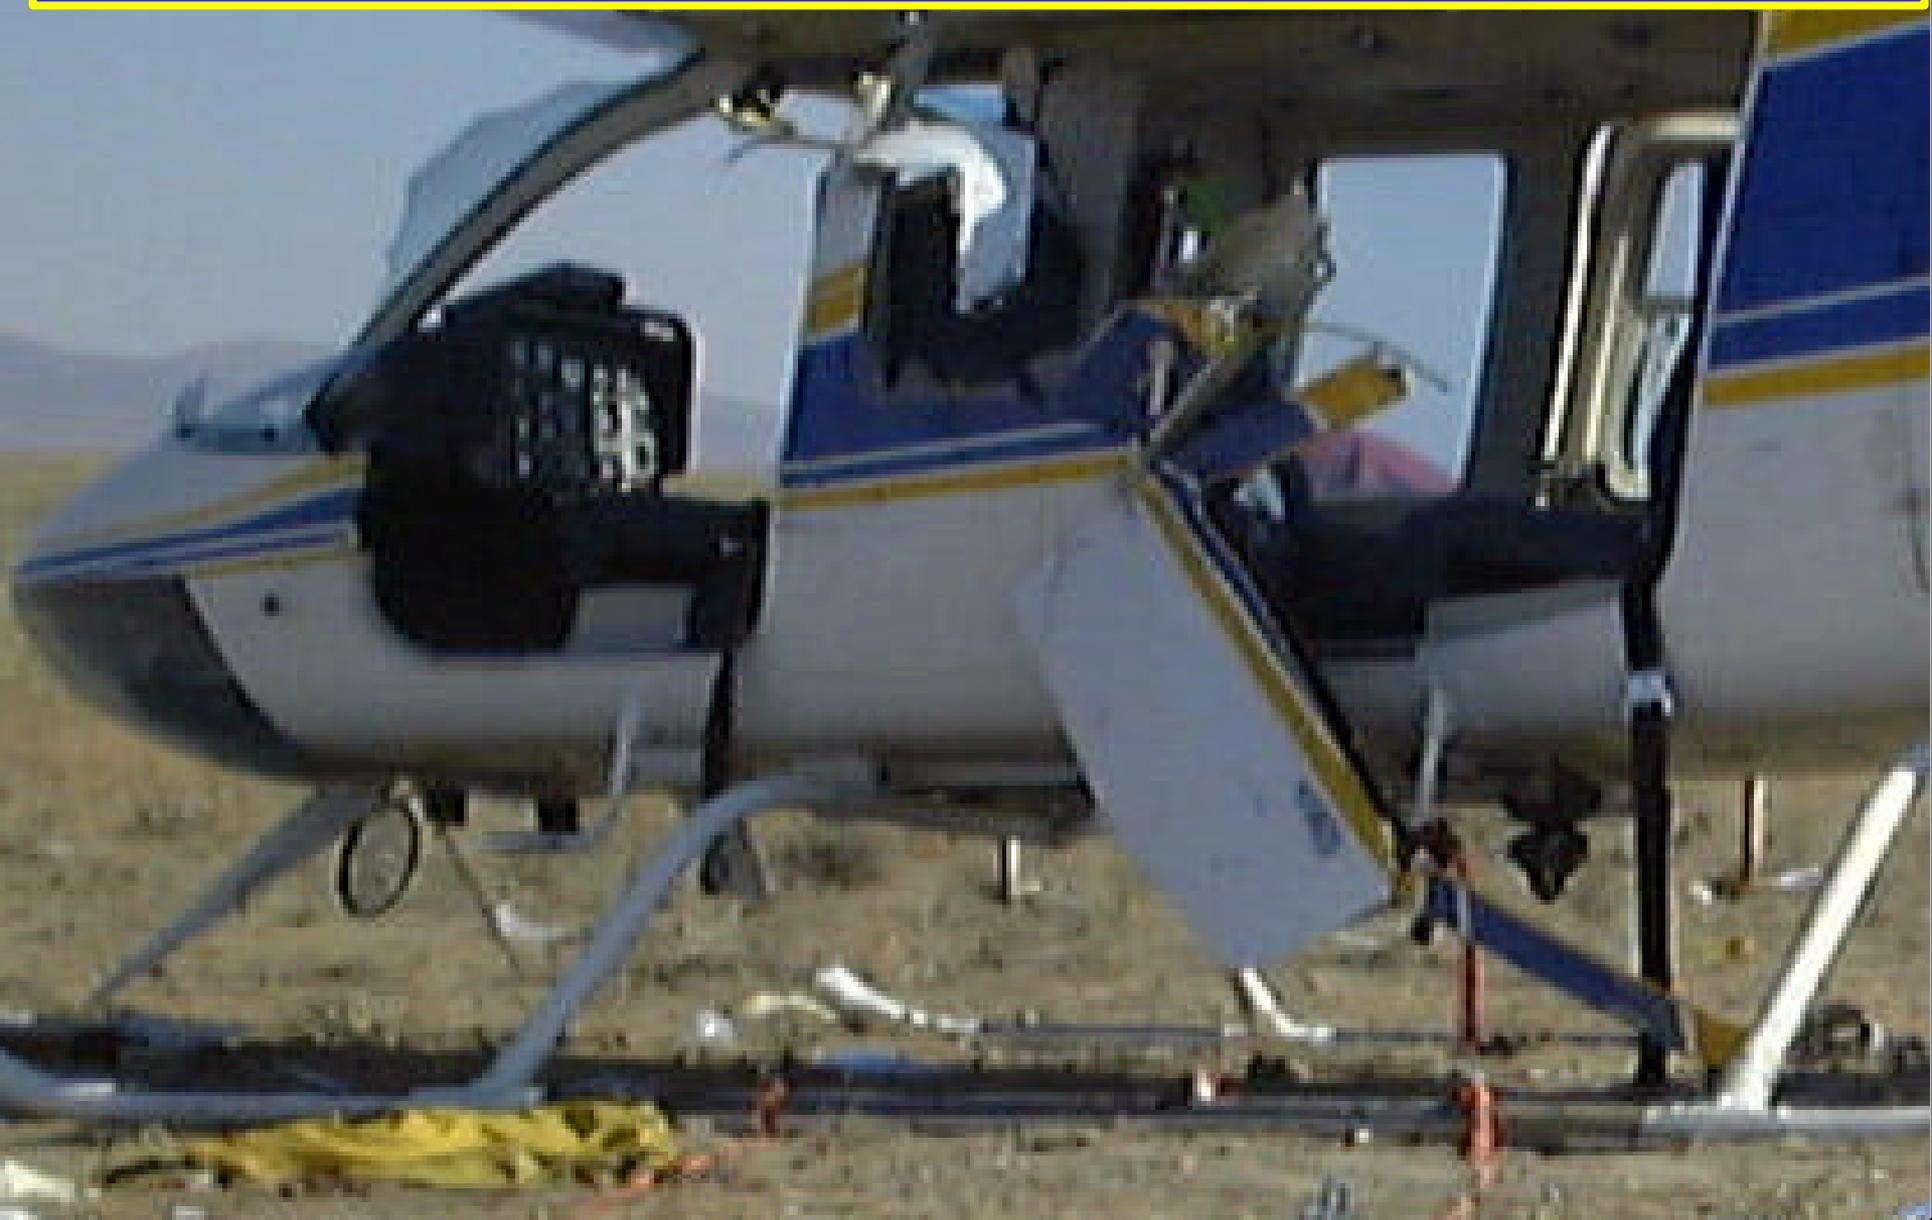
Left Front Passenger

**2nd
Main Rotor
Blade Strike**

**Main Rotor
Blade Strike**

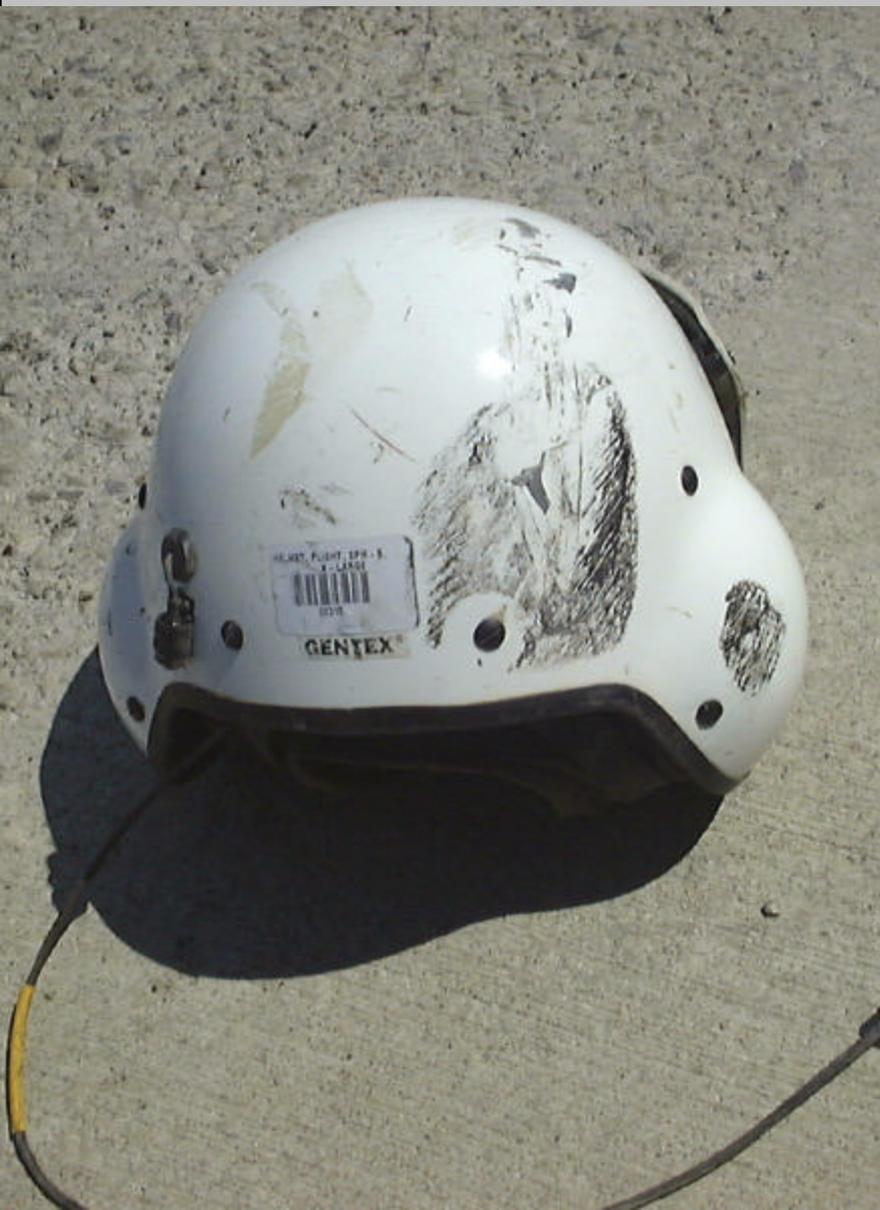
Left Front Passenger

*This helmet
SAVED
a life !!!*

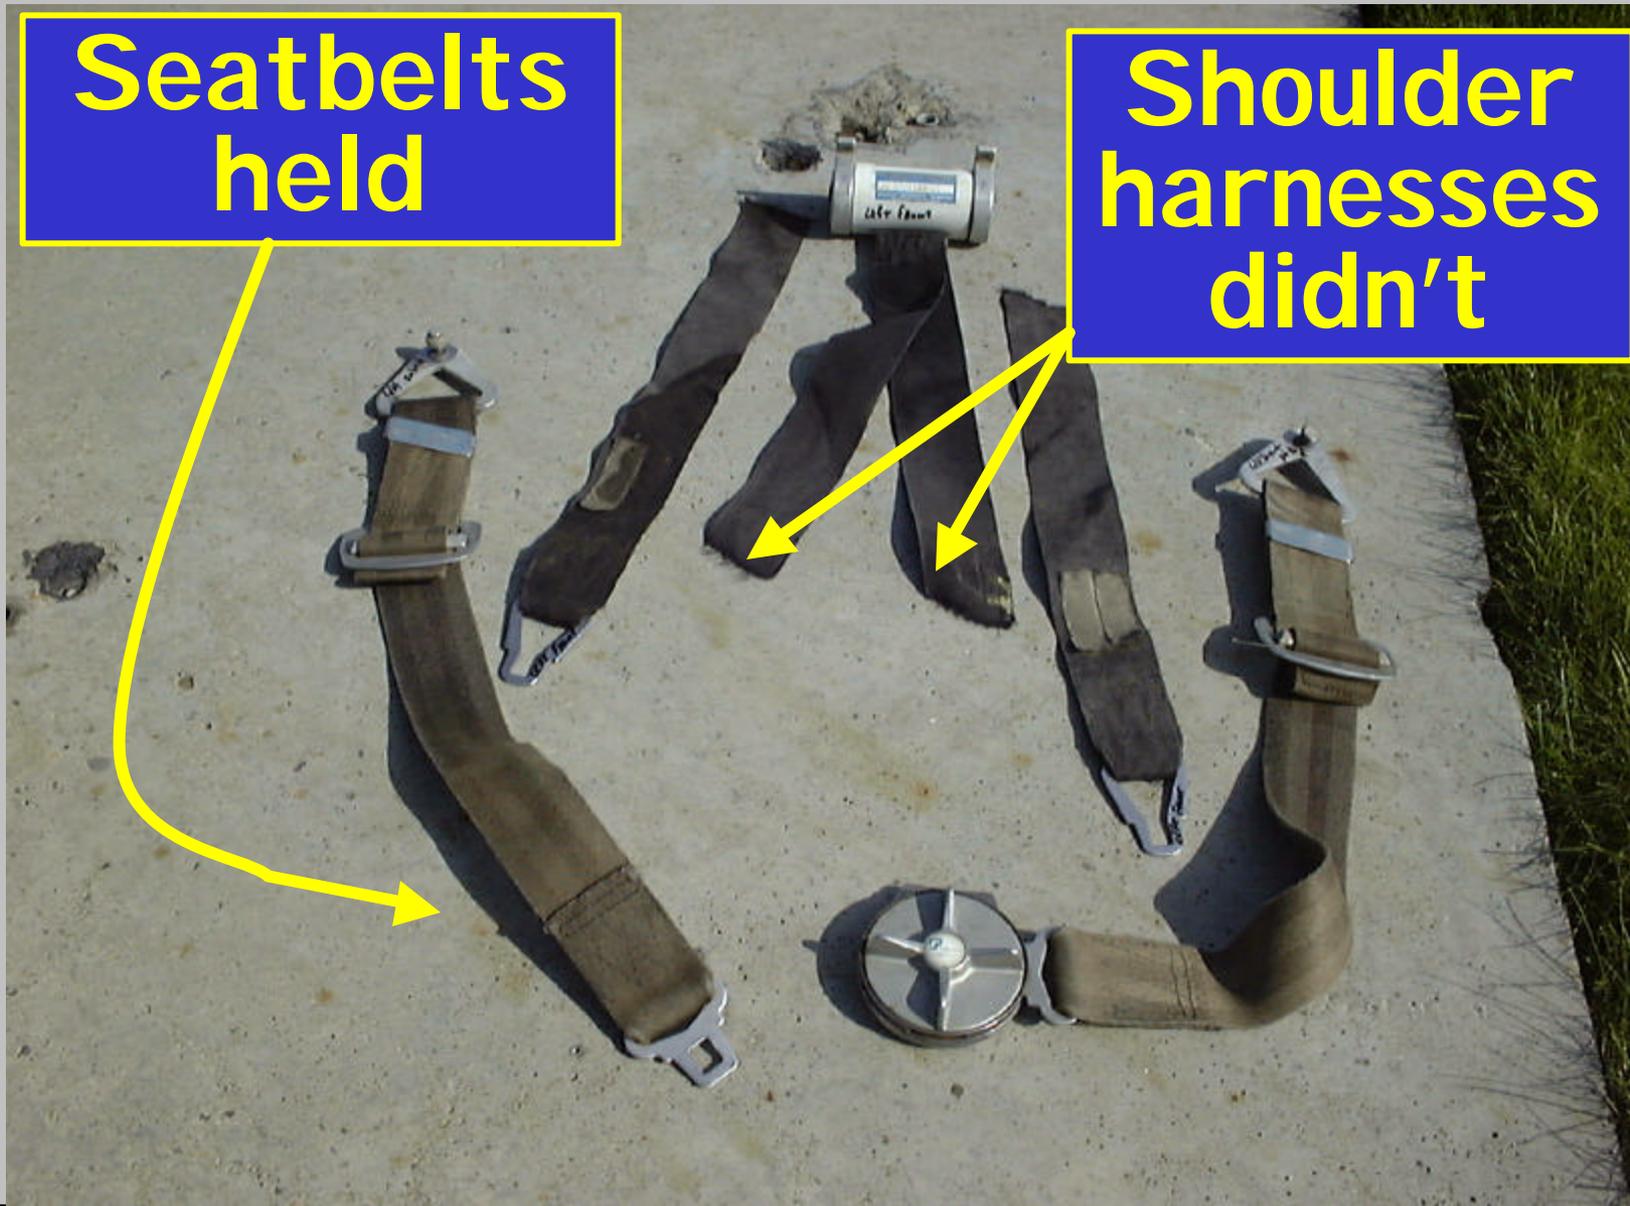
Left Rear Passenger

Seatbelt held

But a shoulder harness was not required and not installed

- How should DOI encourage maximum use of available ALSE (i.e helmets) ?
- Should DOI require the installation of dual shoulder harness restraint systems ?

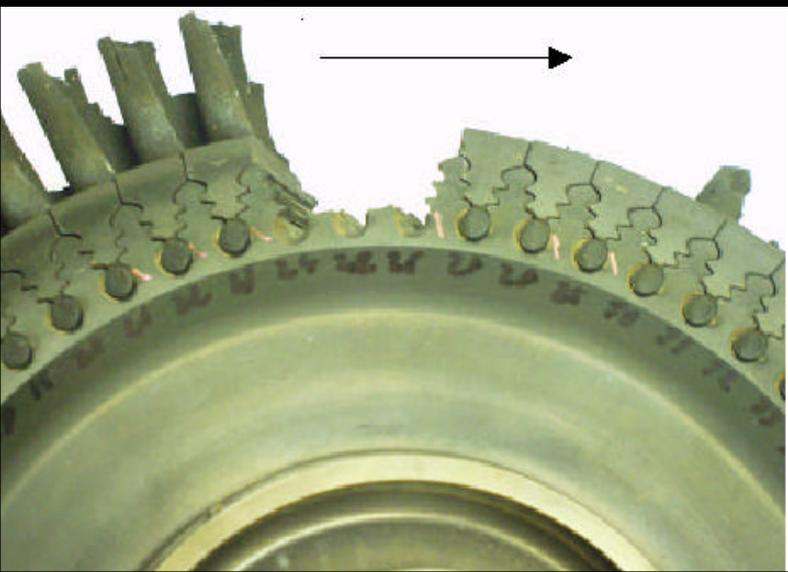
The investigation has revealed that the crash sequence began with a catastrophic failure in the #1 engine's compressor turbine (CT) section.

Detailed metallurgical analysis indicates the fracture of the #1 CT disc occurred as a result of cyclic stress rupture (*a phenomenon where at high temperature a material's strain resistance is compromised*).

"In summary, the CT disc failed due to stress rupture brought about by sustained operation near or above acceptable limits. No material or design deficiencies were identified." (Sidla, TSB)

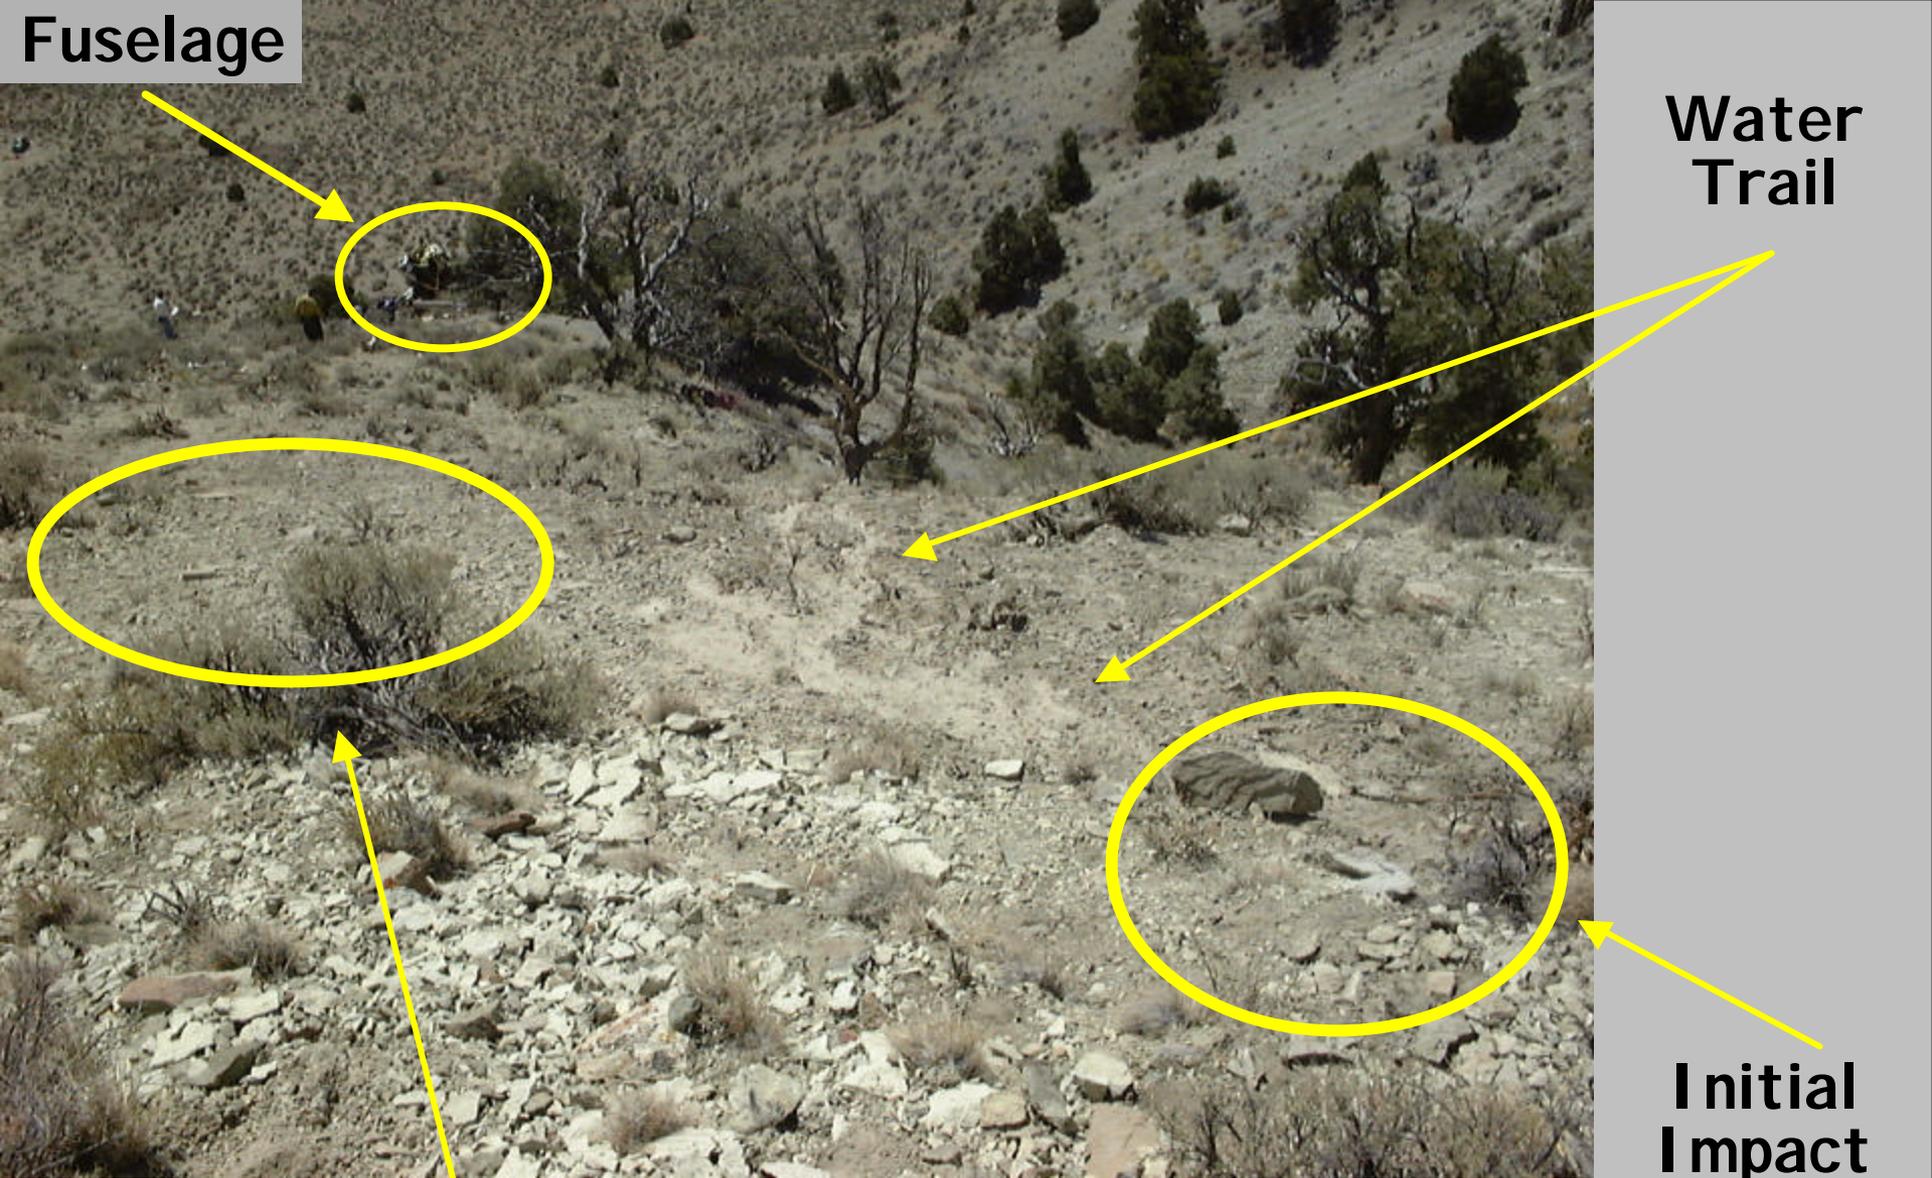
Initial Impact of Fuselage

Initial Impact of Bucket

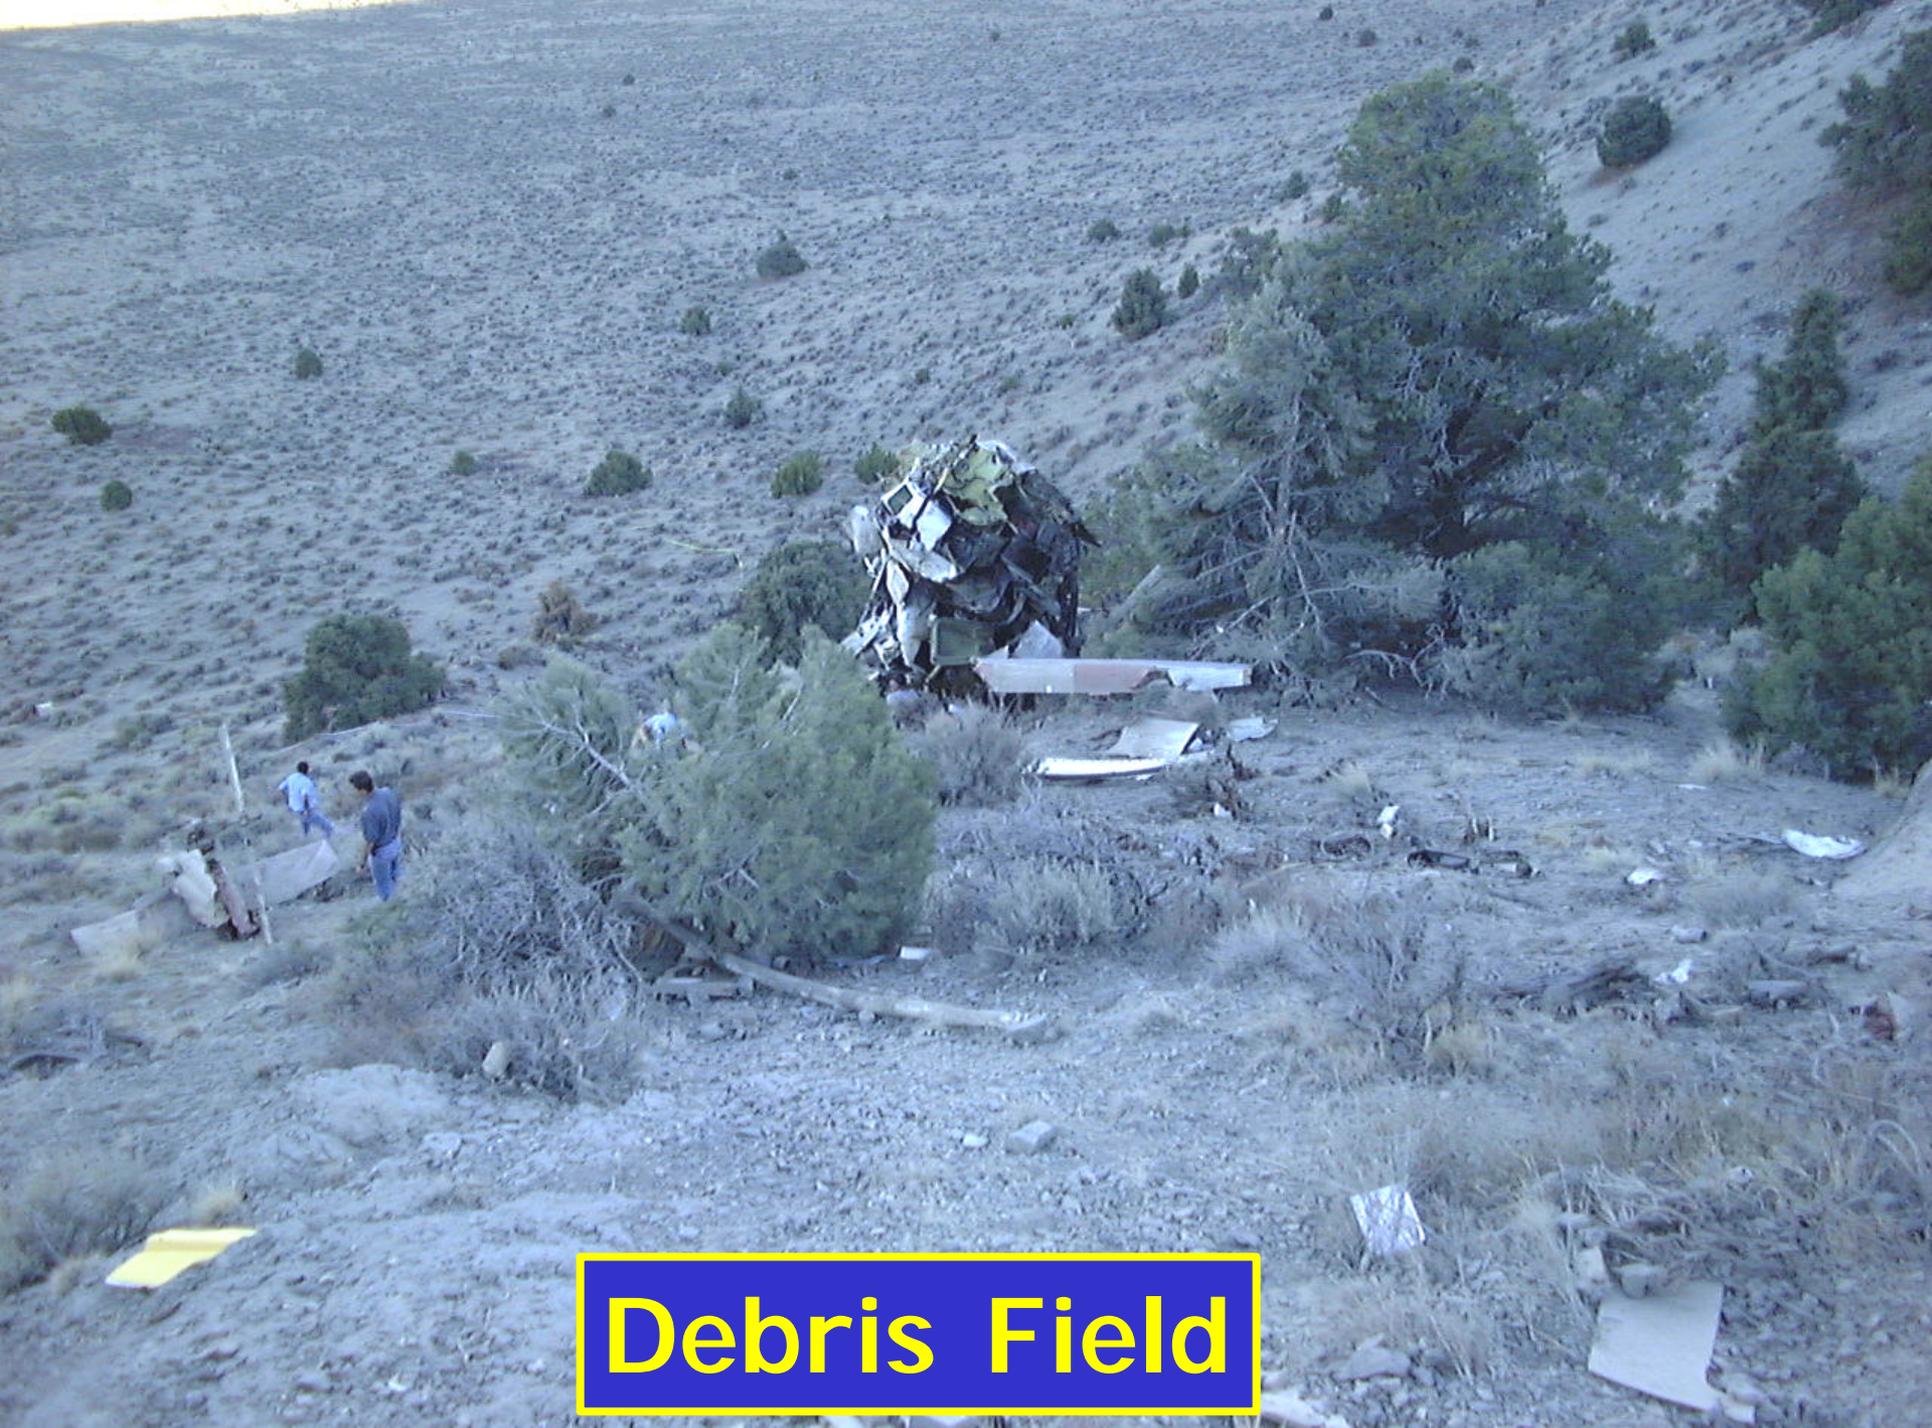
Debris Field

Main Rotor Blade

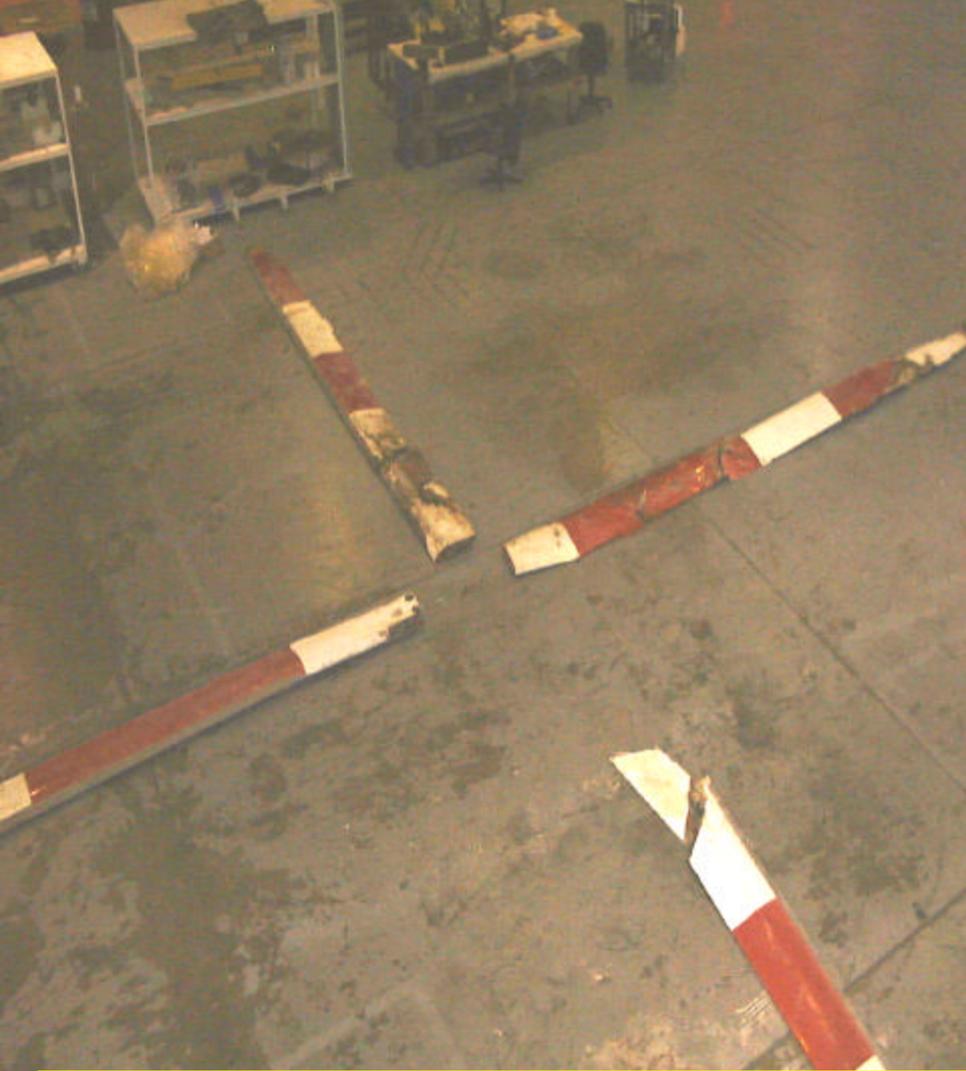
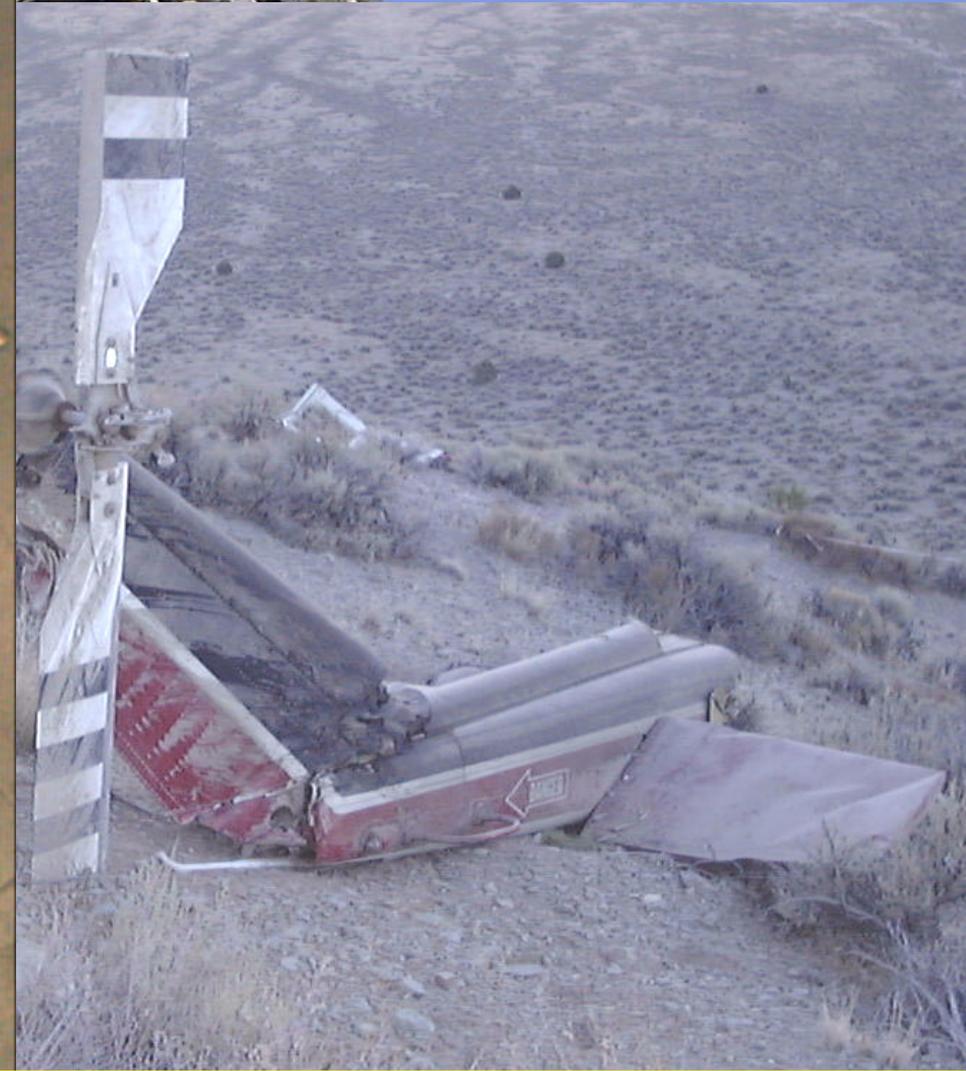
Indications of low rotor RPM at impact

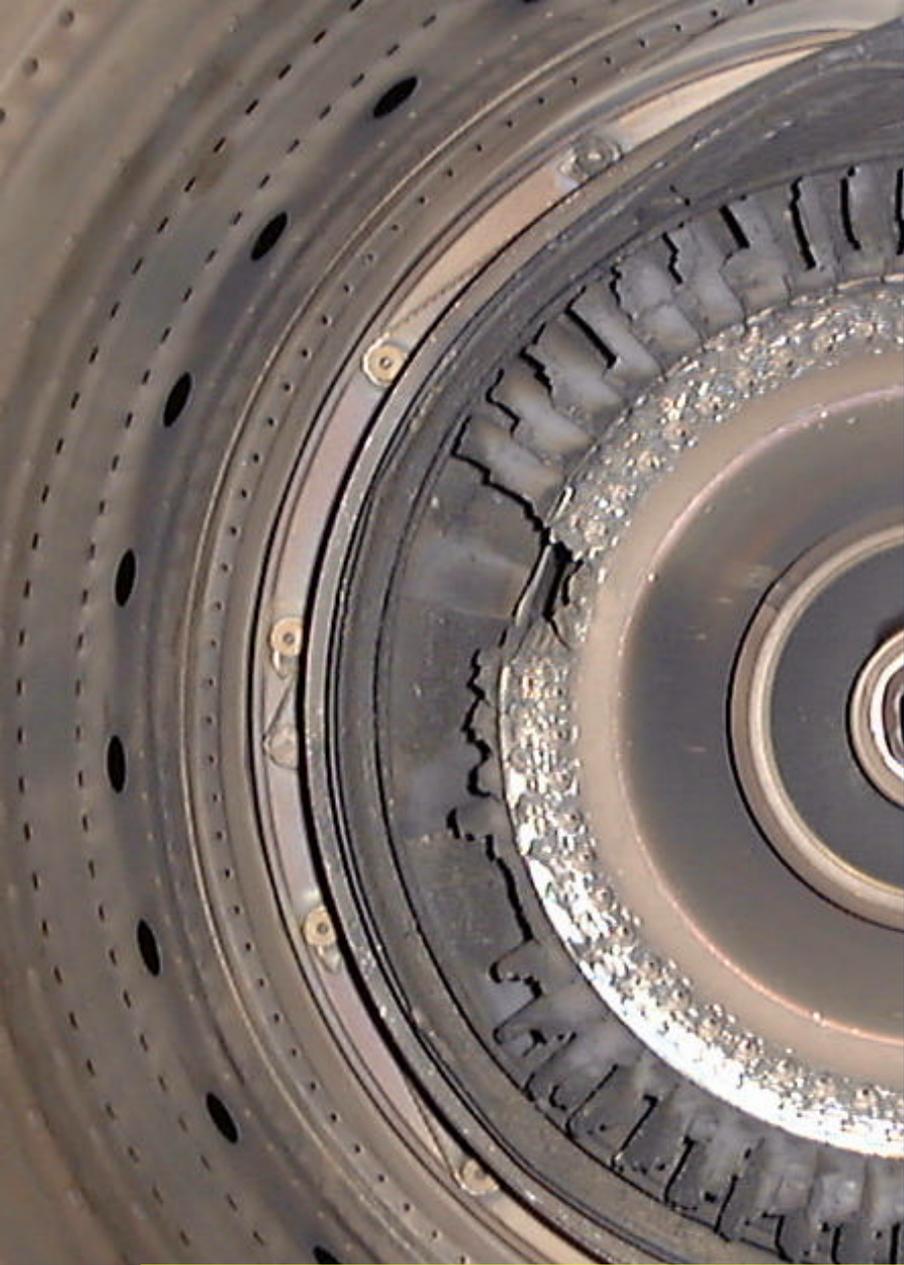
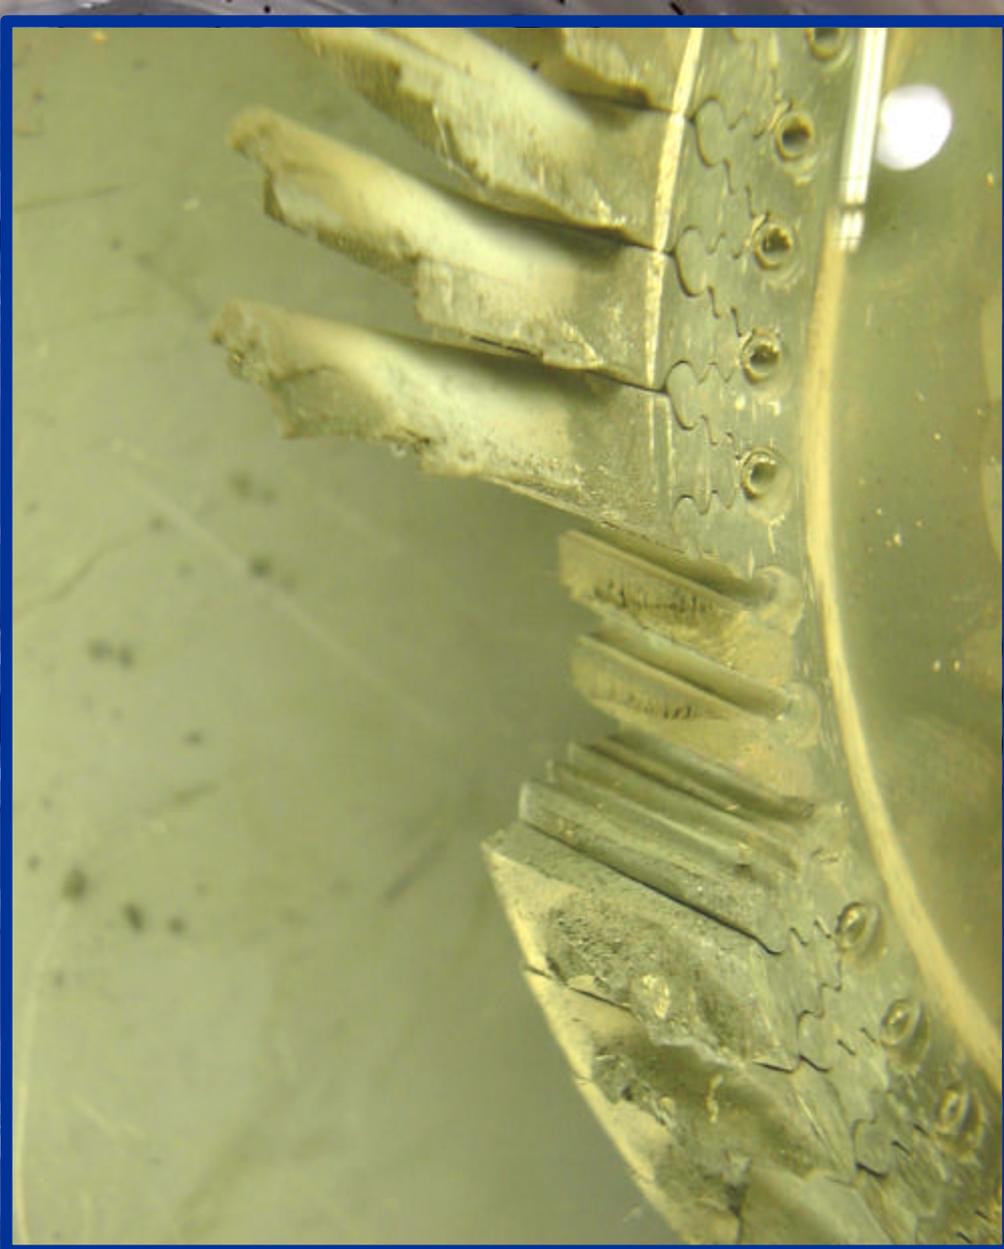
#1 Engine Compressor Turbine

**Sprag
Clutch
Damage**

"Fracture of two firtrees of the P.S. no.1 CT disc occurred as a result of cyclic stress rupture."

NOTE: Stress Rupture or Cyclic Stress Rupture refers to a phenomenon of high temperatures where a material's strain resistance is compromised."

"Cracking associated with necking was observed in about a dozen firtrees on the upstream face."

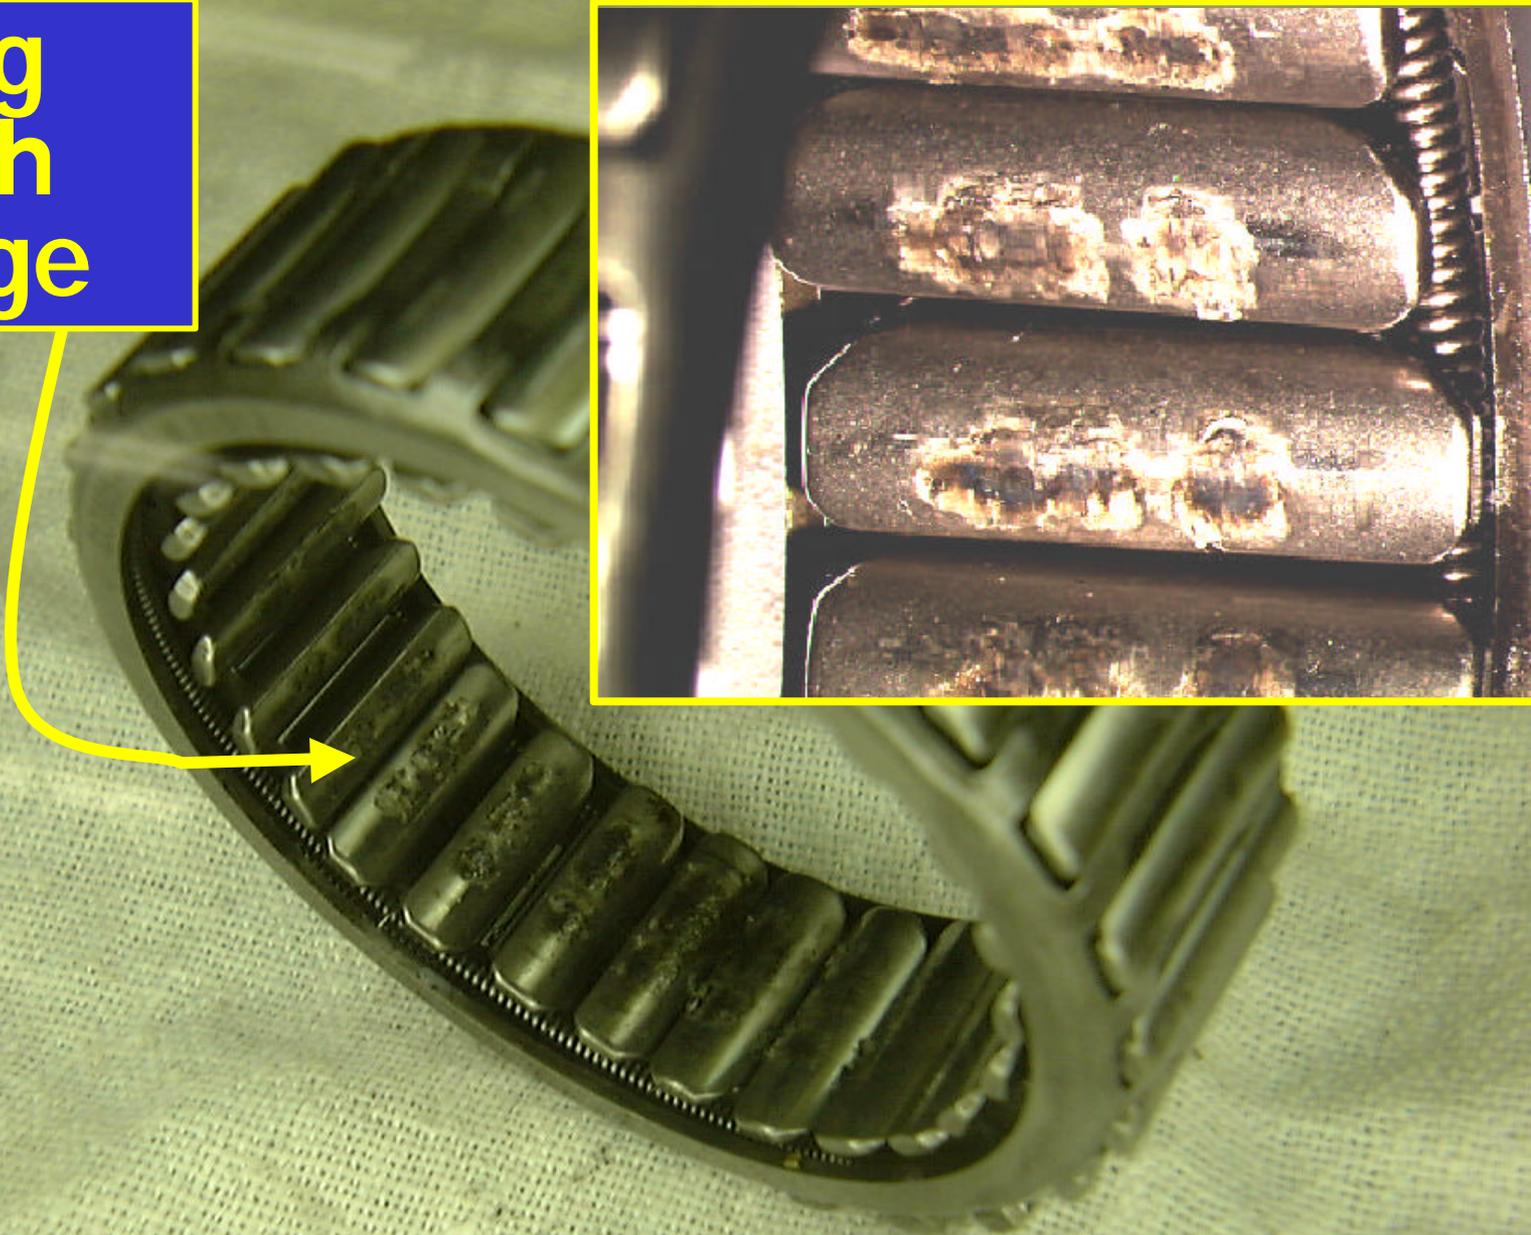
#2 Engine Sprag Clutch

**Sprag
Clutch
Slippage
(Brinelling)**

**Sprag
Clutch
Grab
Marks**

"Damage of the clutch drive shaft and the sprag clutch assembly was due to adhesive wear characteristic of sudden seizure."

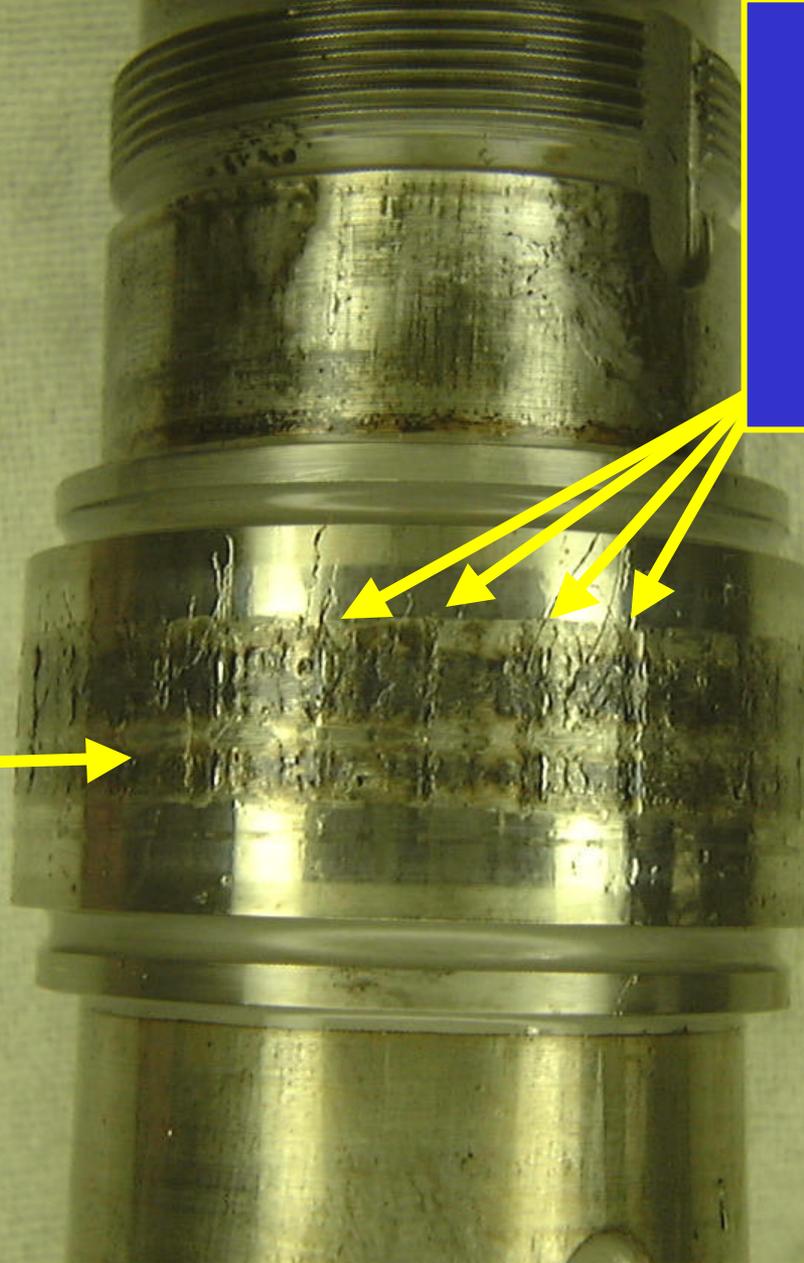
#2 Helical Gear Coupling Shaft

**Intermediate
Coupling Drive
Shaft assembly**

**Transverse
fracture due
to torsional
overload**

"Transverse fracture of the coupling shaft, which engages inside the clutch shaft, was due to torsional overload and was secondary."
