FY00

Department of the Interior Aviation Accident Review

Office of Aircraft Services

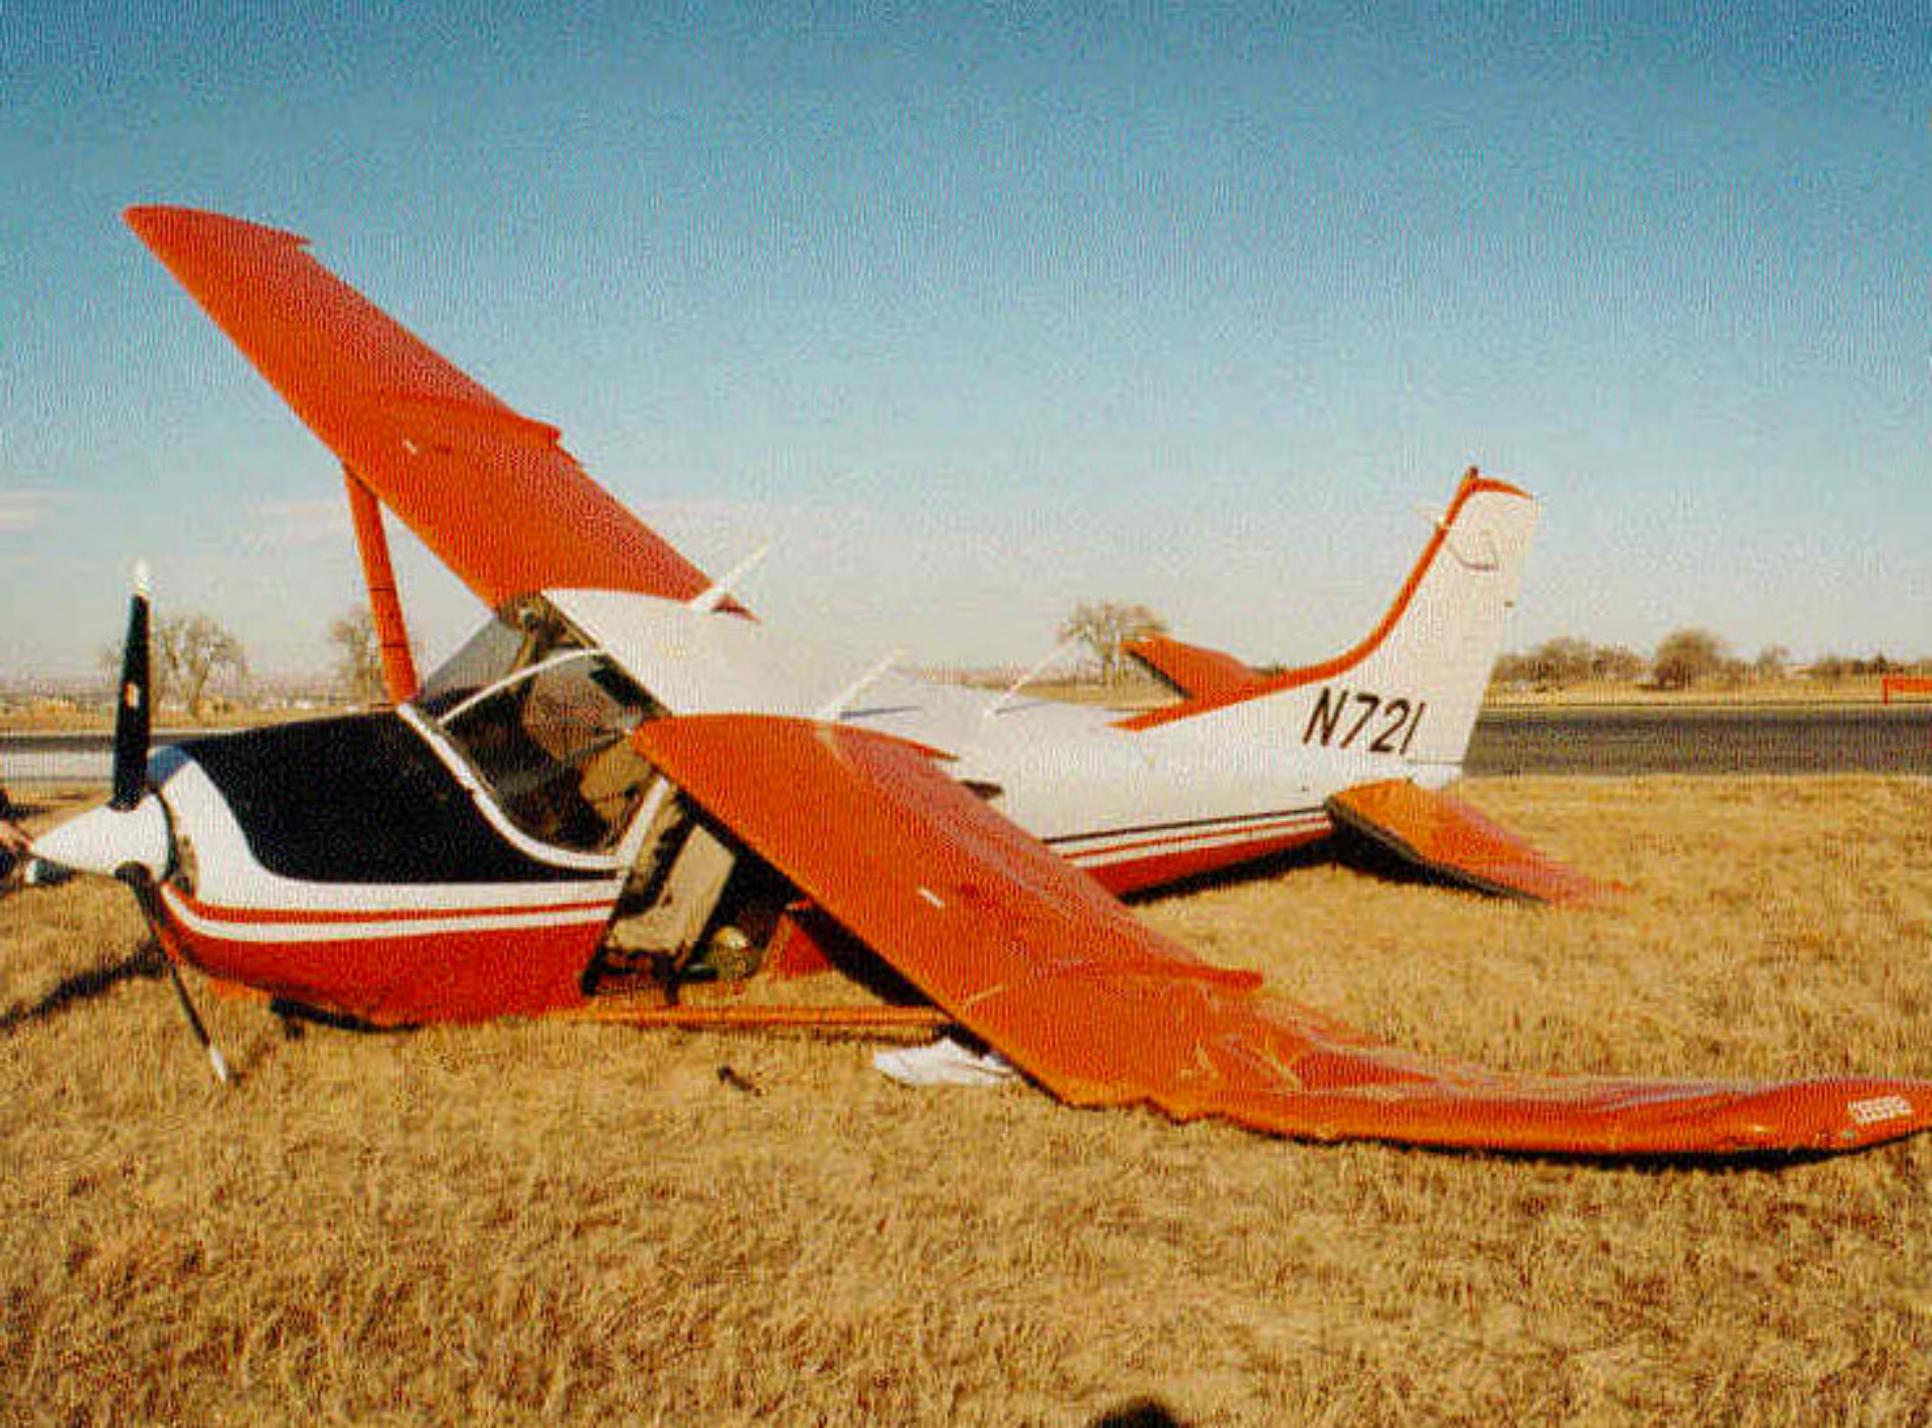
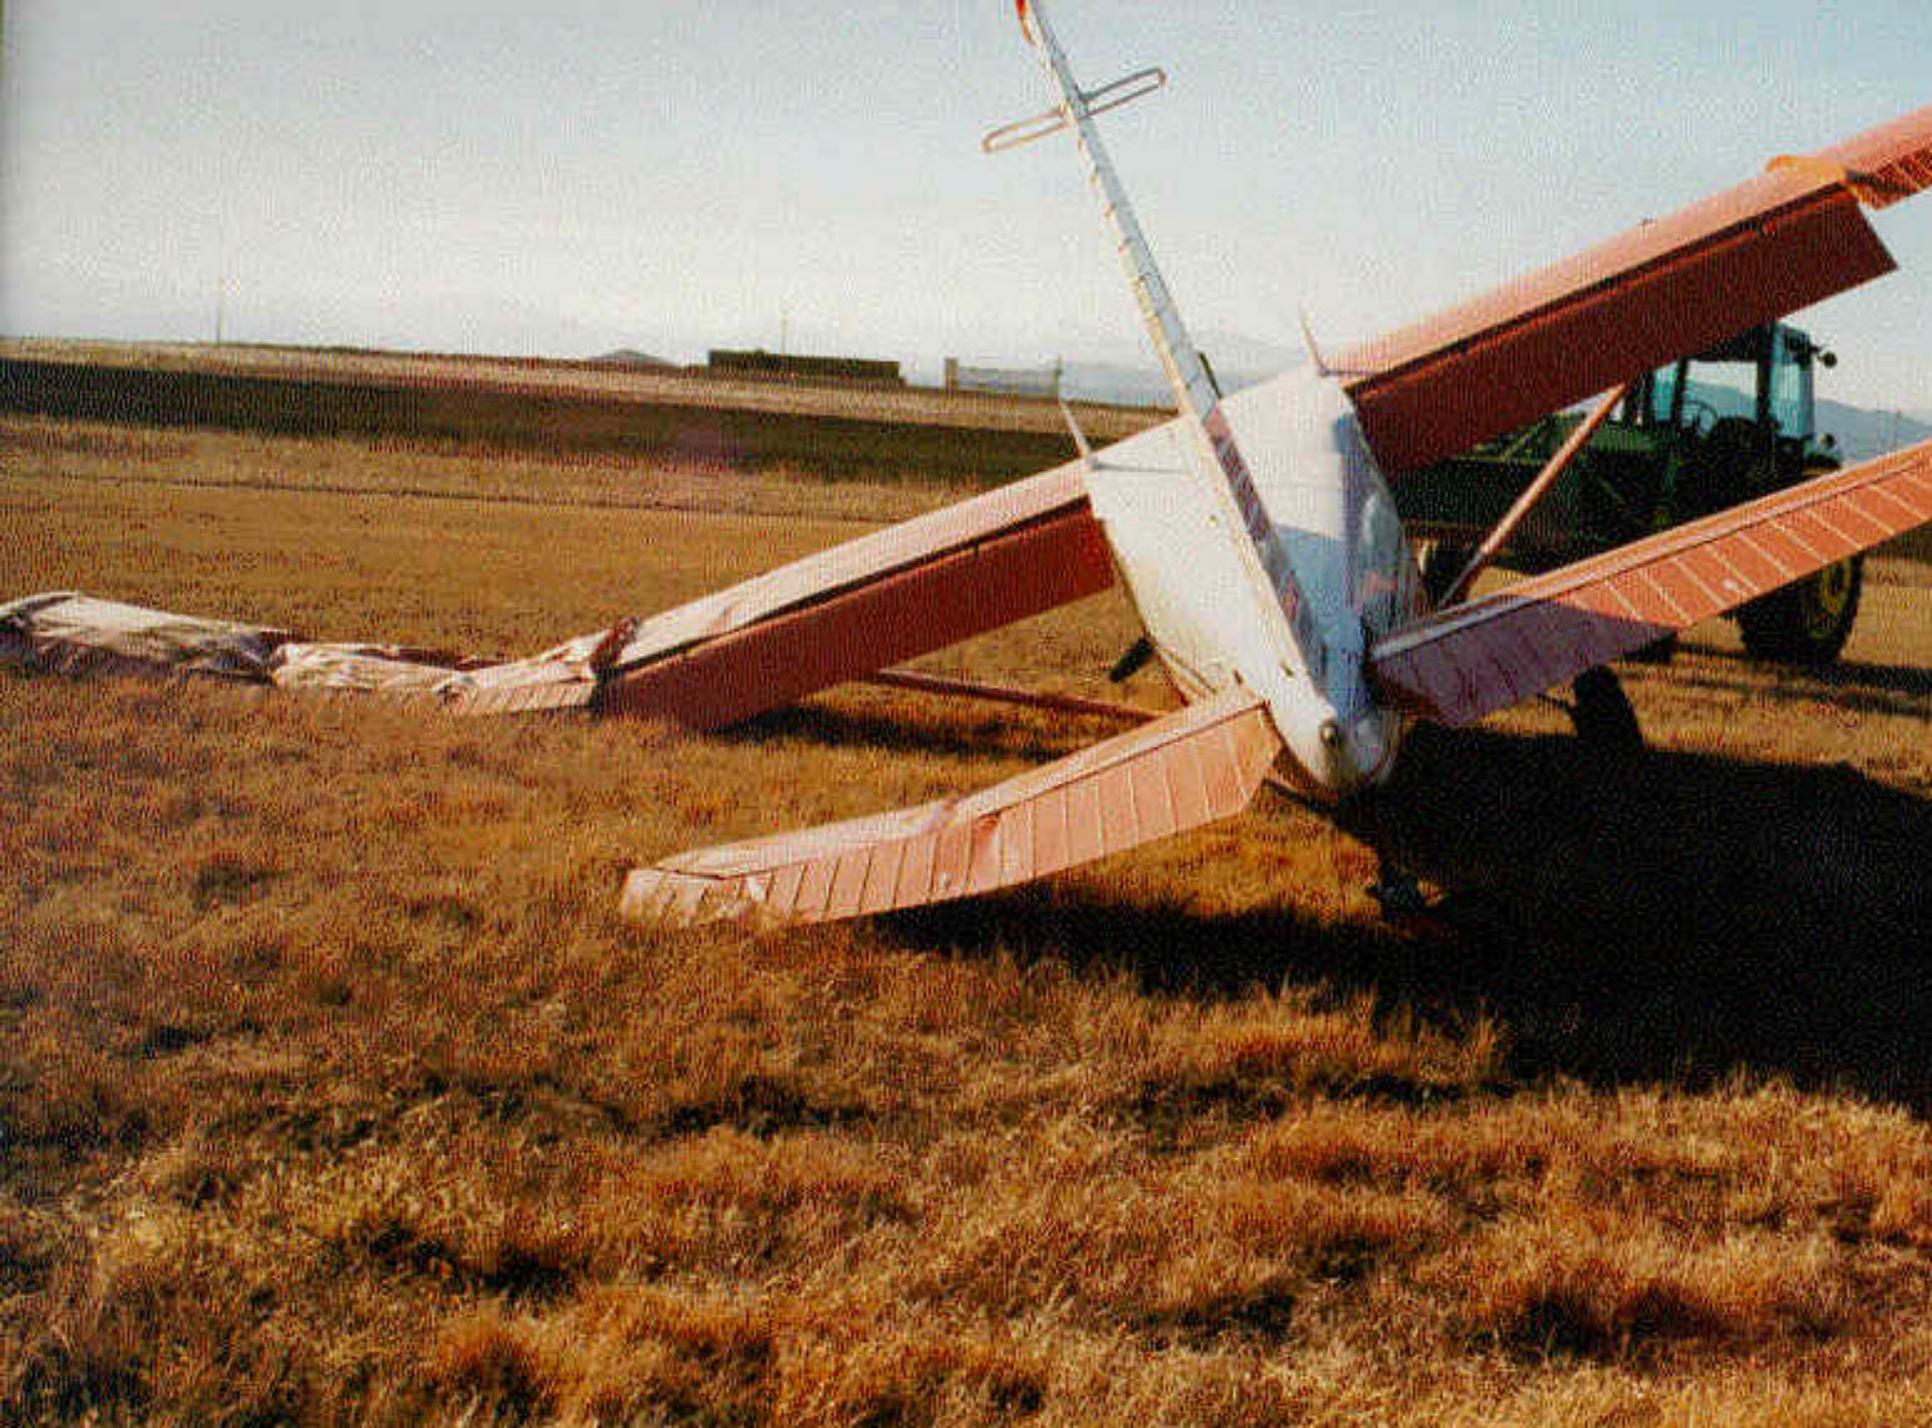
During a flight review, the flight instructor, who was at the controls, failed to maintain directional control as the aircraft touched down and the aircraft spun to the right (ground loop) striking the left wing on the runway.

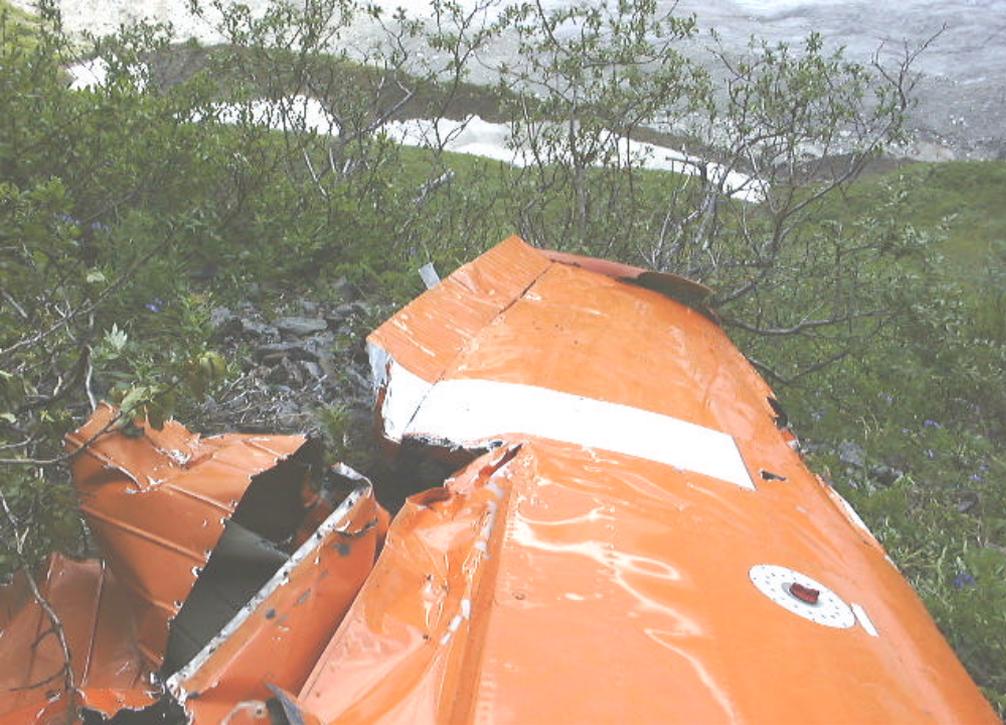
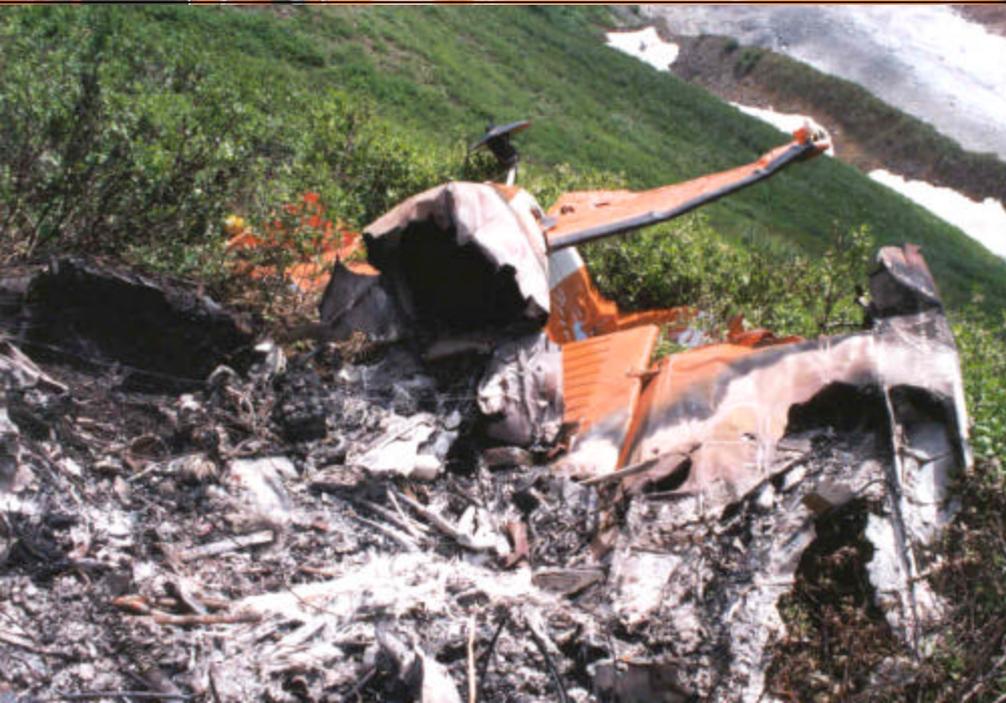
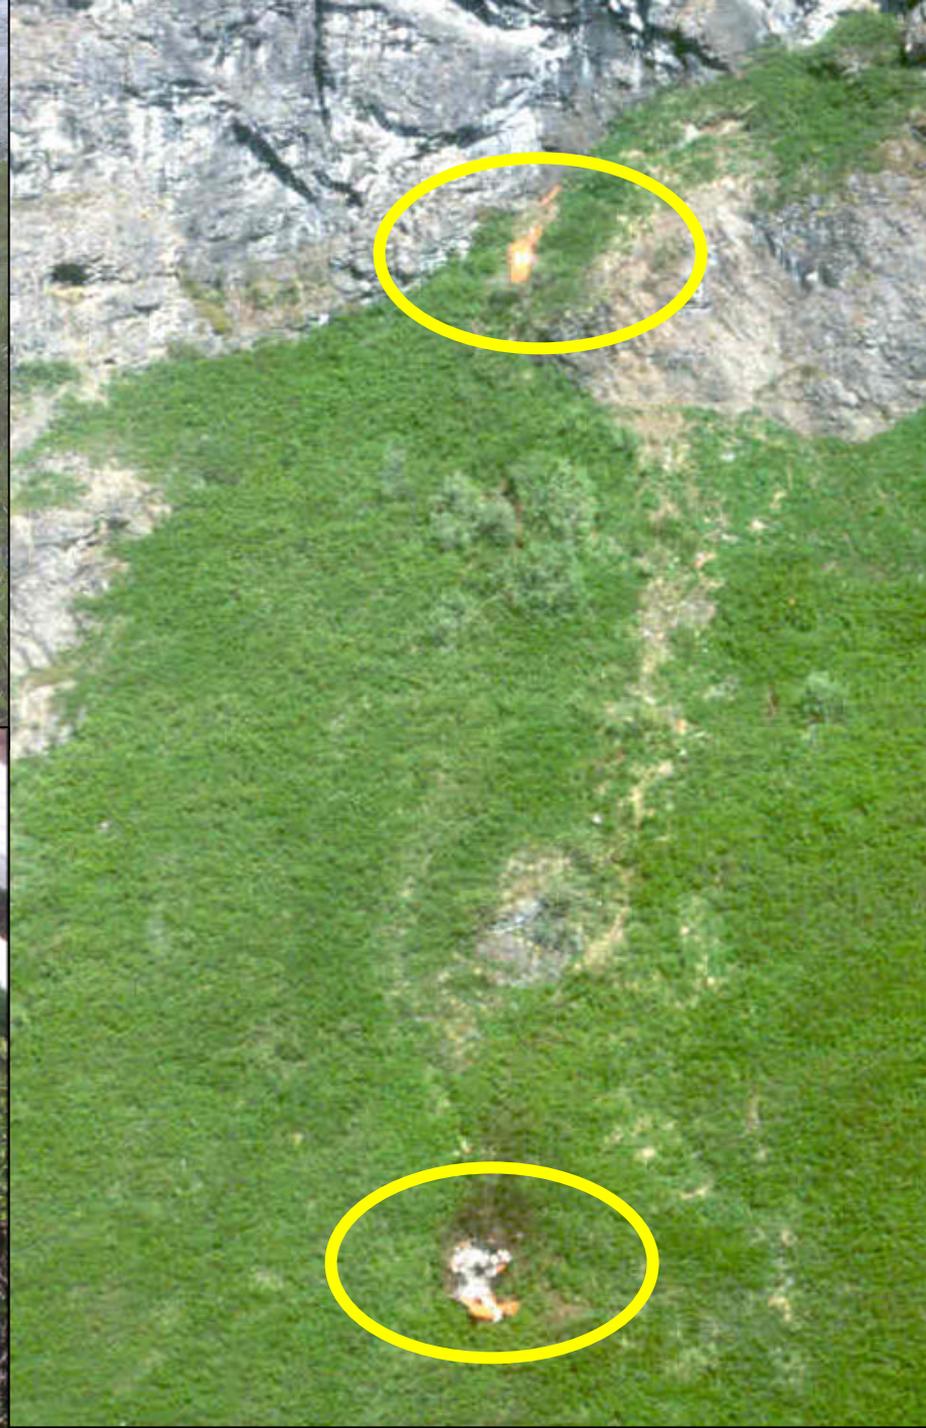
Debris

Left wing

Main fuselage

Approx 3000'
>45° slope

Engine

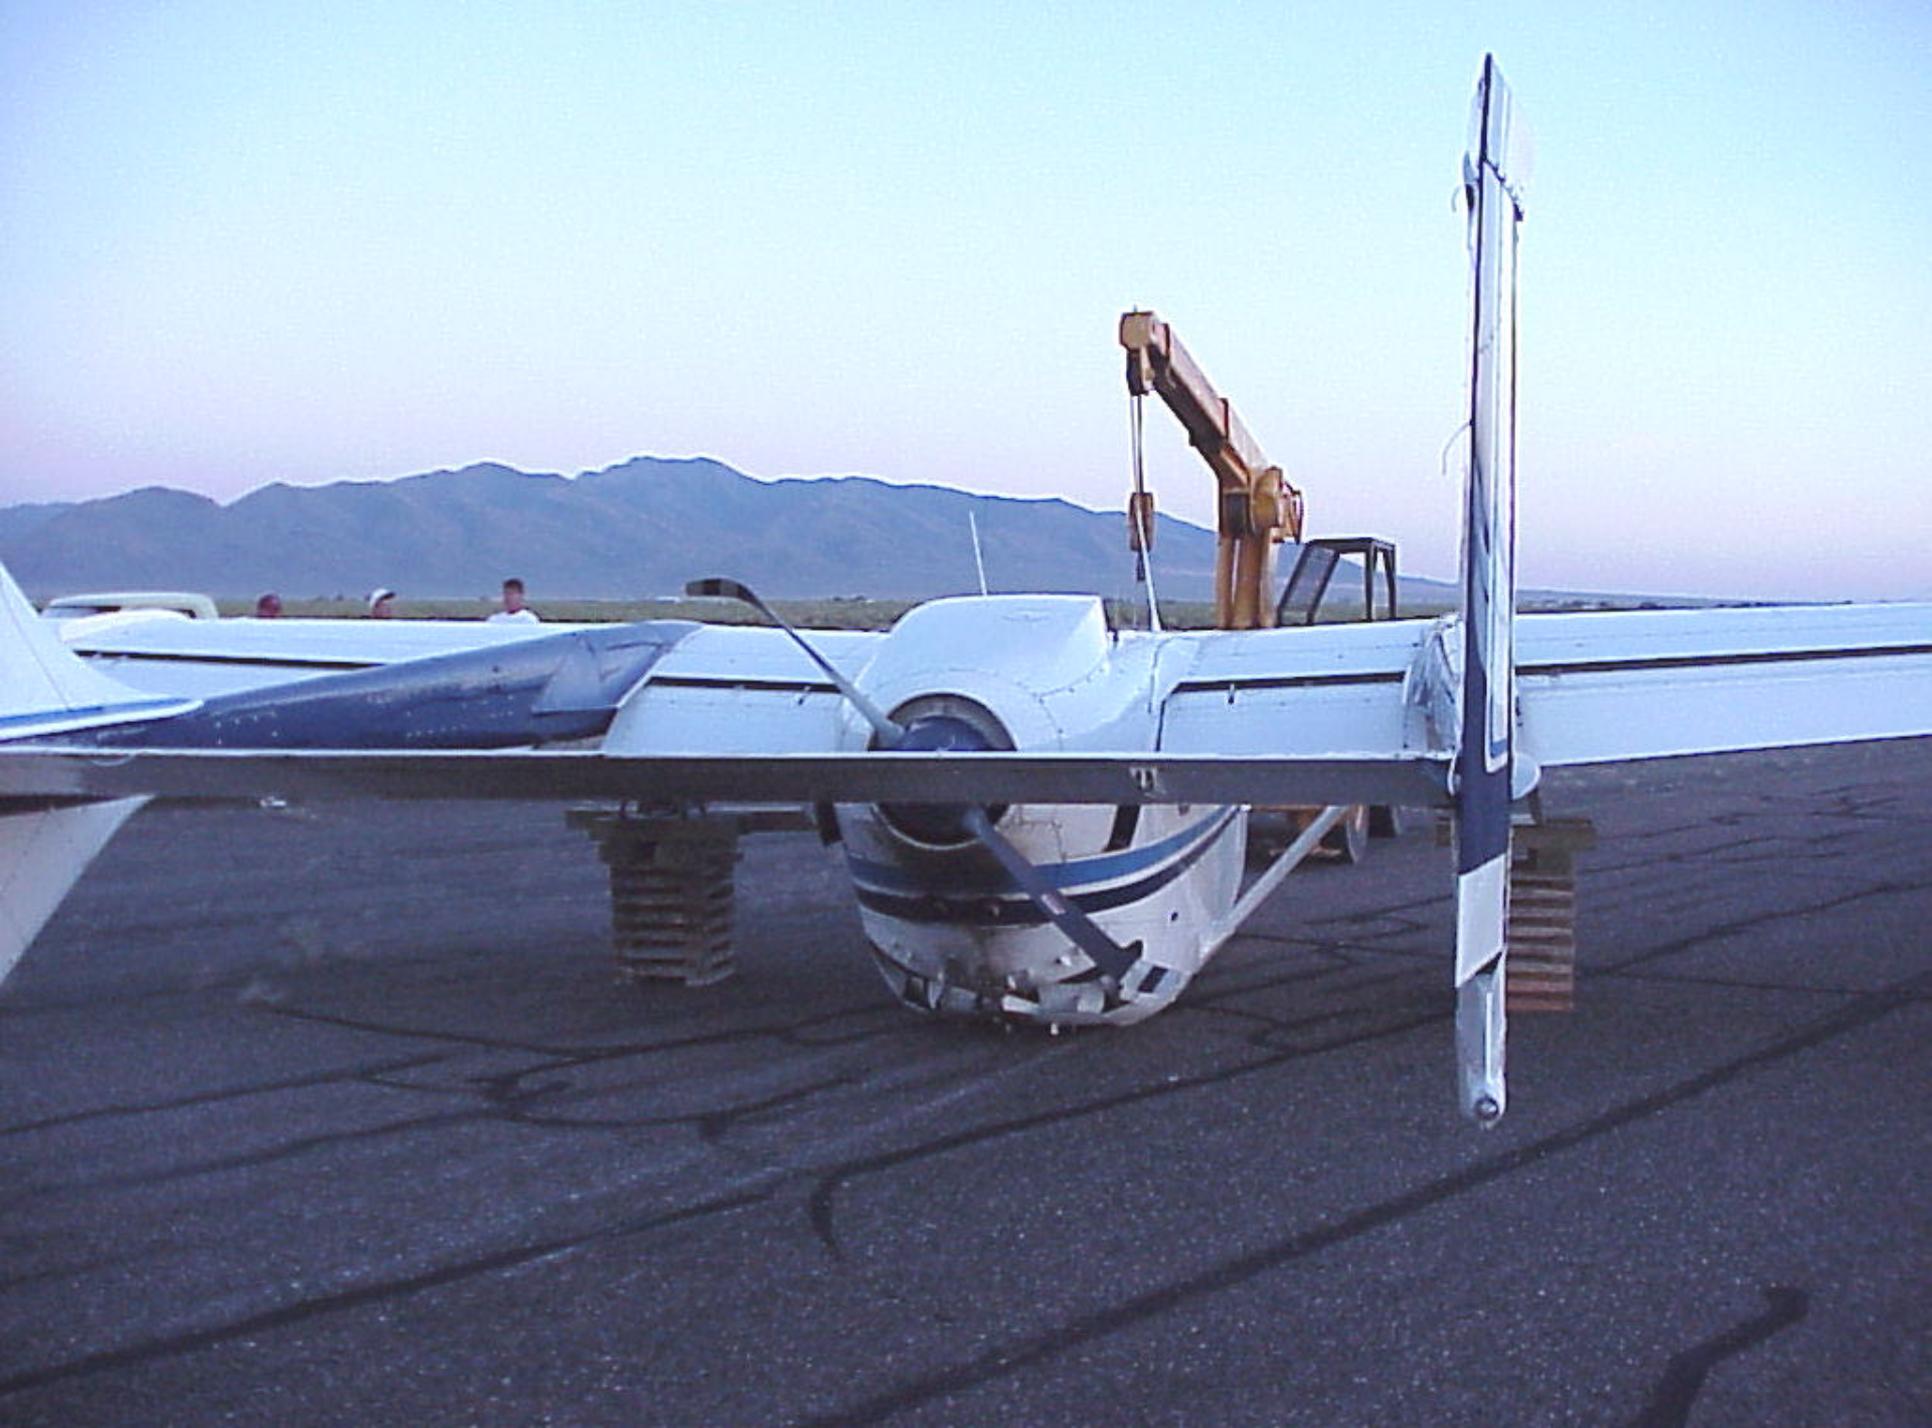
Structural Damage to Frame

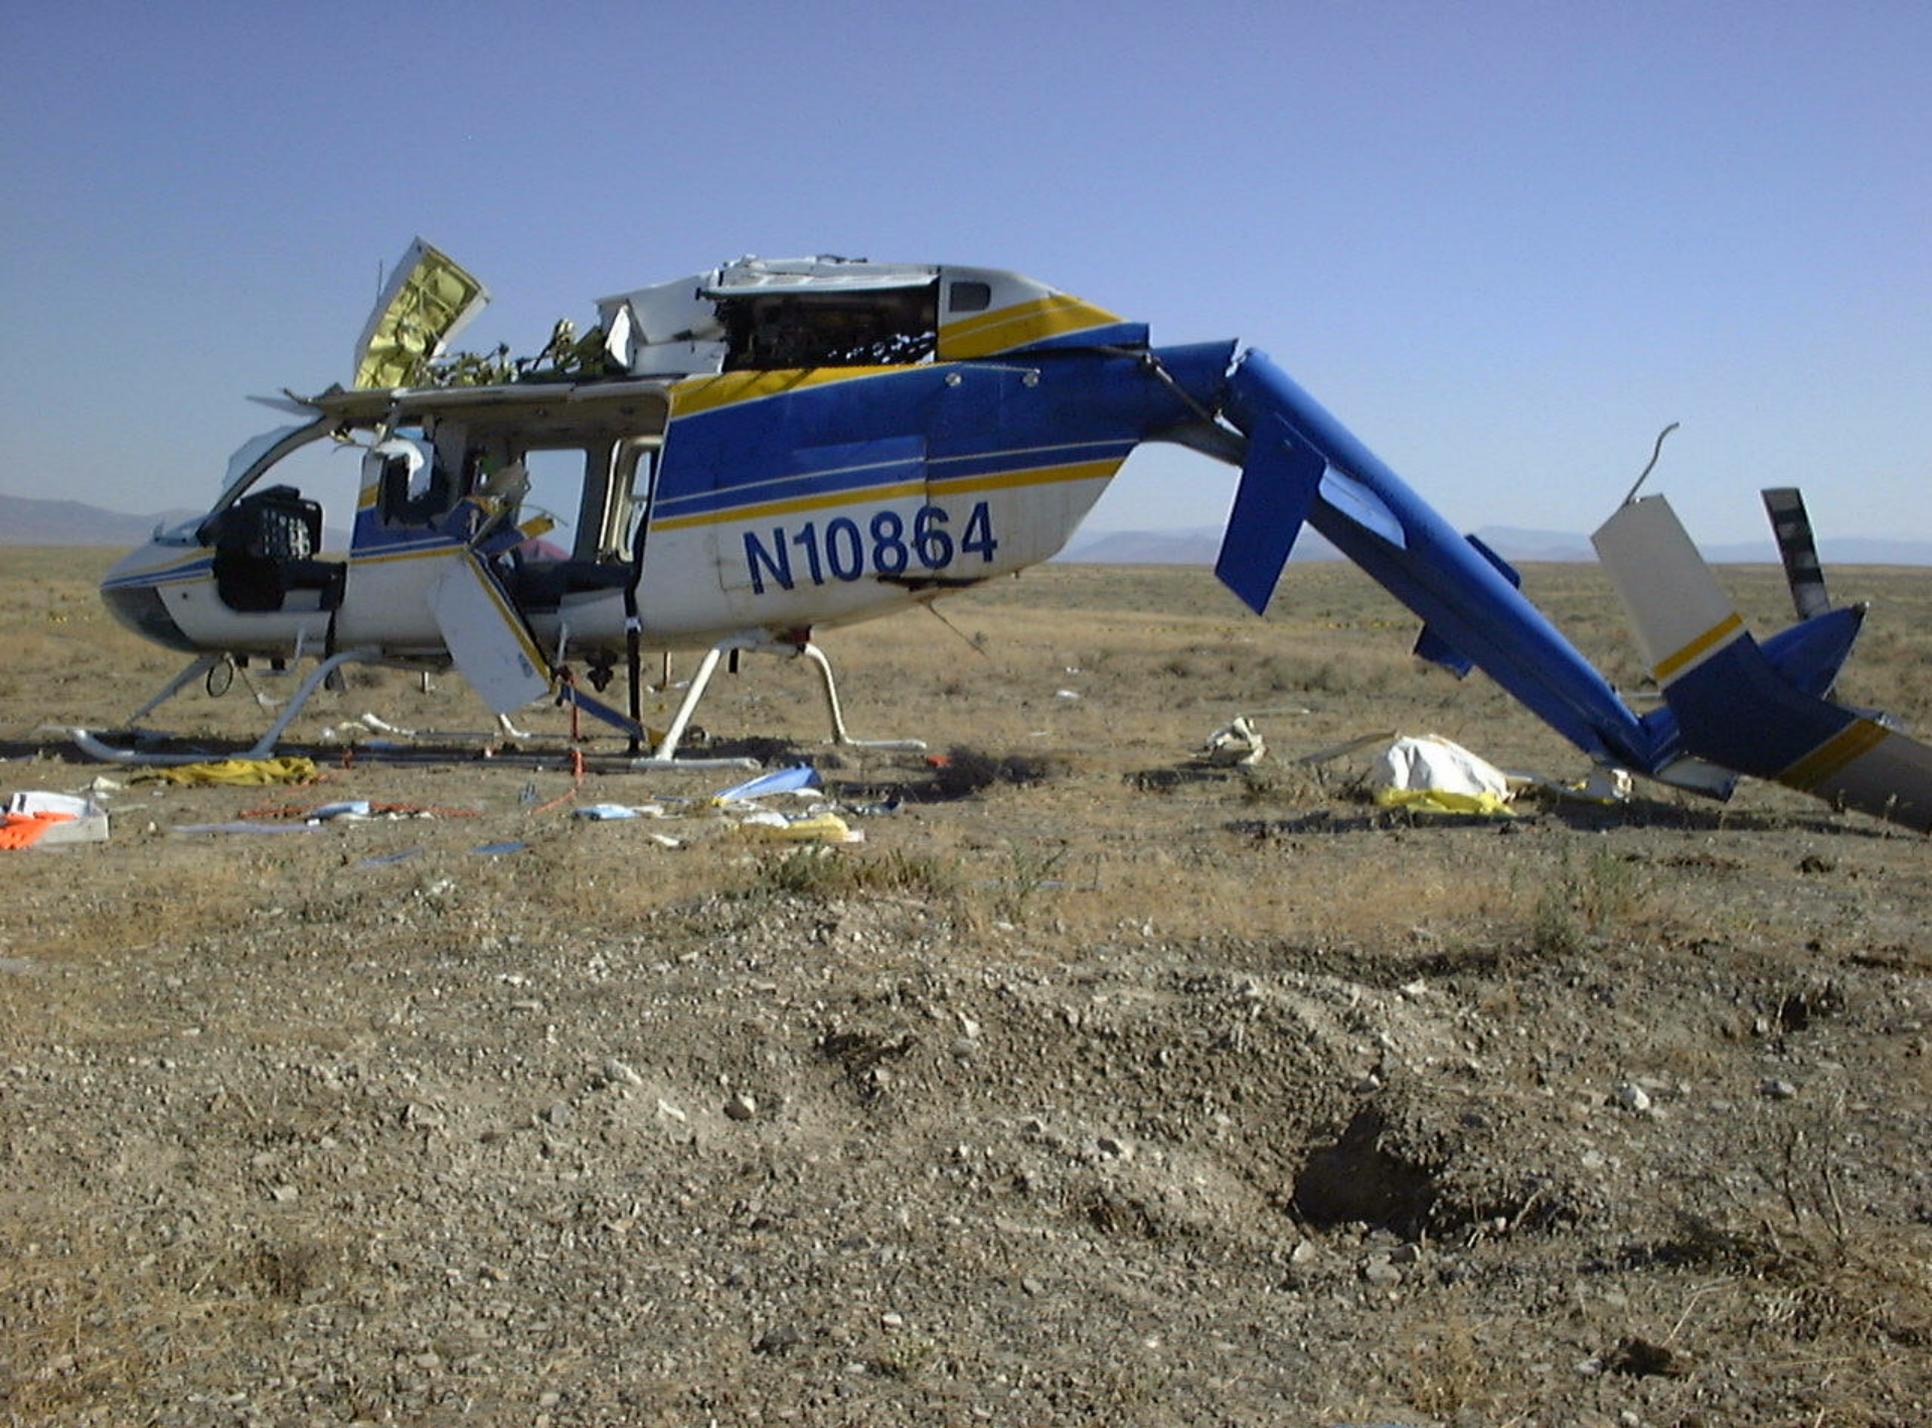
N10864

While on a mission to transport two firefighters, the helicopter was at a 2'-3' hover when it suddenly and violently rolled to the right. The main rotor separated and the aircraft came to rest on its skids. The passenger in the front left seat was seriously injured and the passenger in the left rear seat was fatally injured.

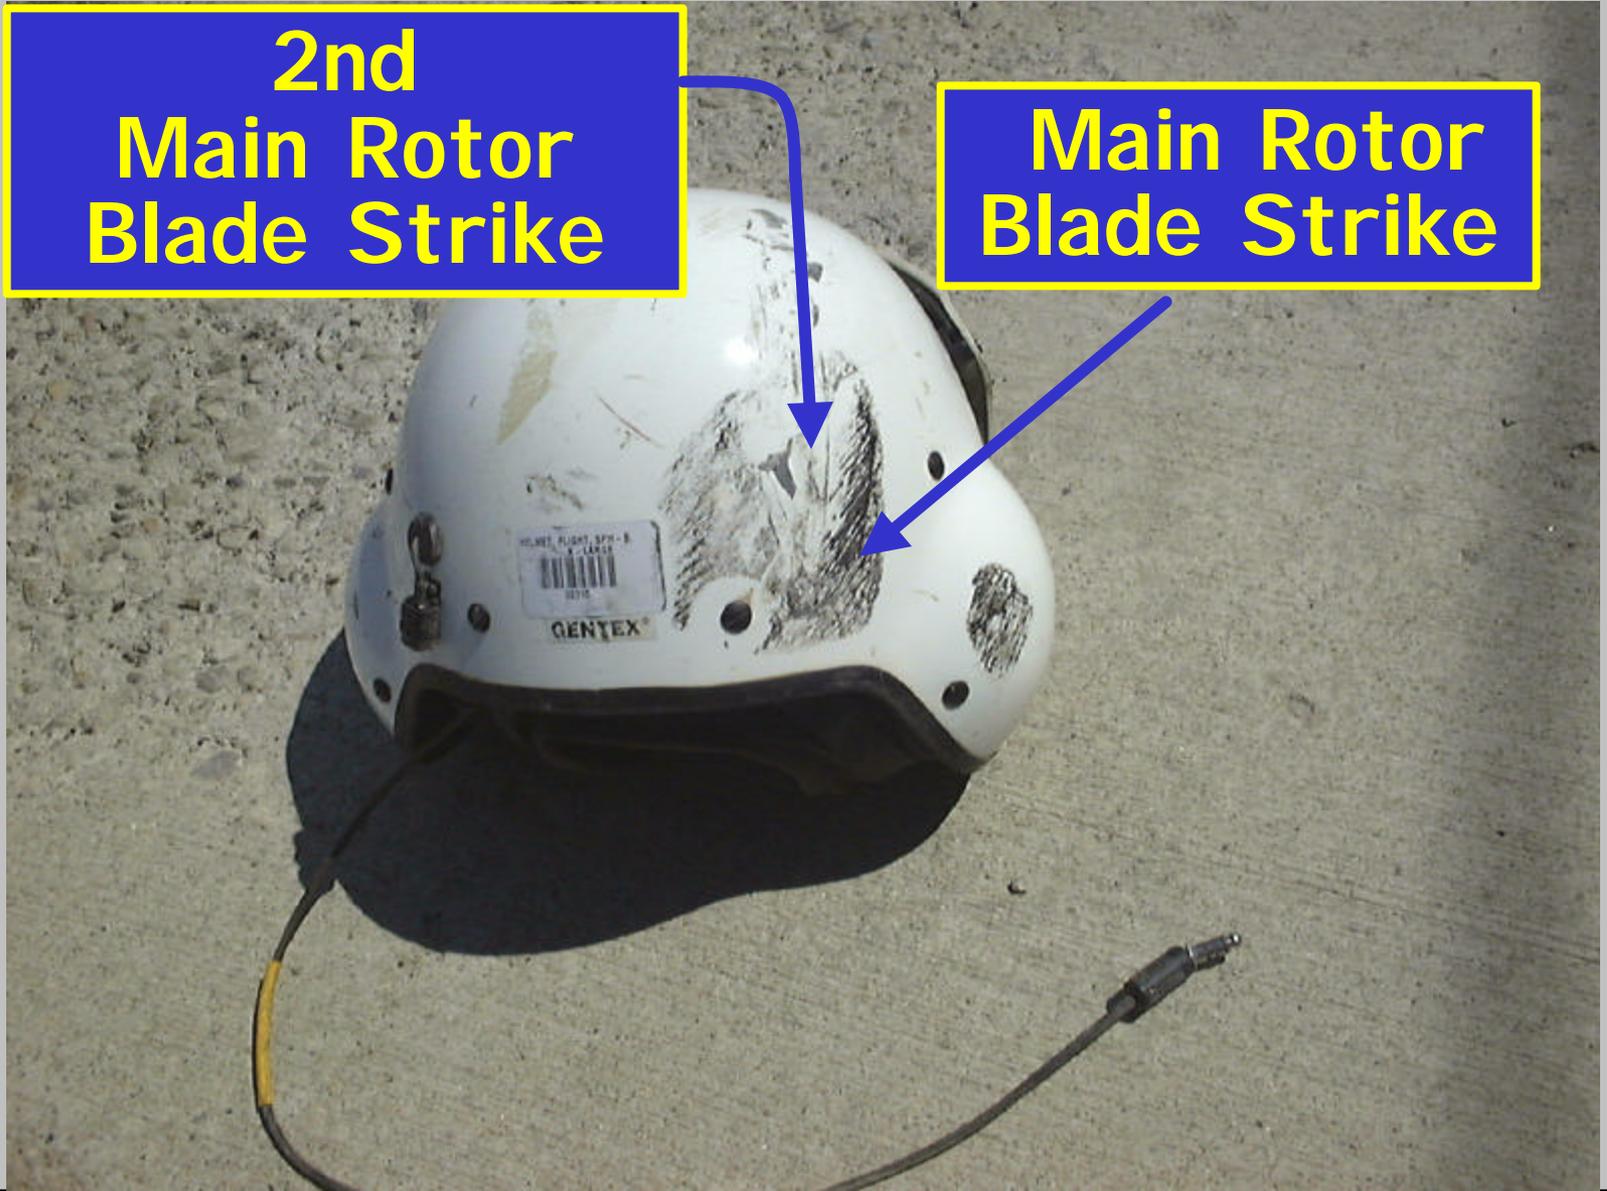
Left Front Passenger

**2nd
Main Rotor
Blade Strike**

**Main Rotor
Blade Strike**

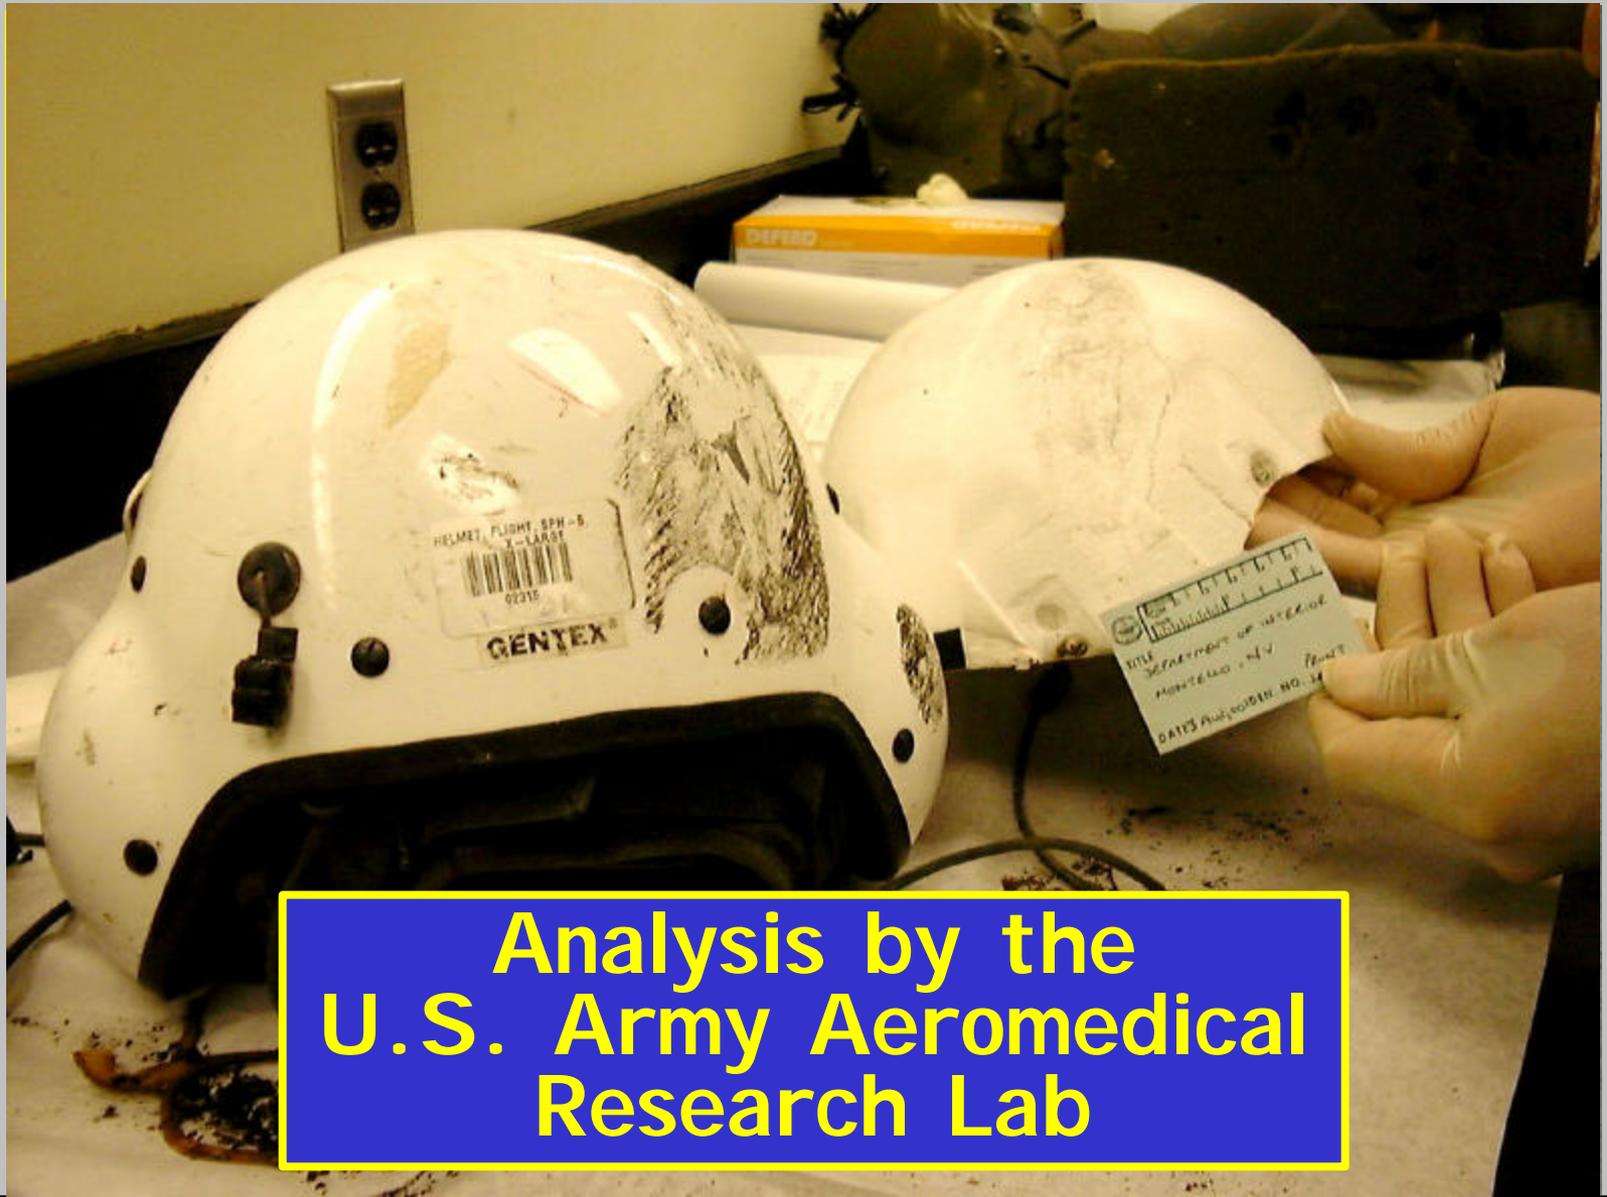
Left Front Passenger

**Analysis by the
U.S. Army Aeromedical
Research Lab**

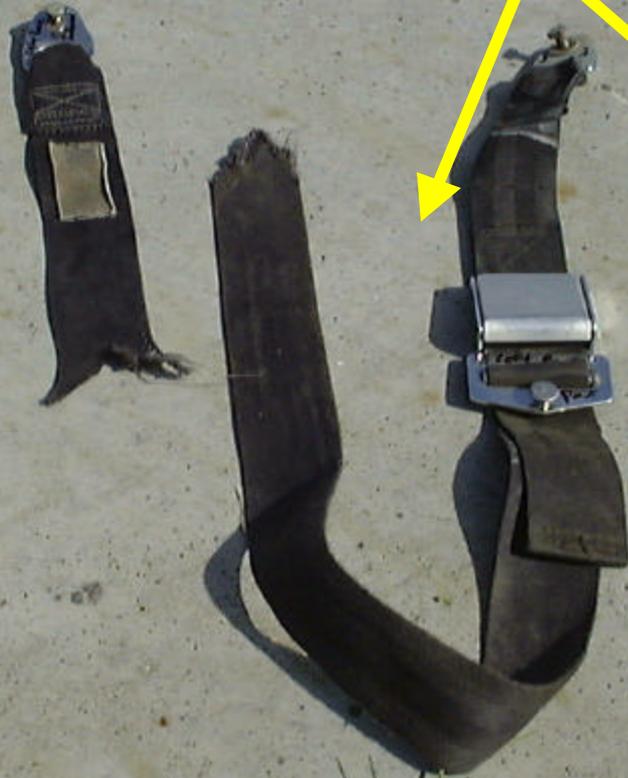
Left Rear Passenger

Seatbelt held

But a shoulder harness was not required and not installed

- How should DOI encourage maximum use of available ALSE (i.e helmets) ?
- Should DOI require the installation of dual shoulder harness restraint systems ?

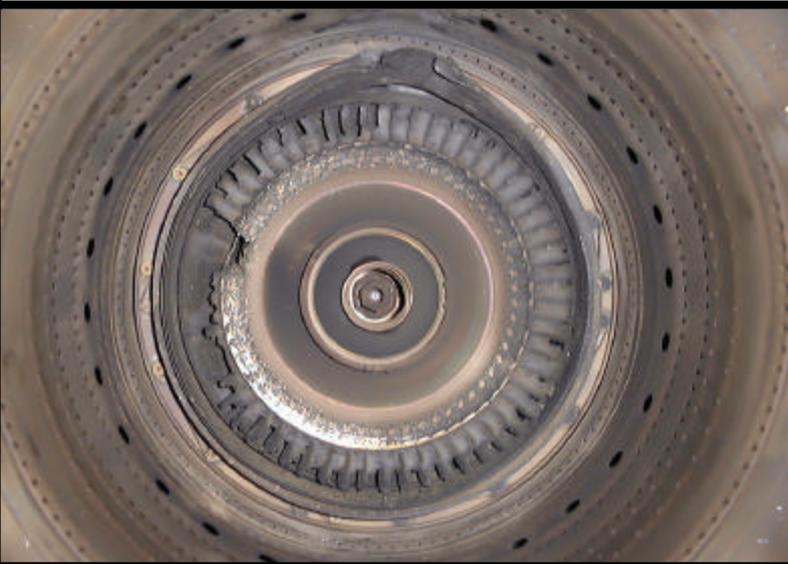
The investigation has revealed that the crash sequence began with a catastrophic failure in the #1 engine's compressor turbine (CT) section.

Detailed metallurgical analysis indicates the fracture of the #1 CT disc occurred as a result of cyclic stress rupture (*a phenomenon where at high temperature a material's strain resistance is compromised*).

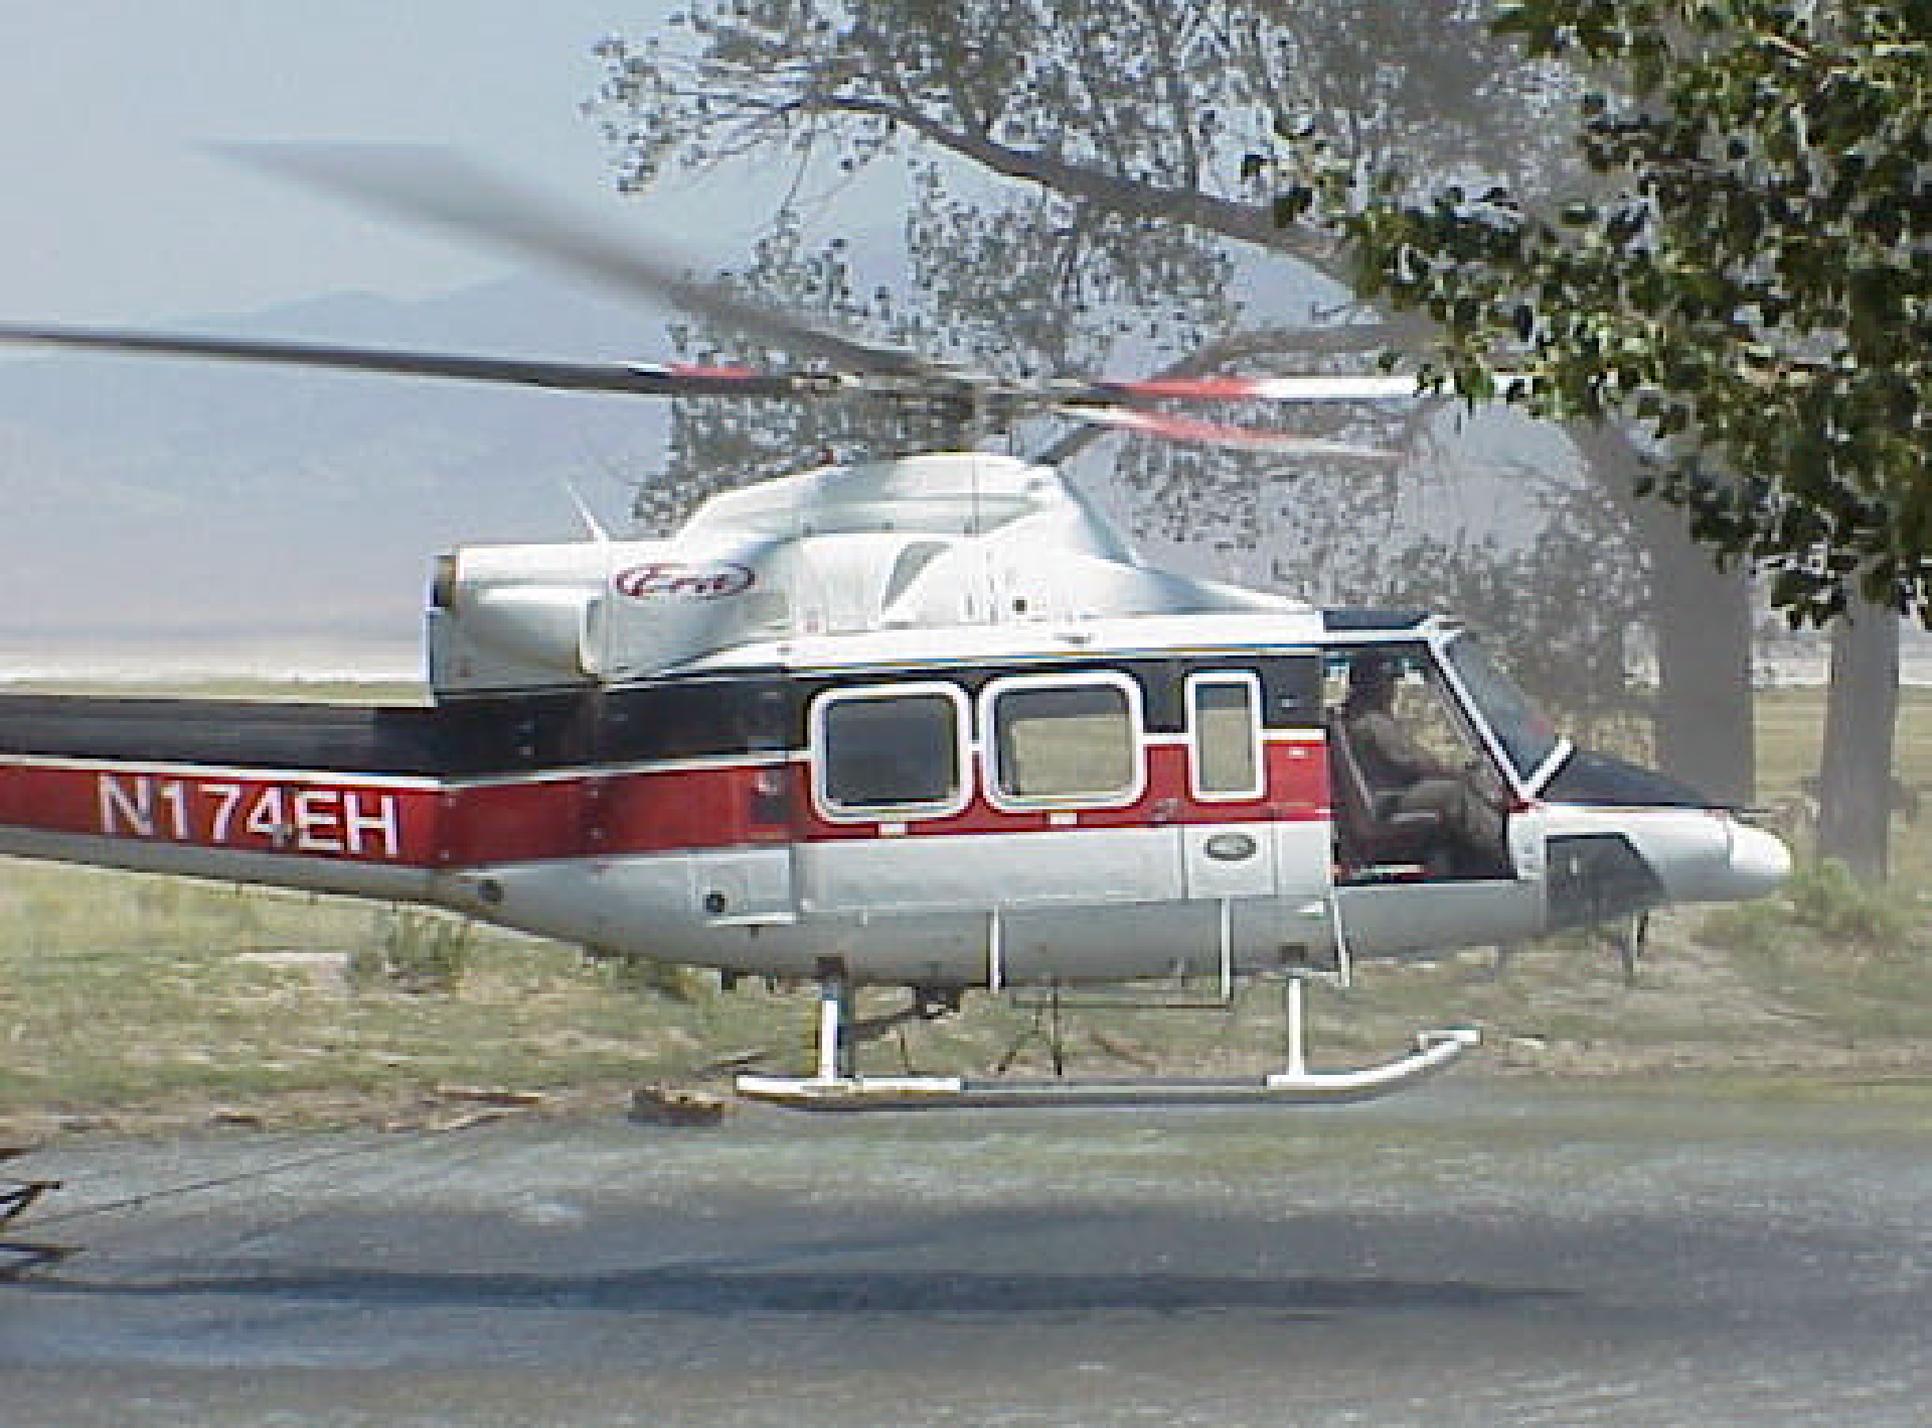
N174EH

"In summary, the CT disc failed due to stress rupture brought about by sustained operation near or above acceptable limits. No material or design deficiencies were identified." (Sidla, TSB)
