FY00

Department of the Interior Aviation Accident Review

Office of Aircraft Services

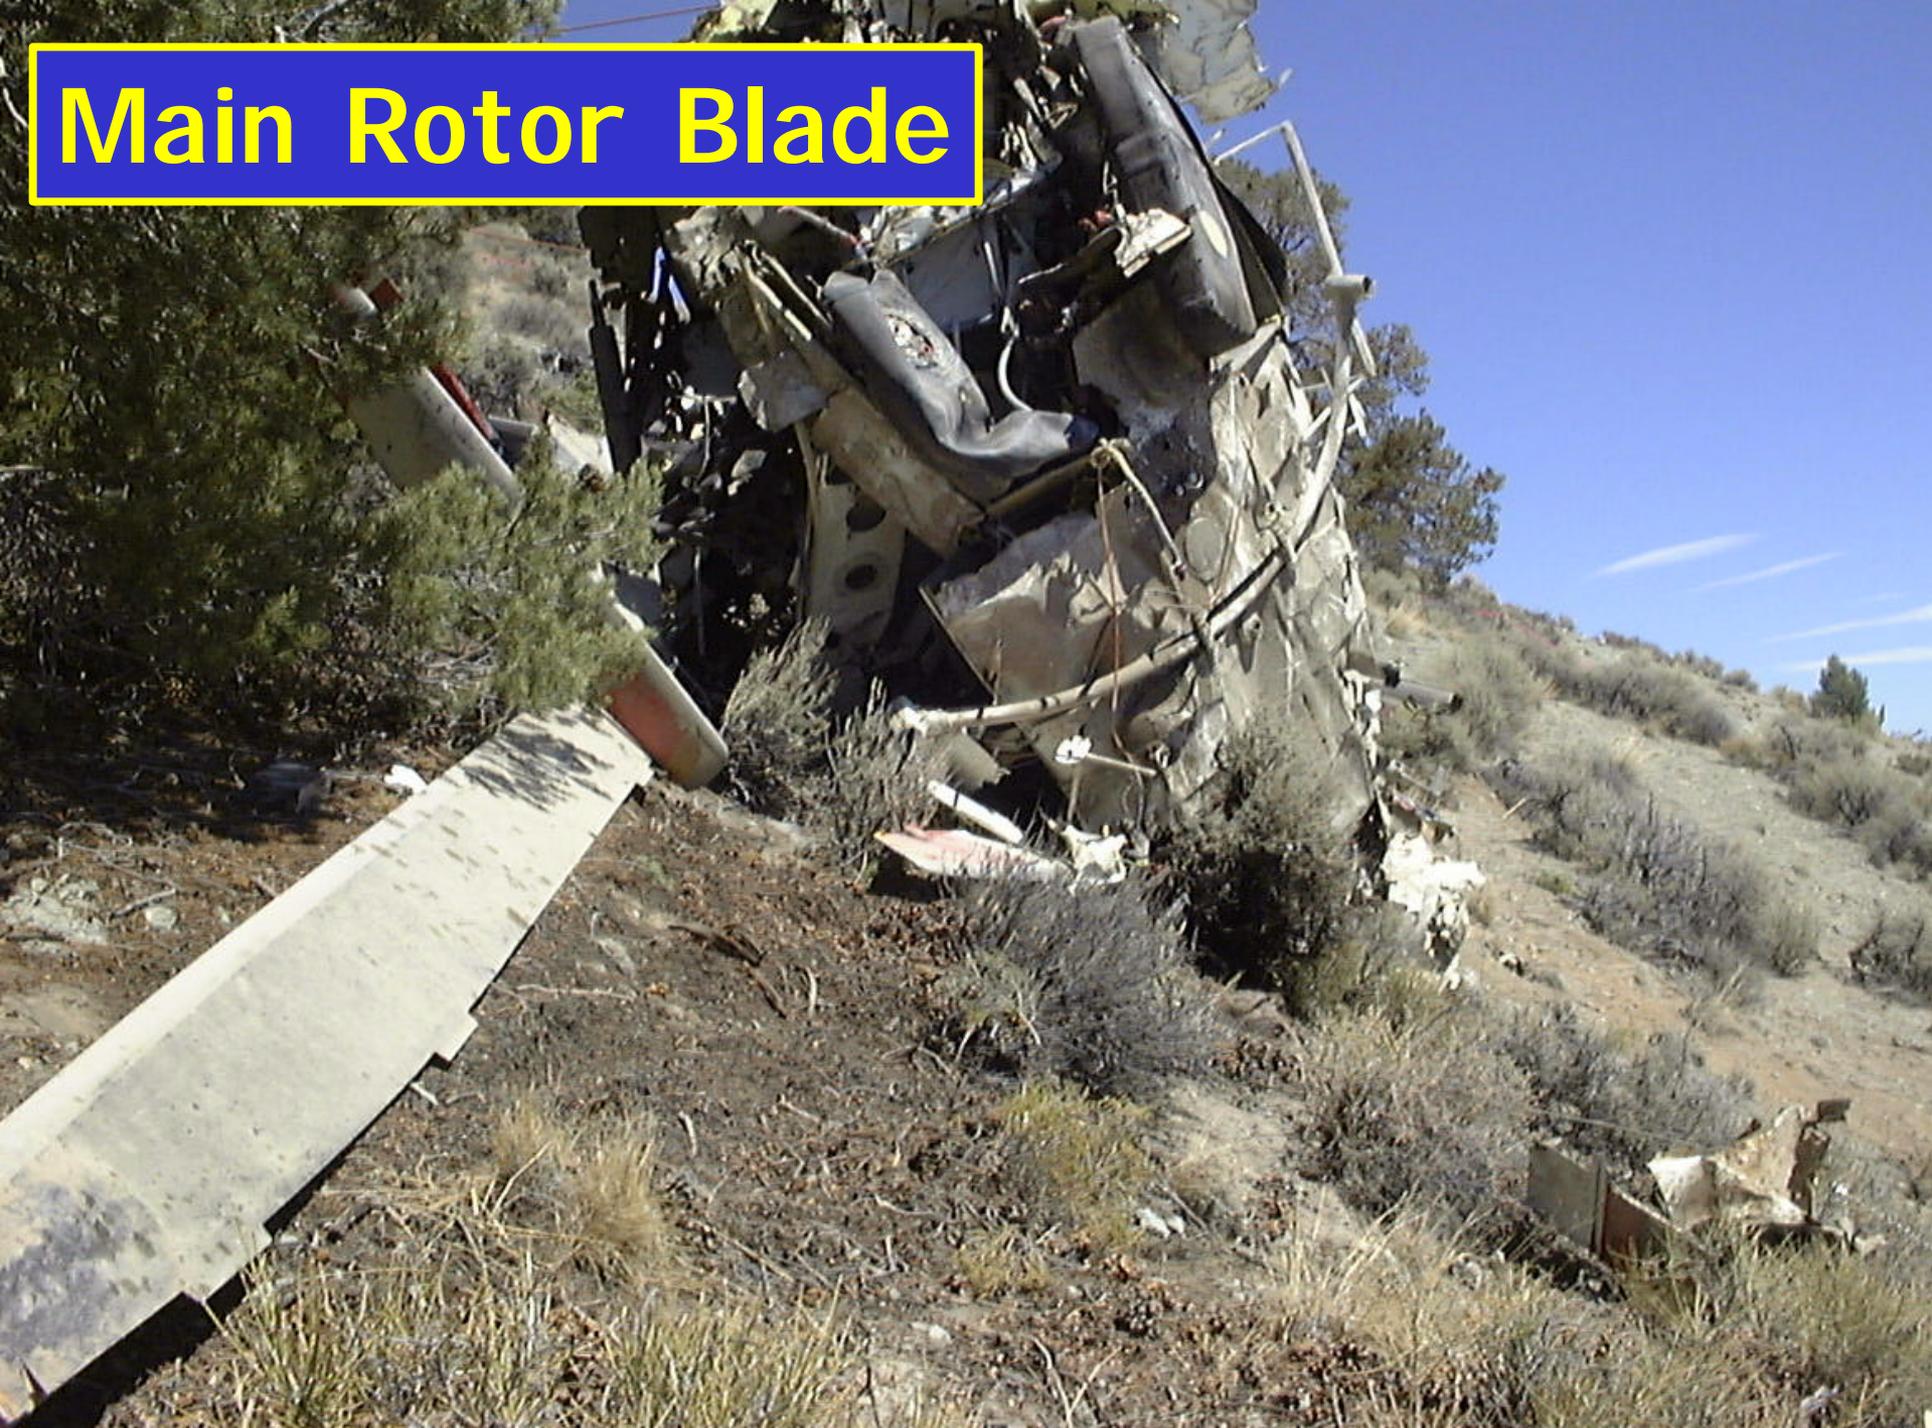
Main Rotor Blade

Tail Rotor

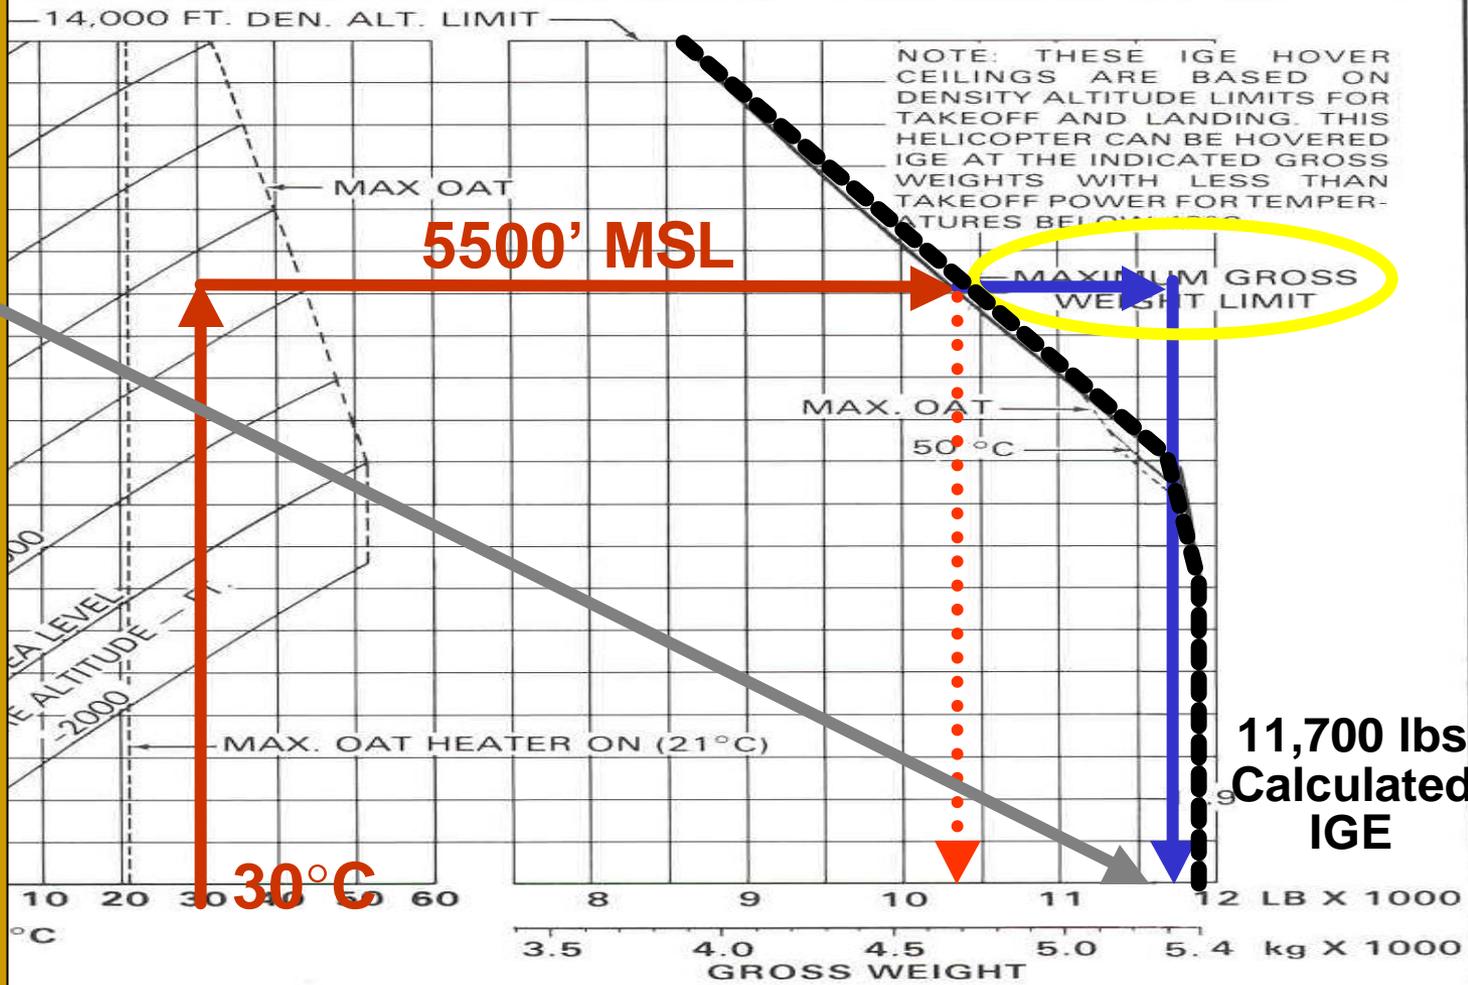
Figure 4-4. Hover ceiling in ground effect (Sheet 1 of 2)

Pilot's Flawed Aircraft Performance Planning

MODEL	412
NO.	174571
Date	8-13-00
Time	
Pressure ALT	5300
Temperature	+30
Pressure ALT	
Temperature	
	7380
	220
	1000
	8600
IGE	OGE
11700	11000
39	JBT
11310	11000
11,700	
11310	11000
8600	8600
2710	2400

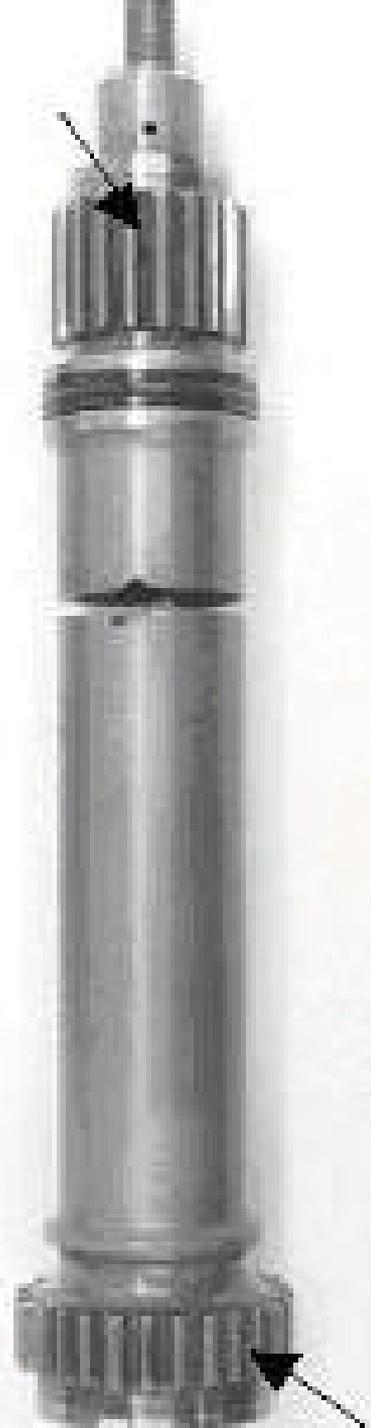
**Intermediate
Coupling Drive
Shaft assembly**

#2 Helical Gear Coupling Shaft

**Transverse
fracture due
to torsional
overload**

"Transverse fracture of the coupling shaft, which engages inside the clutch shaft, was due to torsional overload and was secondary."

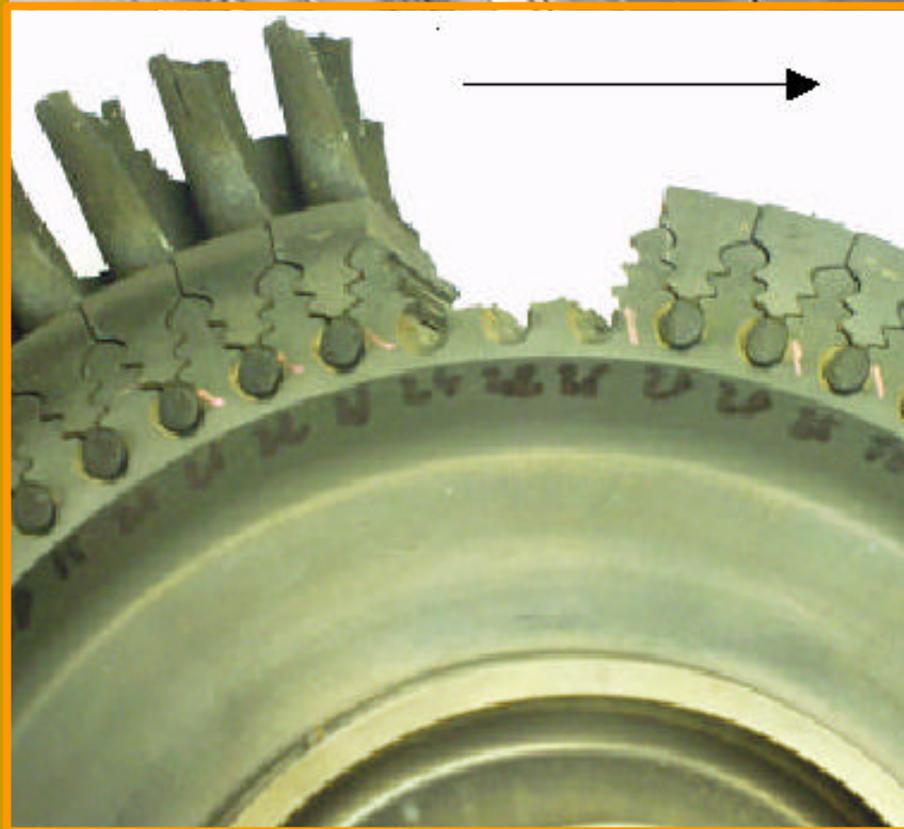
"Fracture of two firtrees of the P.S. no.1 CT disc occurred as a result of cyclic stress rupture."

NOTE: Stress Rupture or Cyclic Stress Rupture refers to a phenomenon of high temperatures where a material's strain resistance is compromised."

"Cracking associated with necking was observed in about a dozen firtrees on the upstream face."

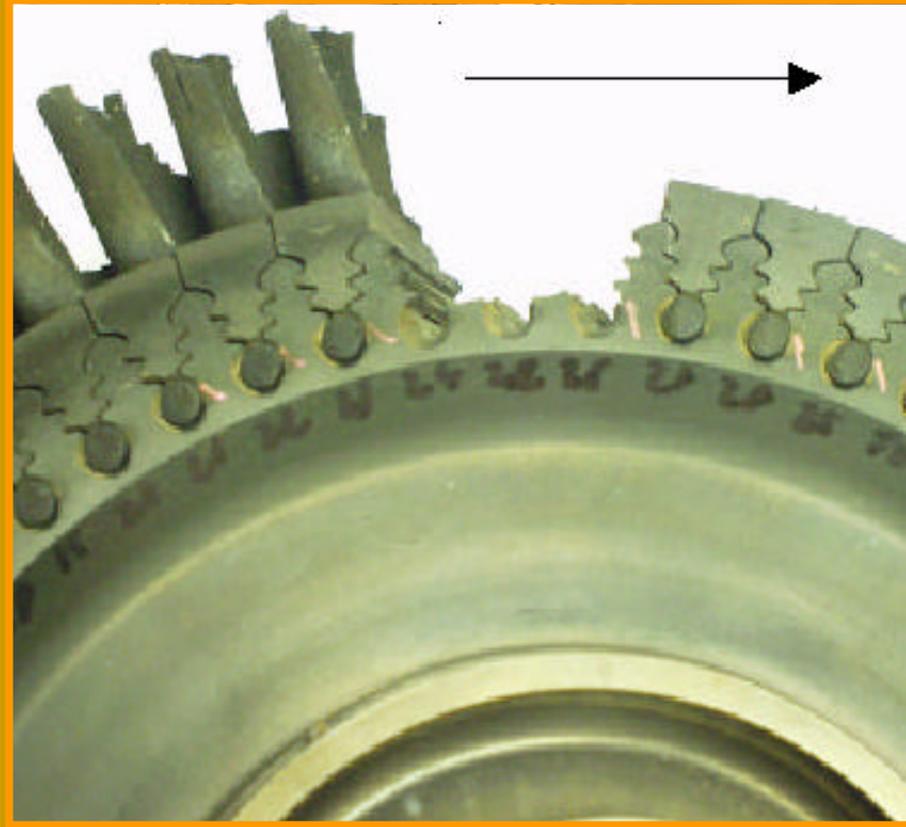
"No microstructure changes were observed in the CT disc firtree."

"Results of dimensional measurements detected growth all around and deformation in the area of the fractures and diametrically opposite, corresponding with the cracking / stretching of the firtrees."

"The CT blades of above disc had fractured by tensile overload promoted by overheating."

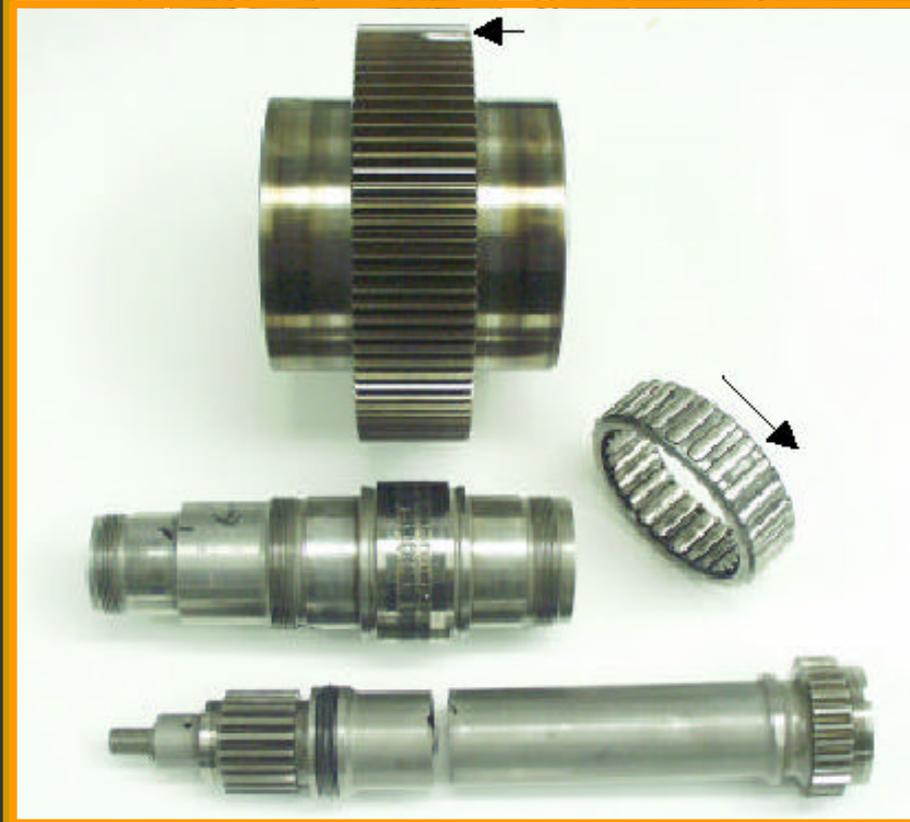
"Damage of the clutch drive shaft and the sprag clutch assembly was due to adhesive wear characteristic of sudden seizure."
